## Baseline Assessment – Stream Attributes

### Reach S-EE1 (Timber Mat Crossing) Ephemeral Spread D Nicholas County, West Virginia

**Spread D Stream S-EE1 (Timber Mat Crossing) Nicholas County**

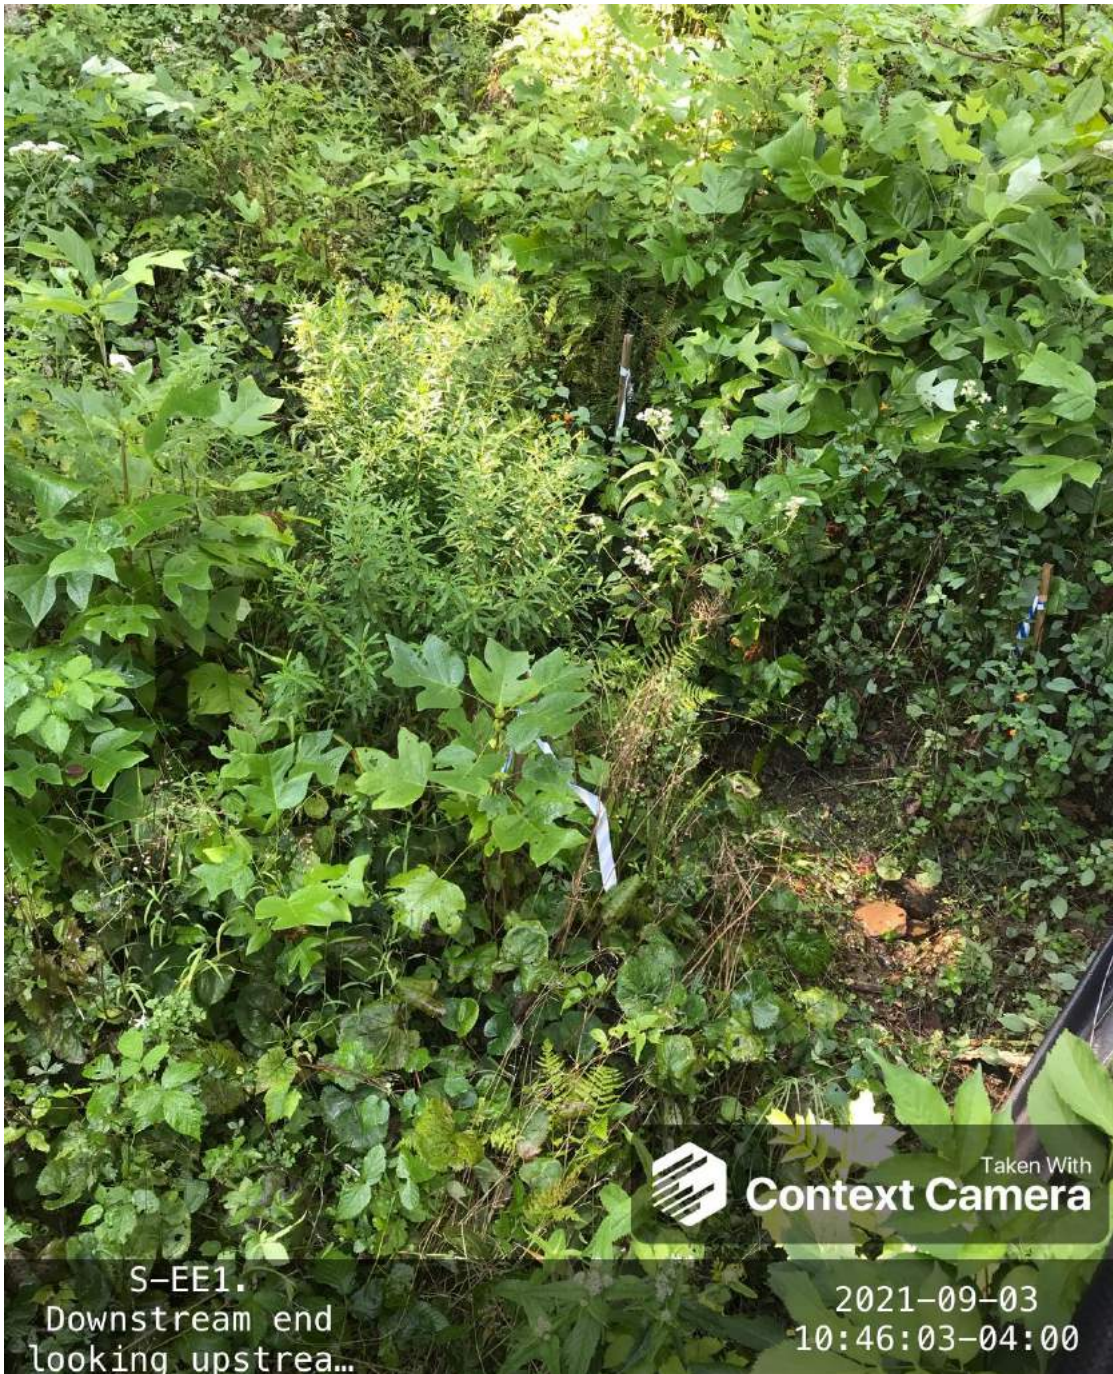
Photo Type: DS, US View  
Location, Orientation, Photographer Initials: Downstream Edge of ROW, Upstream View, SM, KP  
Lat: 38.228921 Long: -80.713076

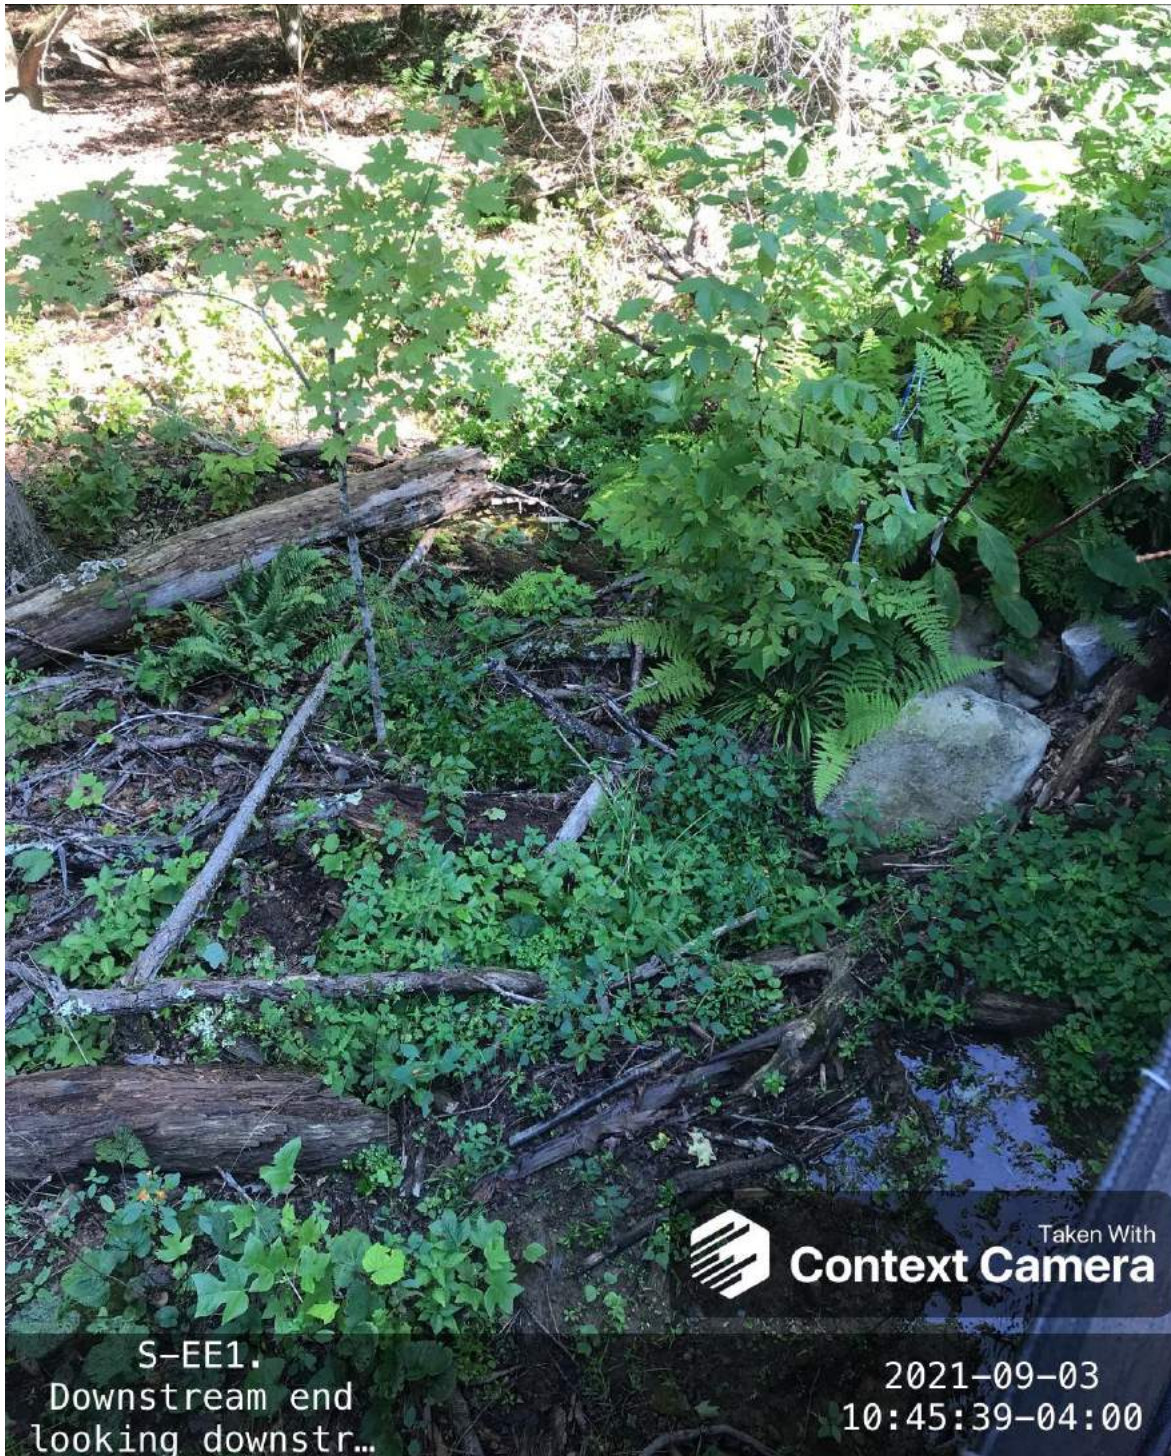
Photo Type: DS, DS View  
Location, Orientation, Photographer Initials: Downstream Edge of ROW, Downstream View, SM, KP  
Lat: 38.228921 Long: -80.713076

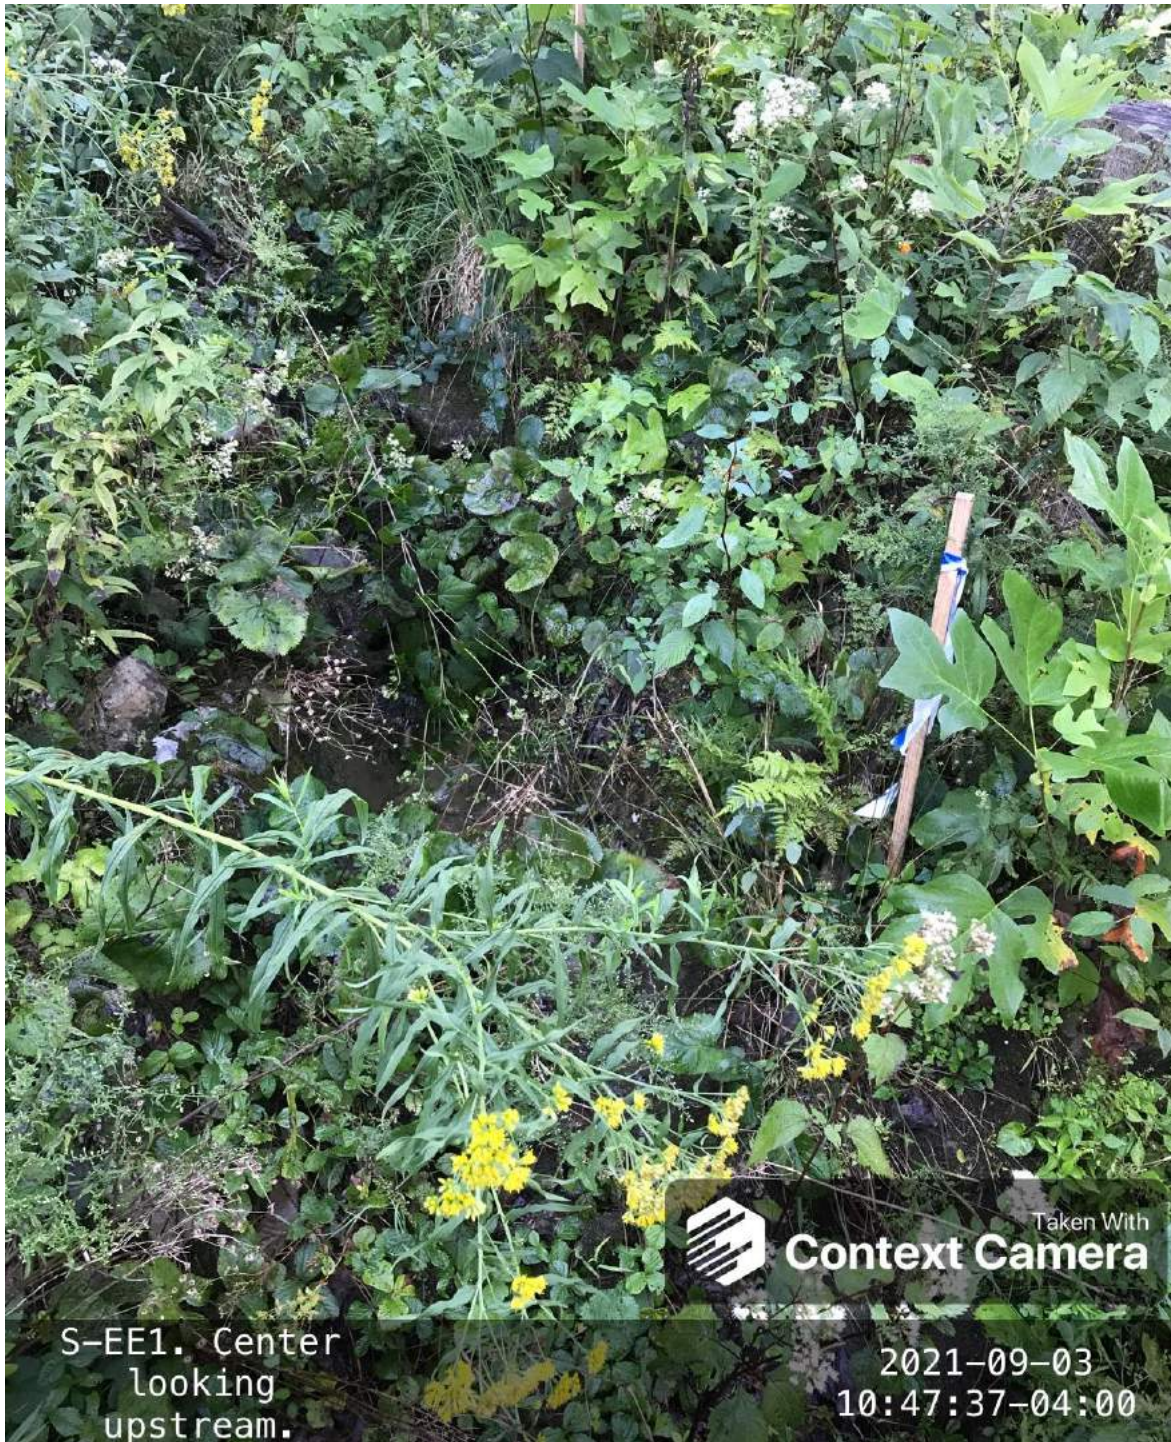
Photo Type: US View at Center  
Location, Orientation, Photographer Initials: Center ROW, Upstream View, SM, KP  
Lat: 38.228921 Long: -80.713076

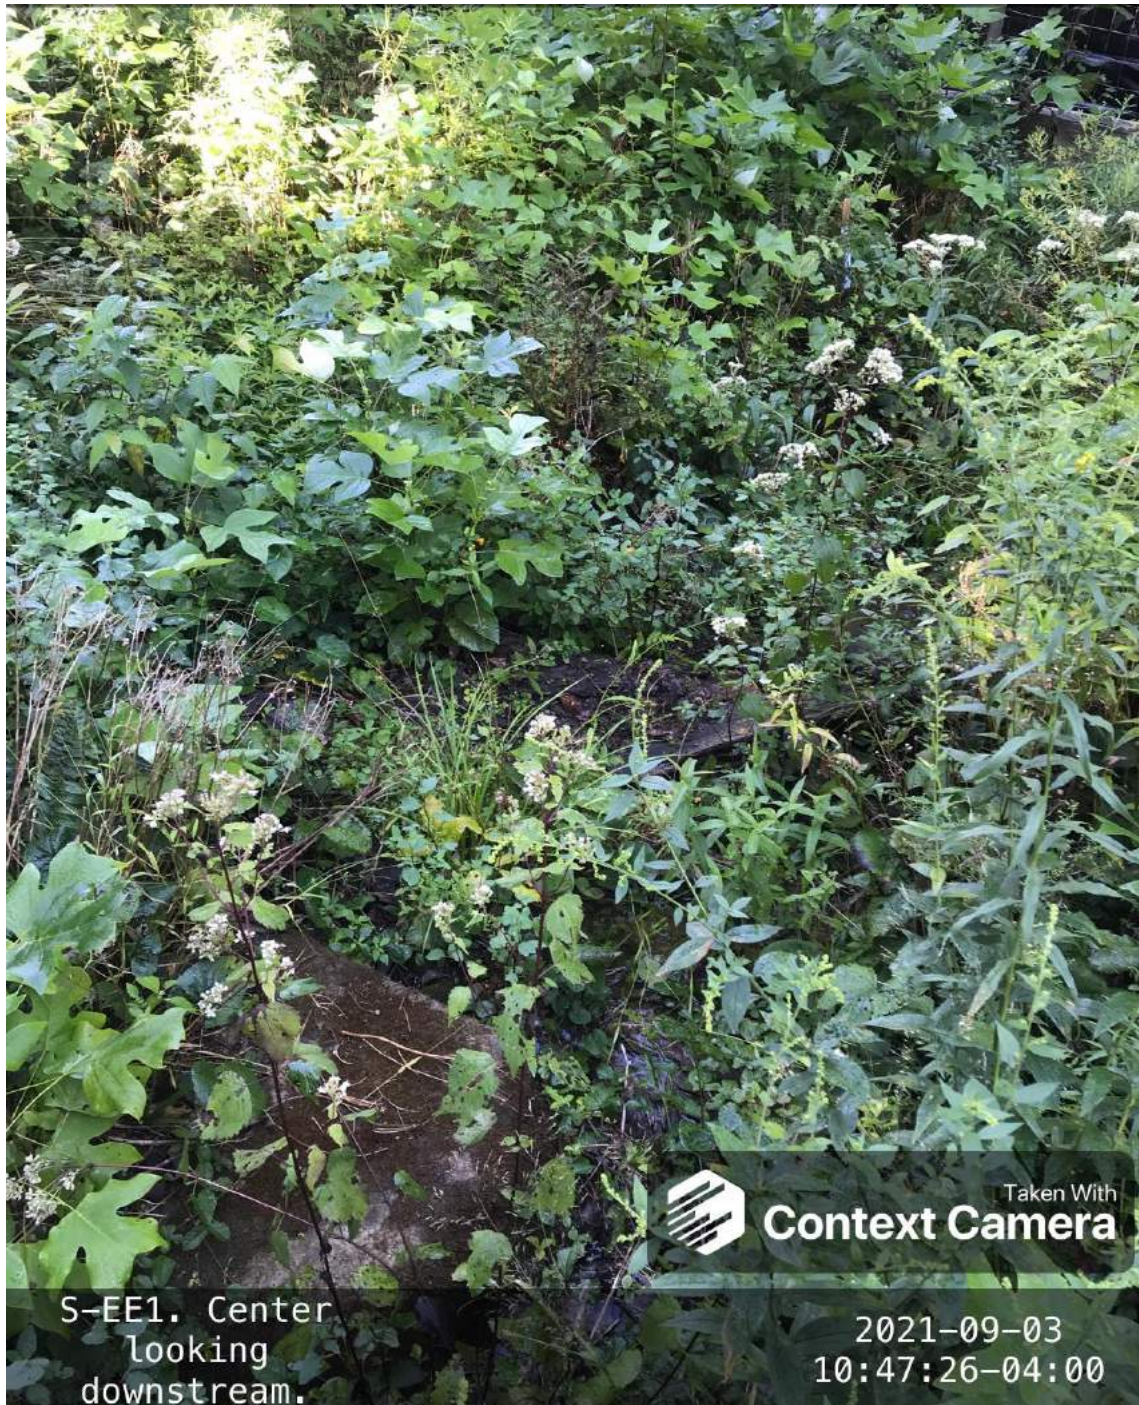
Photo Type: DS View at Center  
Location, Orientation, Photographer Initials: ROW Center, Downstream View, SM, KP  
Lat: 38.228921 Long: -80.713076

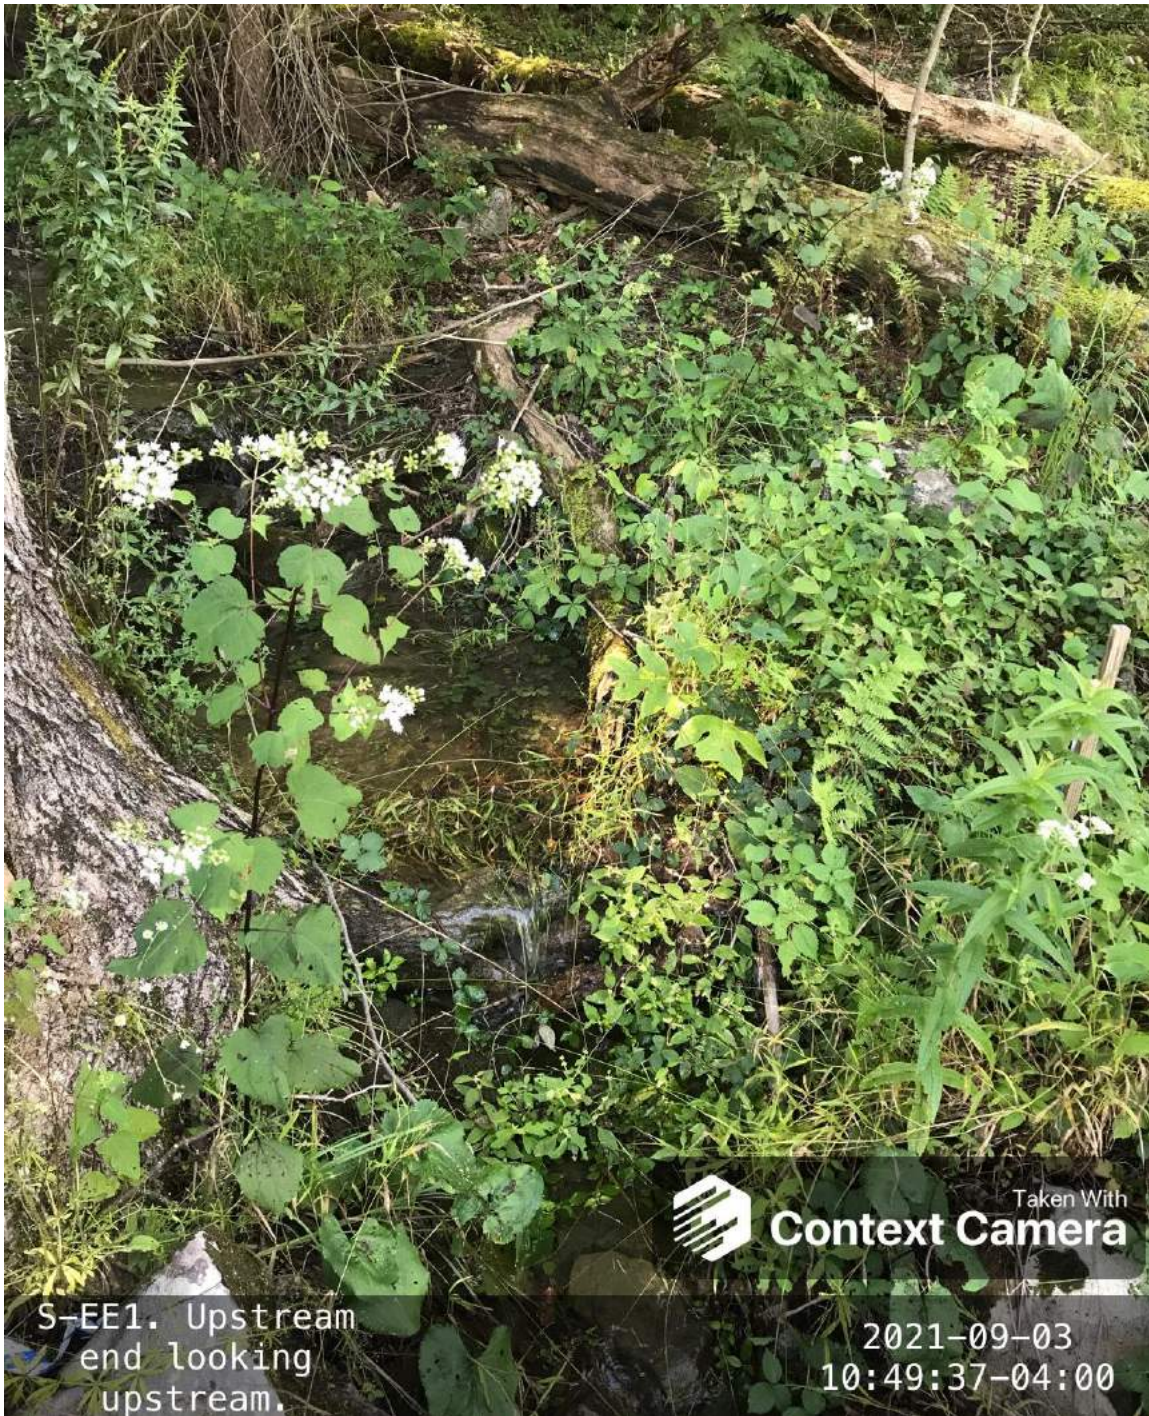
S-EE1. Upstream  
end looking  
upstream.

Photo Type: US, US View  
Location, Orientation, Photographer Initials: Upstream Edge of ROW, Upstream View, SM, KP  
Lat: 38.228921 Long: -80.713076

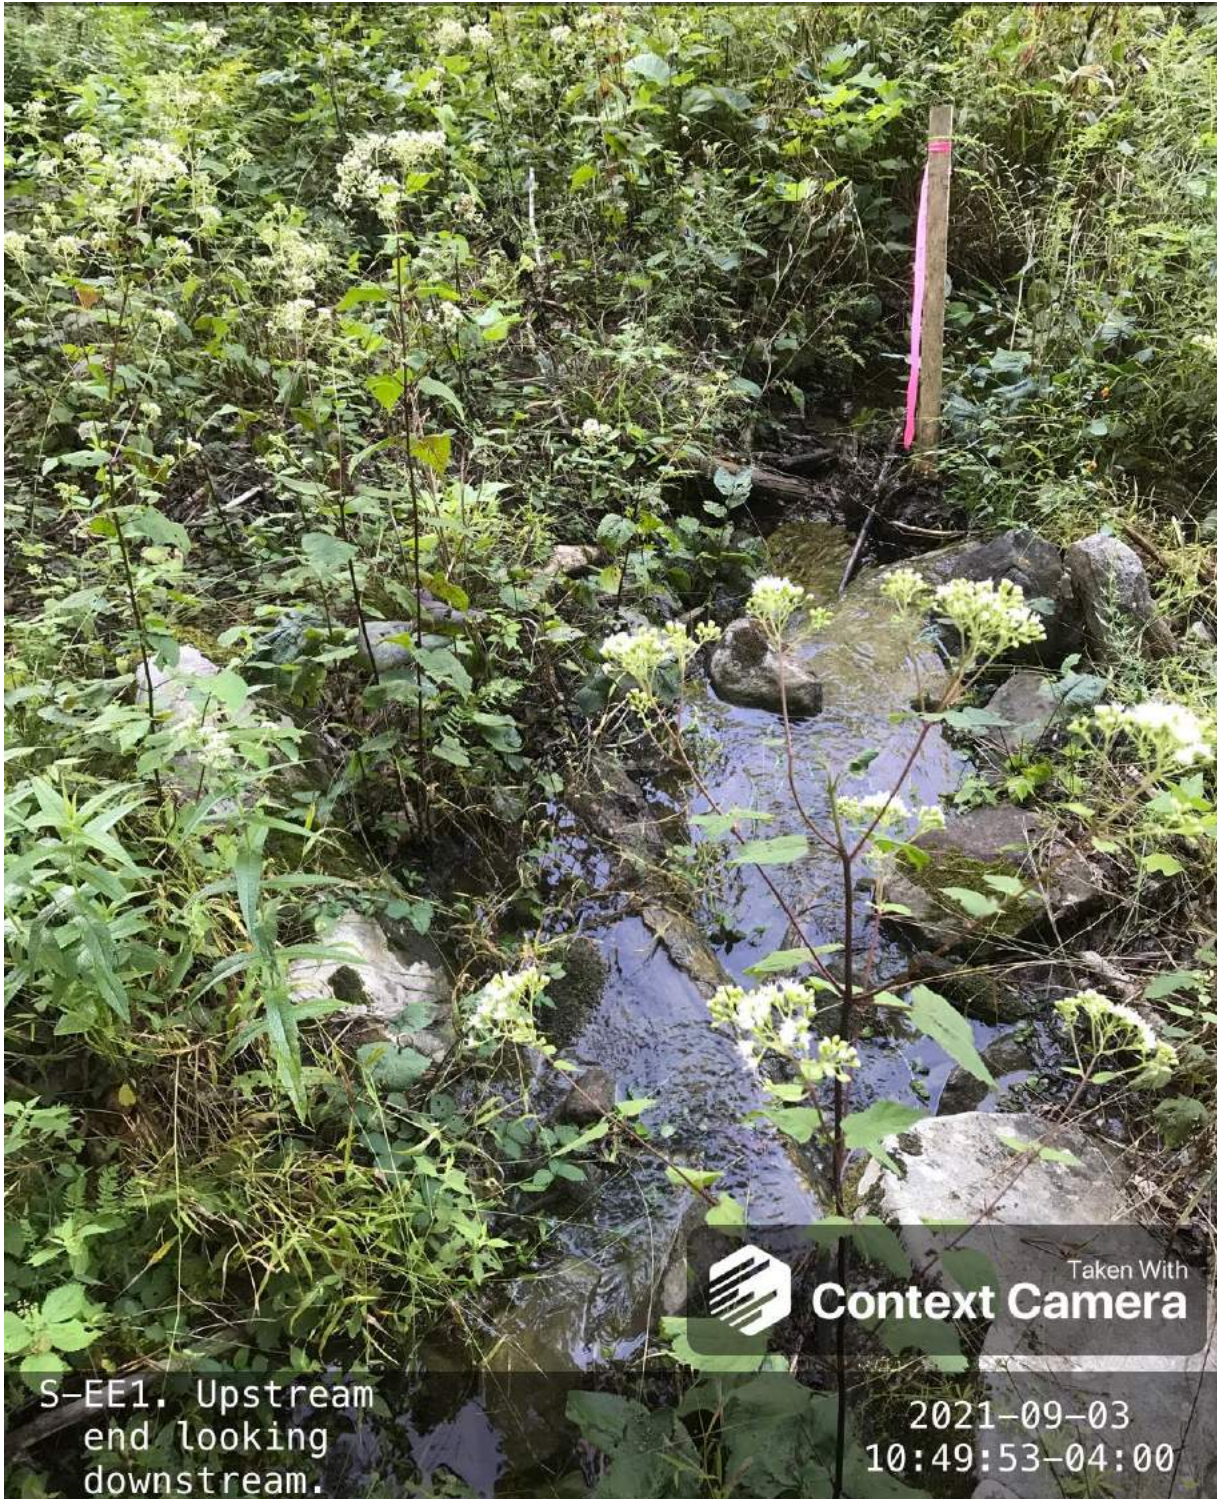
S-EE1. Upstream  
end looking  
downstream.

Photo Type: US, DS View  
Location, Orientation, Photographer Initials: Upstream Edge of ROW, Downstream View, SM, KP  
Lat: 38.228921 Long: -80.713076

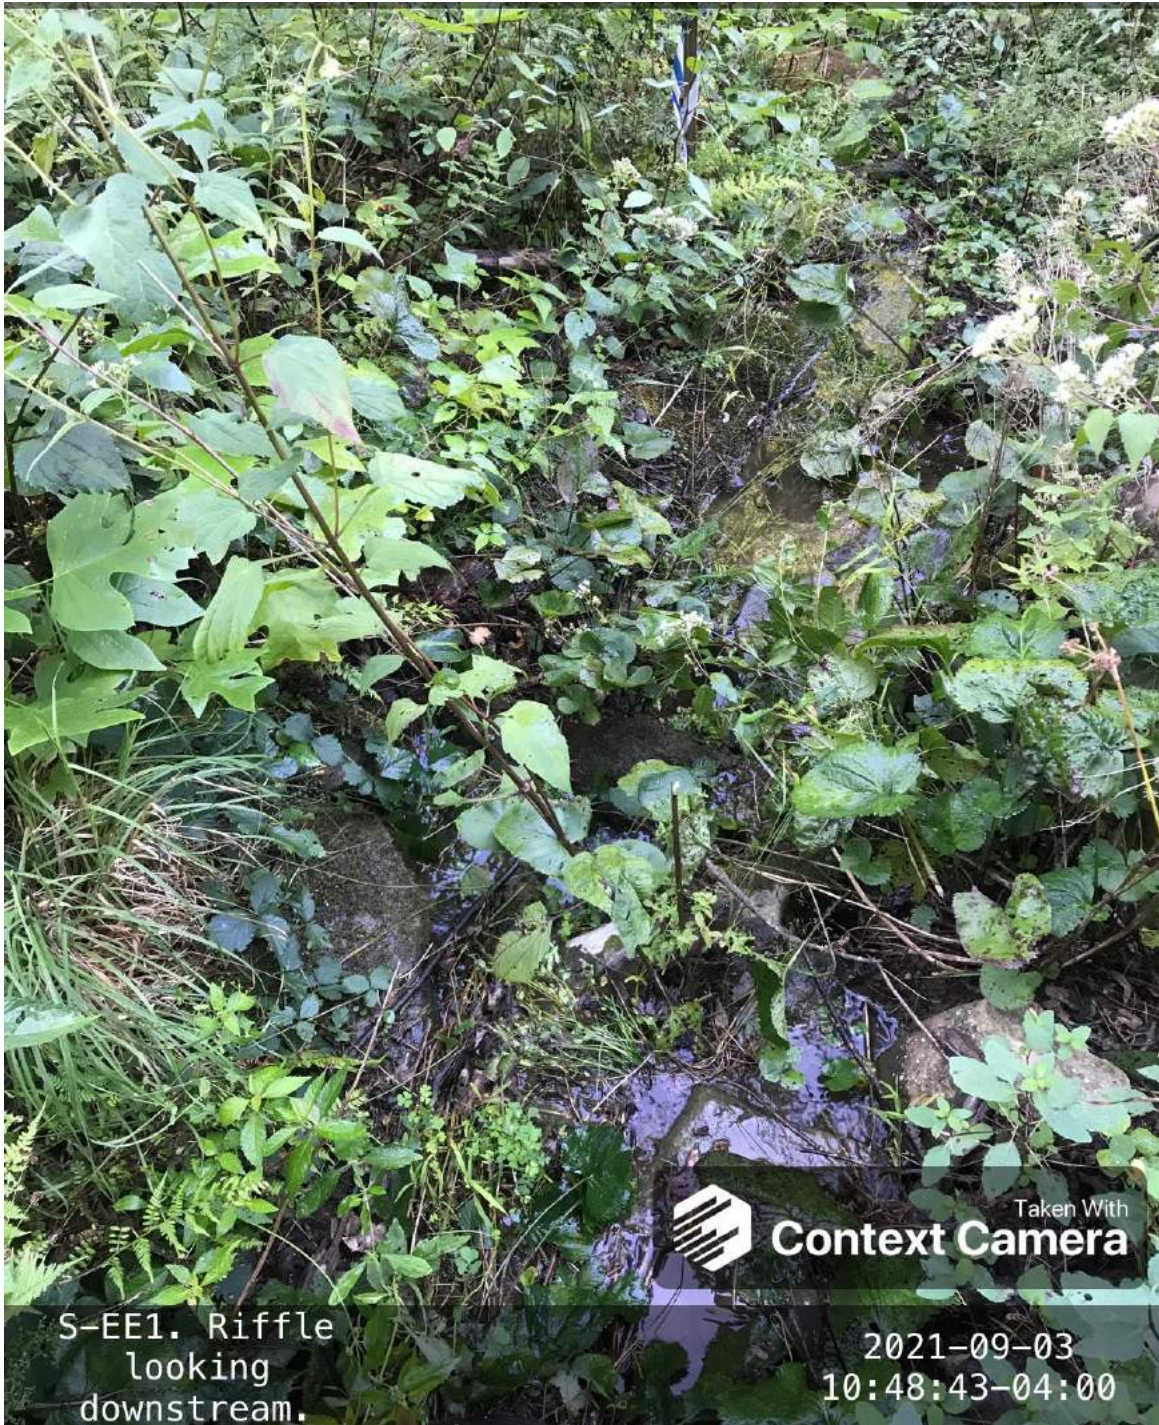
Photo Type: Riffle, DS View  
Location, Orientation, Photographer Initials: Upstream of Riffle, Downstream View, SM, KP  
Lat: 38.228921 Long: -80.713076

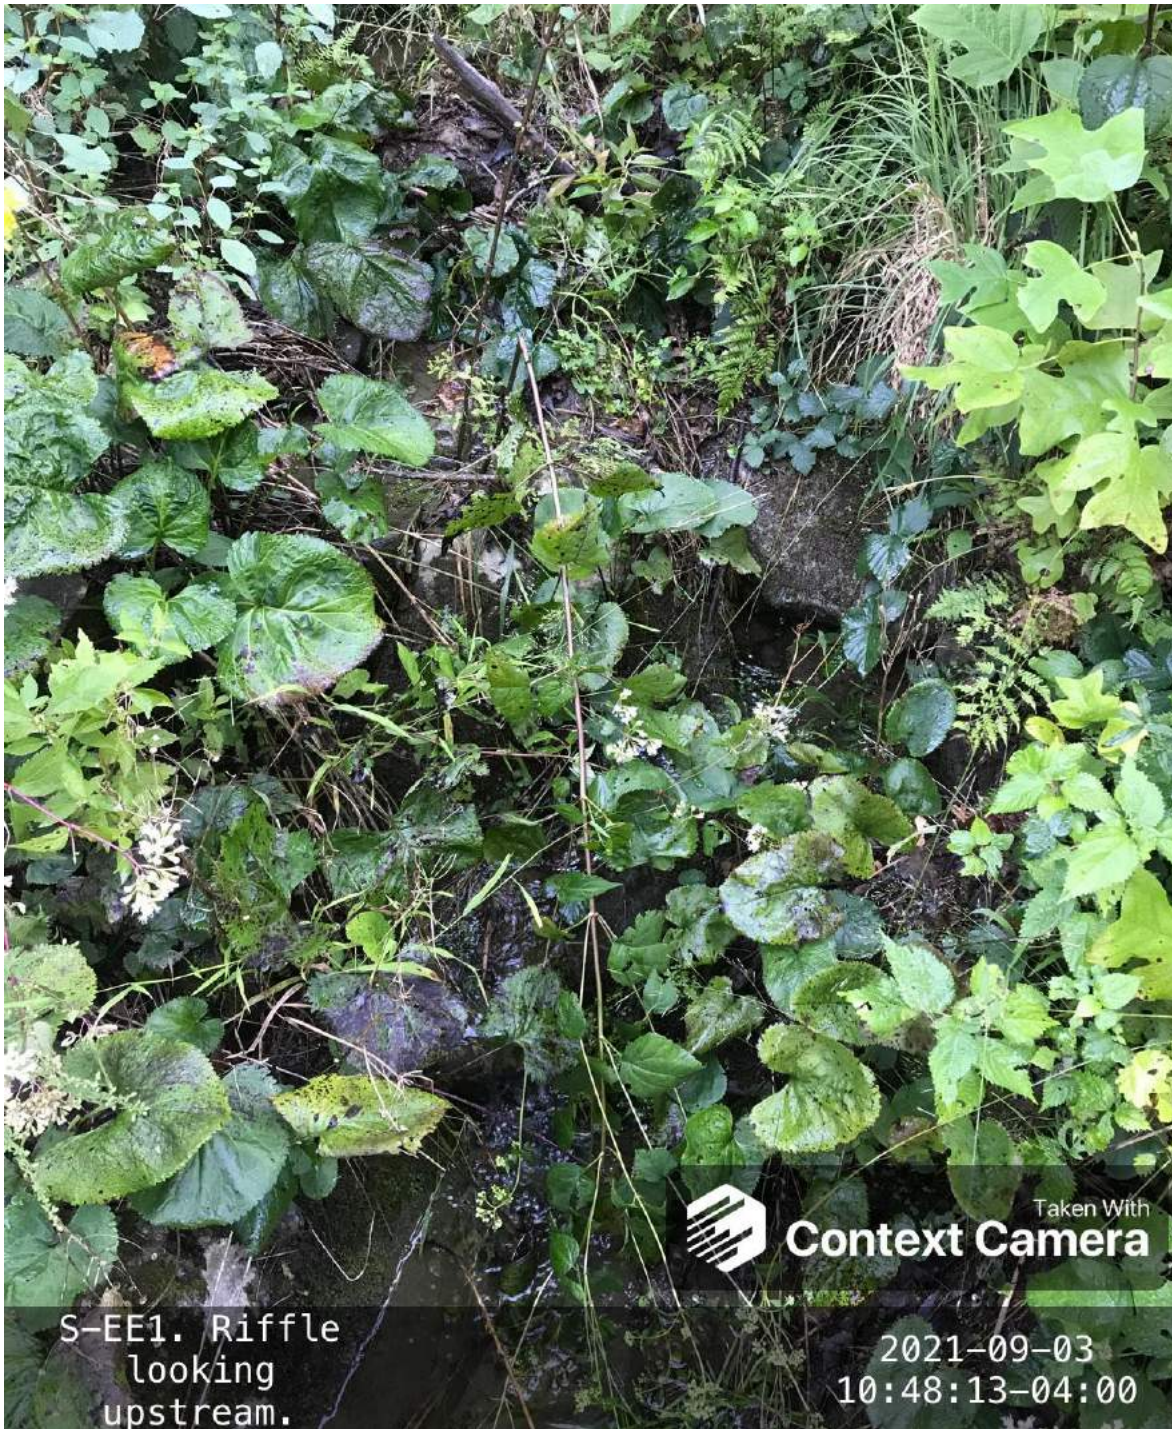
Photo Type: Riffle, US View  
Location, Orientation, Photographer Initials: Downstream of Riffle, Upstream View, SM, KP  
Lat: 38.228921 Long: -80.713076

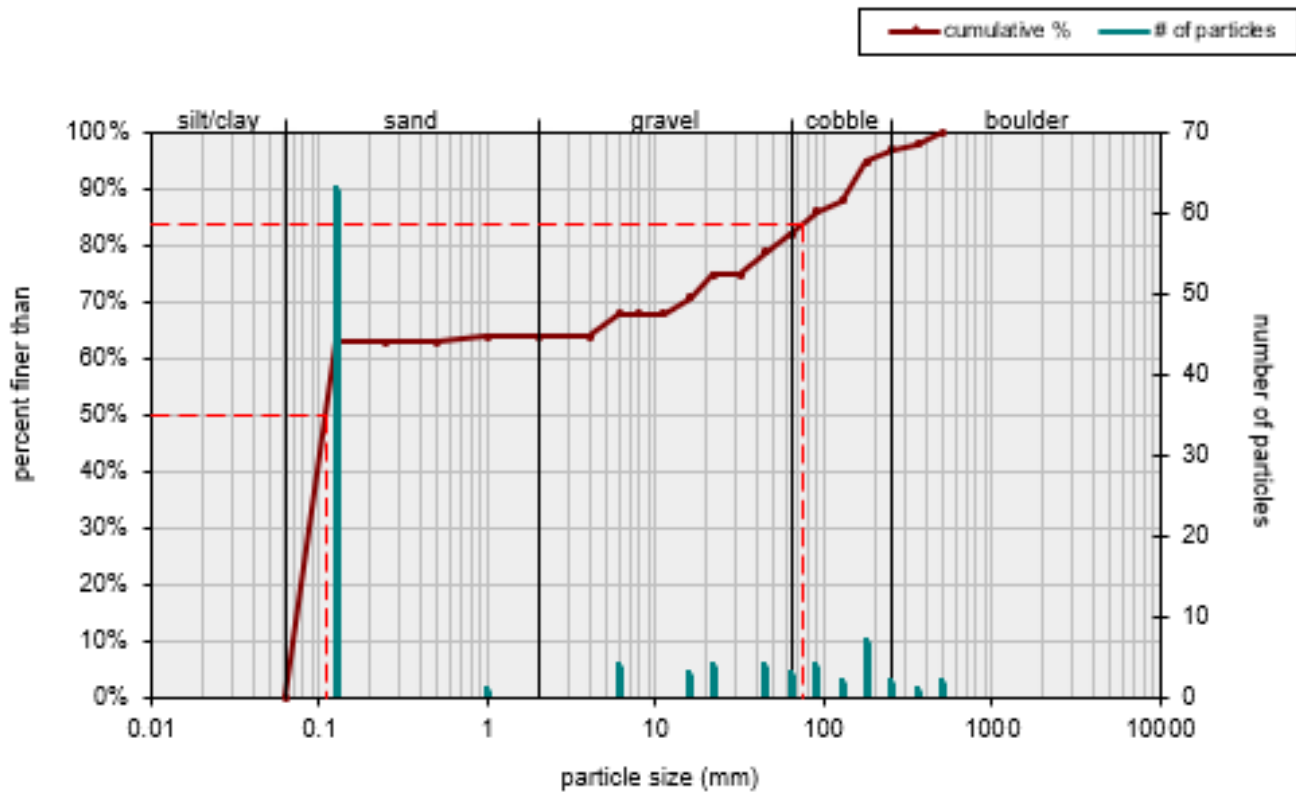
Bankfull Channel Pebble Count, S-EE1

Size (mm)	Size Distribution	Type
D16 0.074	mean 2.4	silt/clay 0%
D35 0.092	dispersion 346.2	sand 64%
D50 0.11	skewness 0.77	gravel 18%
D65 4.4		cobble 15%
D84 76		boulder 3%
D95 180

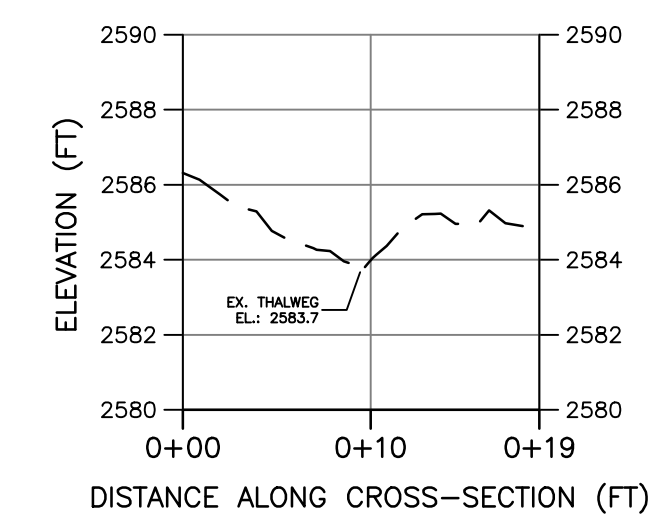
S-EE1 BASELINE CROSS-SECTION A  
RIFFLE

CROSS SECTION	
SCALE:	H: 1"=10' V: 1"=5'

AS-BUILT TABLE: S-EE1 CROSS SECTION A					
PT. LOC.	PRE-CROSSING			AS-BUILT	
	NORTHING	EASTING	ELEV.	VERT. DIFF.	HORZ. DIFF.
TS-L	13882048.30	1722808.38	2584.92		
THW	13882045.02	1722806.18	2583.67		
TS-R	13882042.25	1722805.25	2585.05
