Baseline Assessment – Stream Attributes

Reach S-H103 (Pipeline ROW) Intermittent Spread C Webster County, West Virginia

Title: PROFILE AND CROSS-SECTIONS
 BASELINE SURVEY
 CROSSING S-H103 - UNNAMED TRIB. TO
 CAMP CREEK (MP 93.50)
 WEBSTER COUNTY, WV

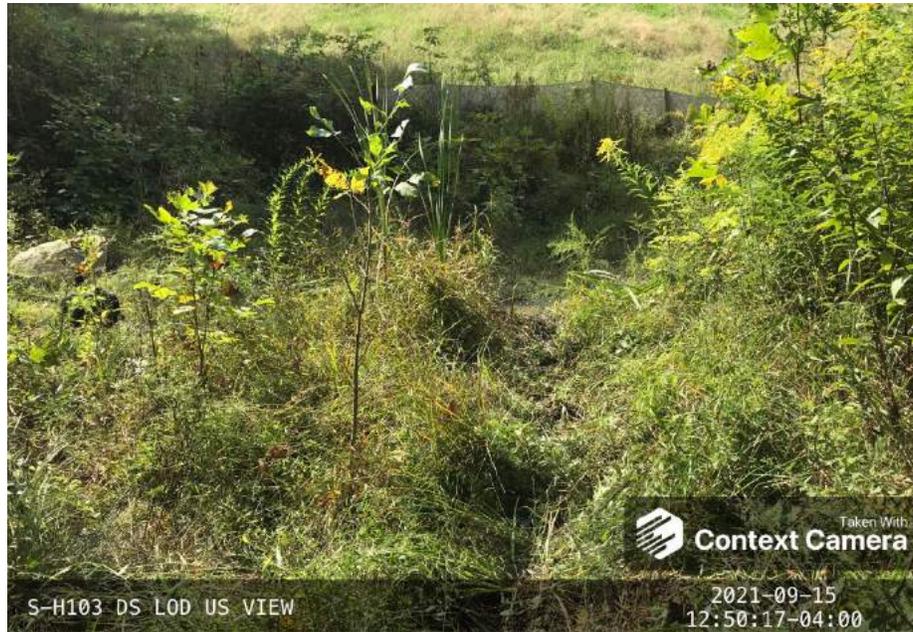
Photo Type: DS, US View
Location, Orientation, Photographer Initials: Downstream Edge of ROW, Upstream View, RH/PF
Lat: 38.545817 Long: -80.542972

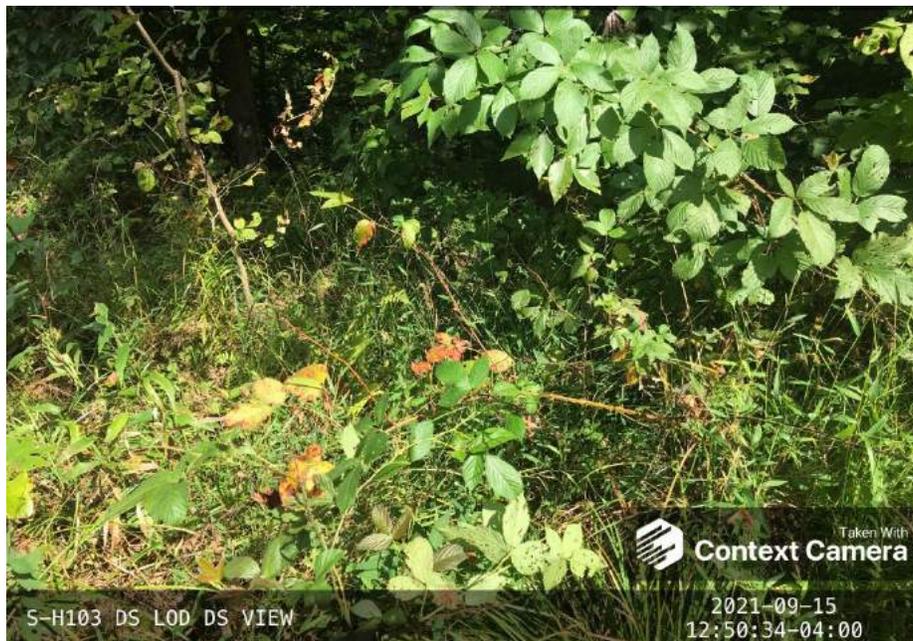
Photo Type: DS, DS View
Location, Orientation, Photographer Initials: Downstream Edge of ROW, Downstream View, RH/PF
Lat: 38.545817 Long: -80.542972

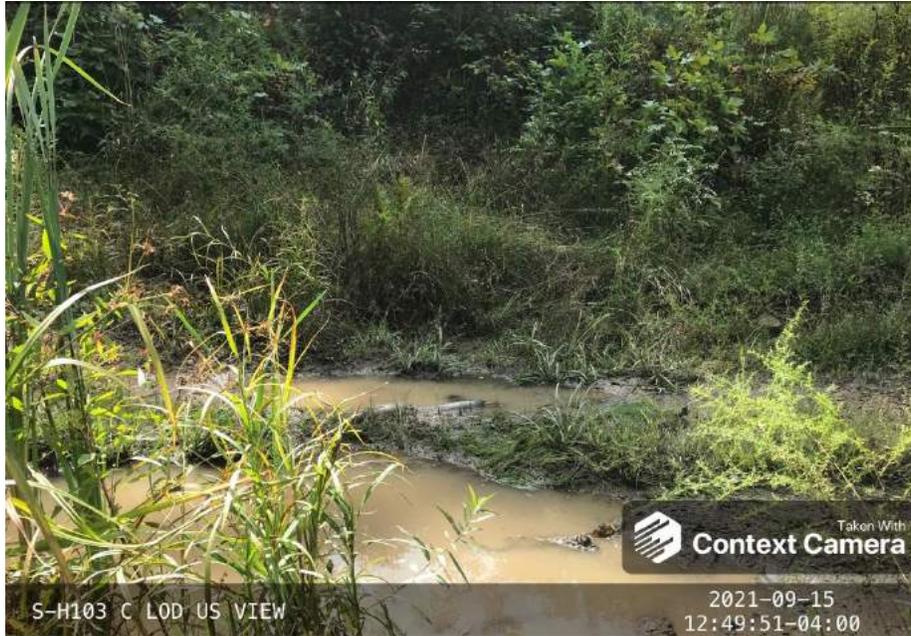
Photo Type: US View at Center
Location, Orientation, Photographer Initials: Center ROW, Upstream View, RH/PF
Lat: 38.545817 Long: -80.542972

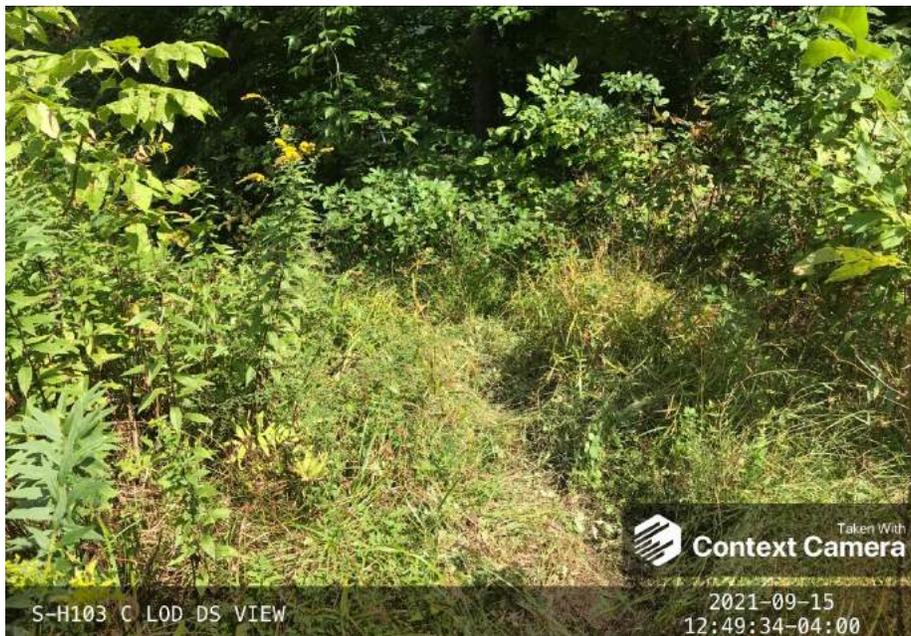
Photo Type: DS View at Center
Location, Orientation, Photographer Initials: ROW Center, Downstream View, RH/PF
Lat: 38.545817 Long: -80.542972

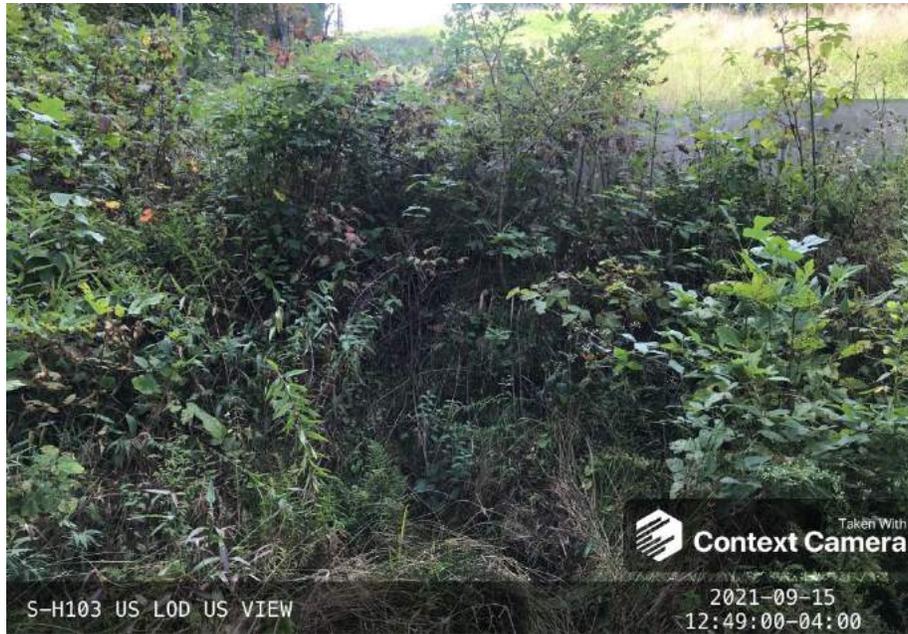
Photo Type: US, US View

Location, Orientation, Photographer Initials: Upstream Edge of ROW, Upstream View, RH/PF
Lat: 38.545817 Long: -80.542972

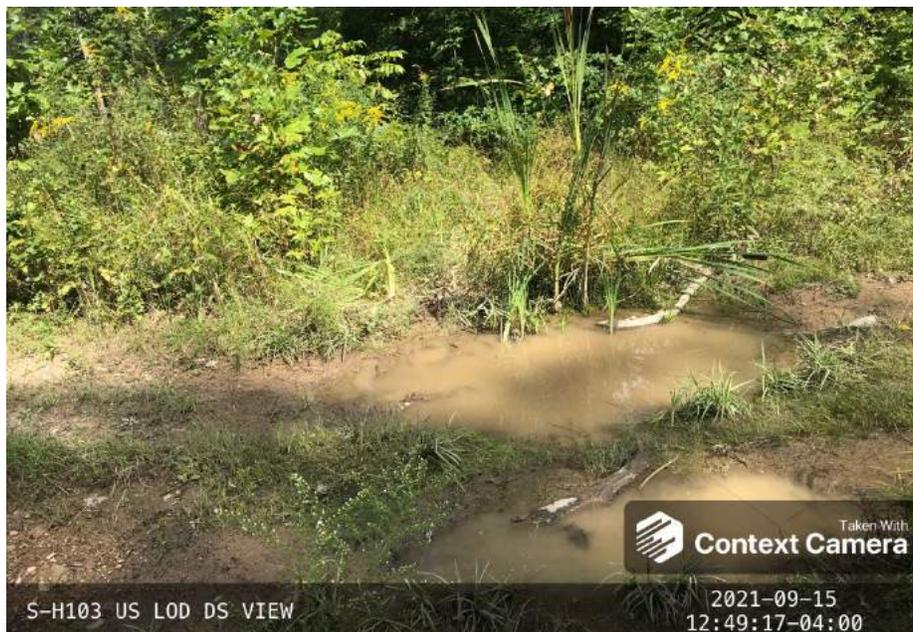
Photo Type: US, DS View

Location, Orientation, Photographer Initials: Upstream Edge of ROW, Downstream View, RH/PF
Lat: 38.545817 Long: -80.542972

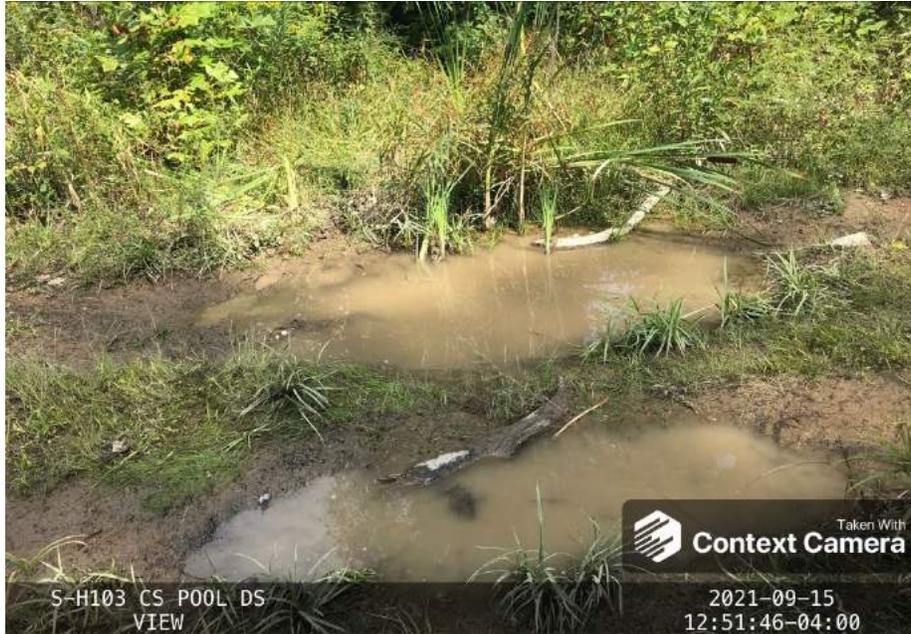
Photo Type: Pool, DS View
Location, Orientation, Photographer Initials: Upstream of Pool, Downstream View, RH/PF
Lat: 38.545817 Long: -80.542972

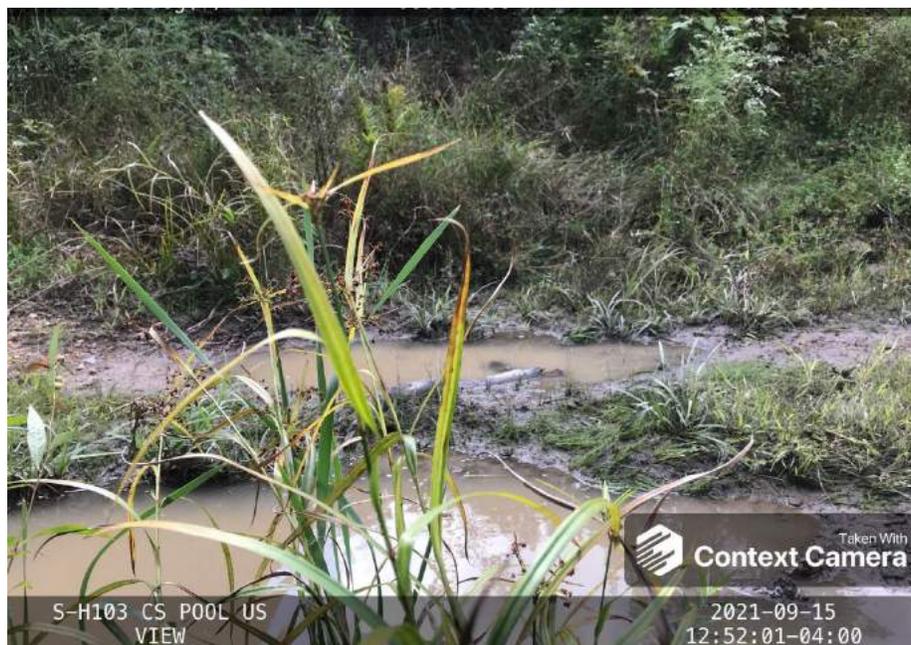
Photo Type: Pool, US View
Location, Orientation, Photographer Initials: Downstream of Pool, Upstream View, RH/PF
Lat: 38.545817 Long: -80.542972

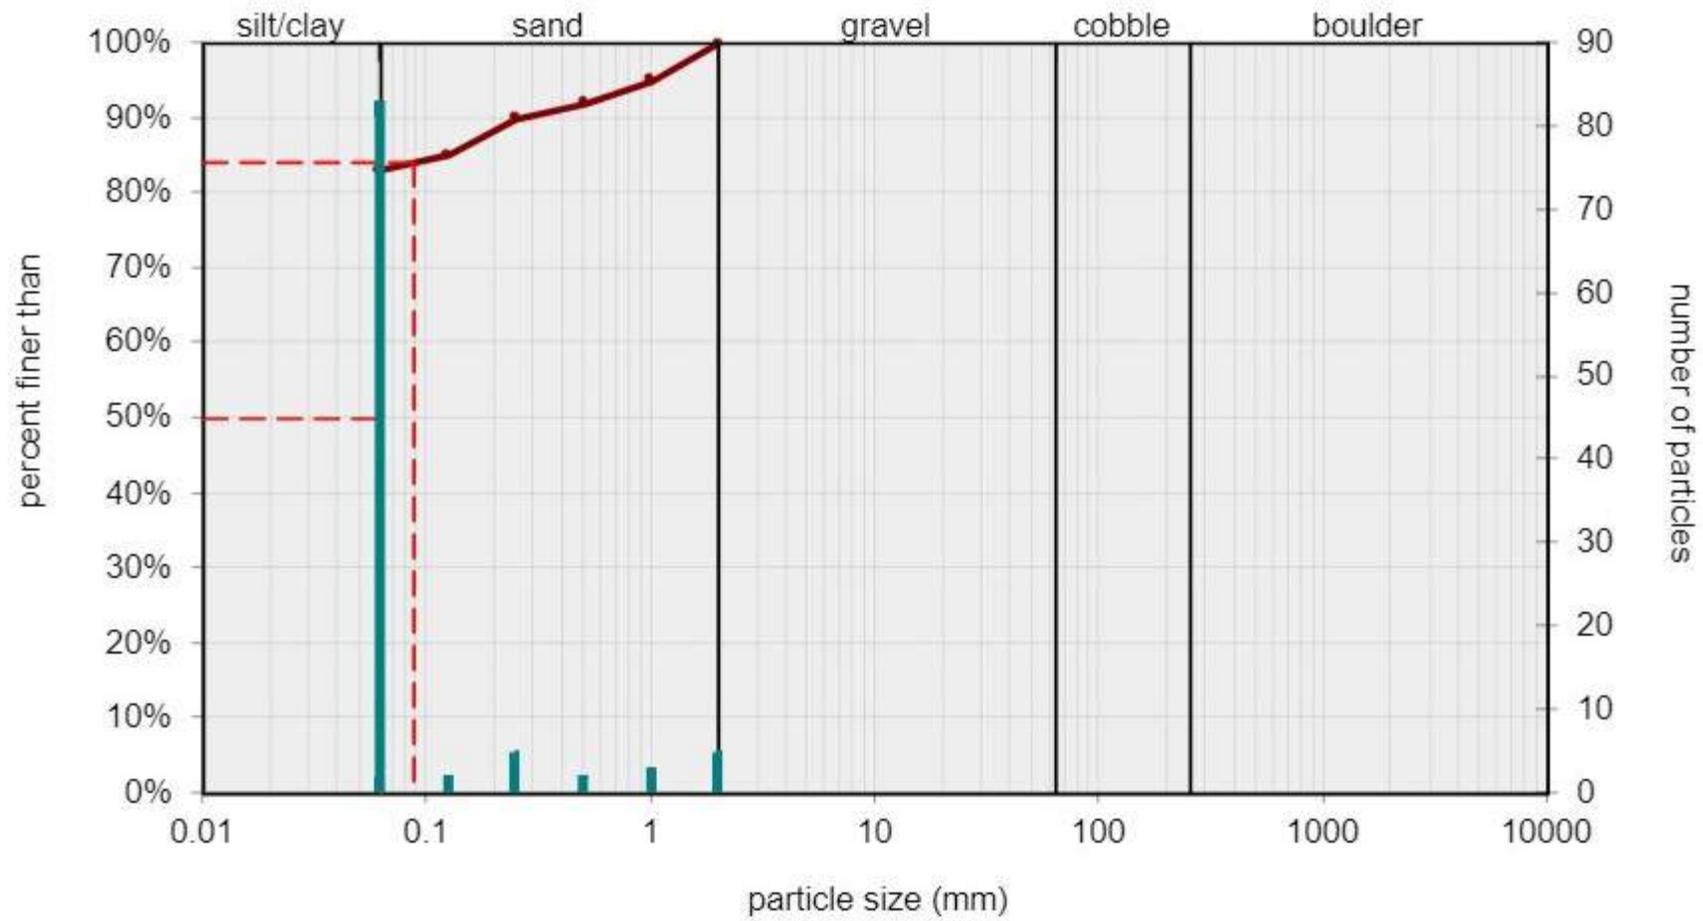
Bankfull Channel Pebble Count, S-H103, UNT to Camp Creek

Size (mm)	
D16	0.062
D35	0.062
D50	0.062
D65	0.062
D84	0.088
D95	1

Size Distribution	
mean	0.1
dispersion	1.2
skewness	0.19

Type	
silt/clay	83%
sand	17%
gravel	0%
cobble	0%
boulder	0%

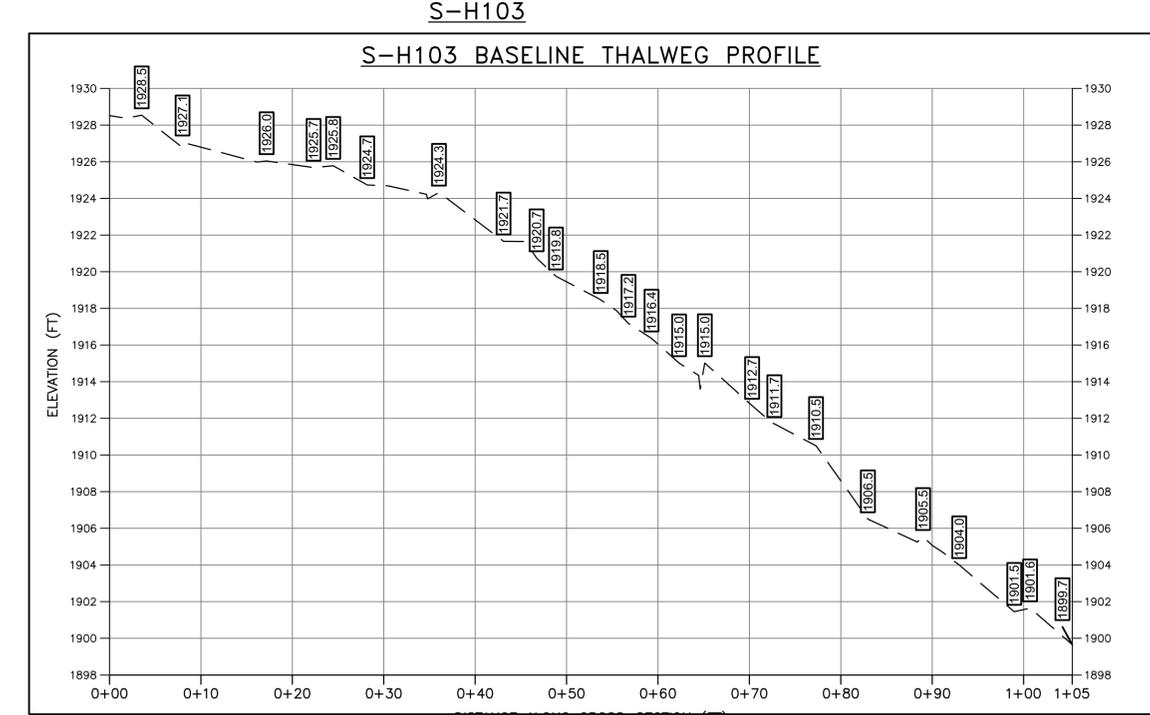
EXISTING STREAM PROFILE
 INVERT ALONG THALWEG

SCALE: H: 1"=10'
 V: 1"=5'

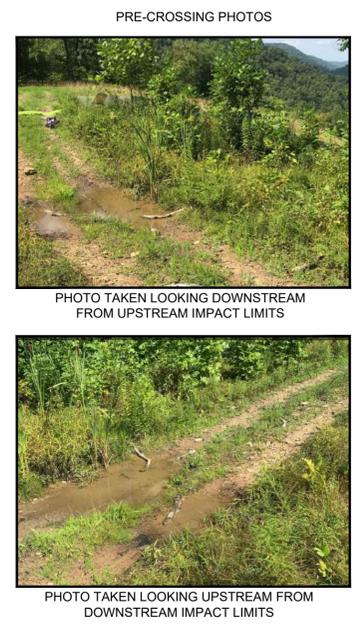
AS-BUILT TABLE: S-H103 CROSS SECTION A

TYPICAL 5-POINT CROSS-SECTION (FACING DOWNSTREAM)

TS: TOP OF SLOPE
 BS: BOTTOM OF SLOPE
 THW: THALWEG (INVERT)

PT. LOC.	PRE-CROSSING			AS-BUILT	
	NORTHING	EASTING	ELEV.	VERT. DIFF.	HORZ. DIFF.
TS-L	13997592.2500	1771072.8490	1926.710'		
BS-L	13997591.1600	1771075.3170	1926.056'		
THW	13997590.7900	1771075.6110	1925.984'		
BS-R	13997589.5100	1771076.9990	1926.308'		
TS-R	13997588.3400	1771078.1650	1926.275'

EXISTING GRADE
 CROSS SECTION
 SCALE: H: 1"=10'
 V: 1"=5'
