Baseline Assessment – Stream Attributes

Reach S-H112 (Timber Mat Crossing) Intermittent Spread C Webster County, West Virginia

Spread C Stream S-H112 (Timber Mat Crossing) Webster County

Title: PROFILE AND CROSS-SECTIONS
BASELINE SURVEY
CROSSING S-H112 - UNNAMED TRIB. TO
ELK RIVER (MP 87.52)
WEBSTER COUNTY, WV

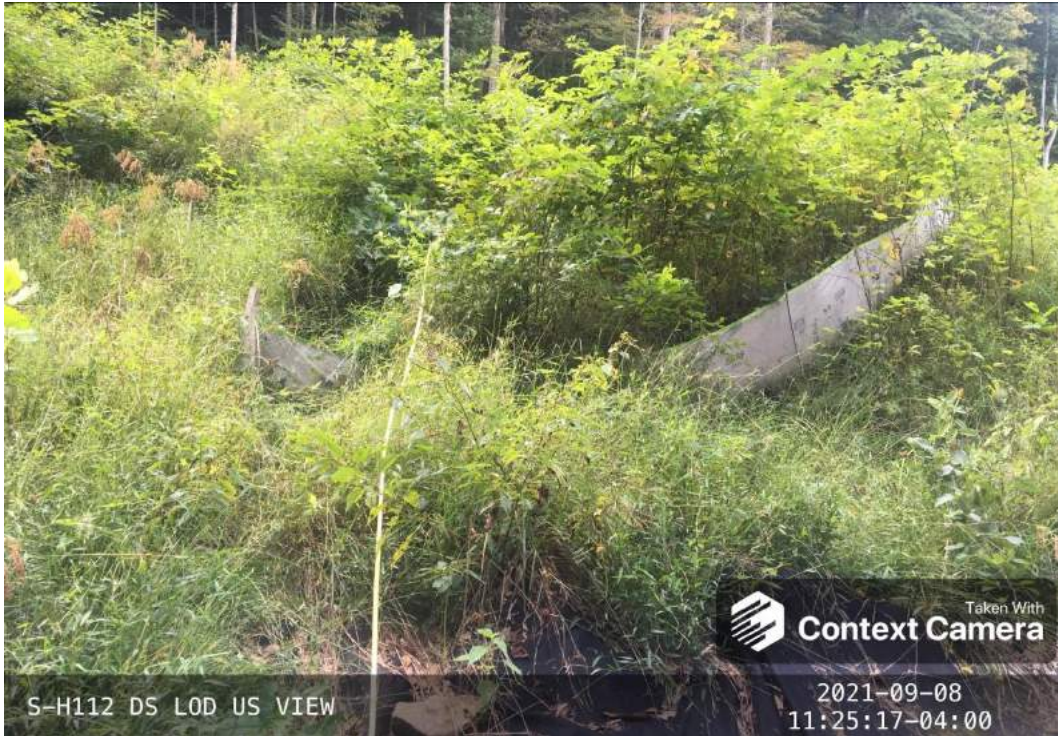
Photo Type: DS, US View
Location, Orientation, Photographer Initials: Downstream Edge of ROW, Upstream View, AC/VM/HK
Lat: 38.613163 Long: -80.504012

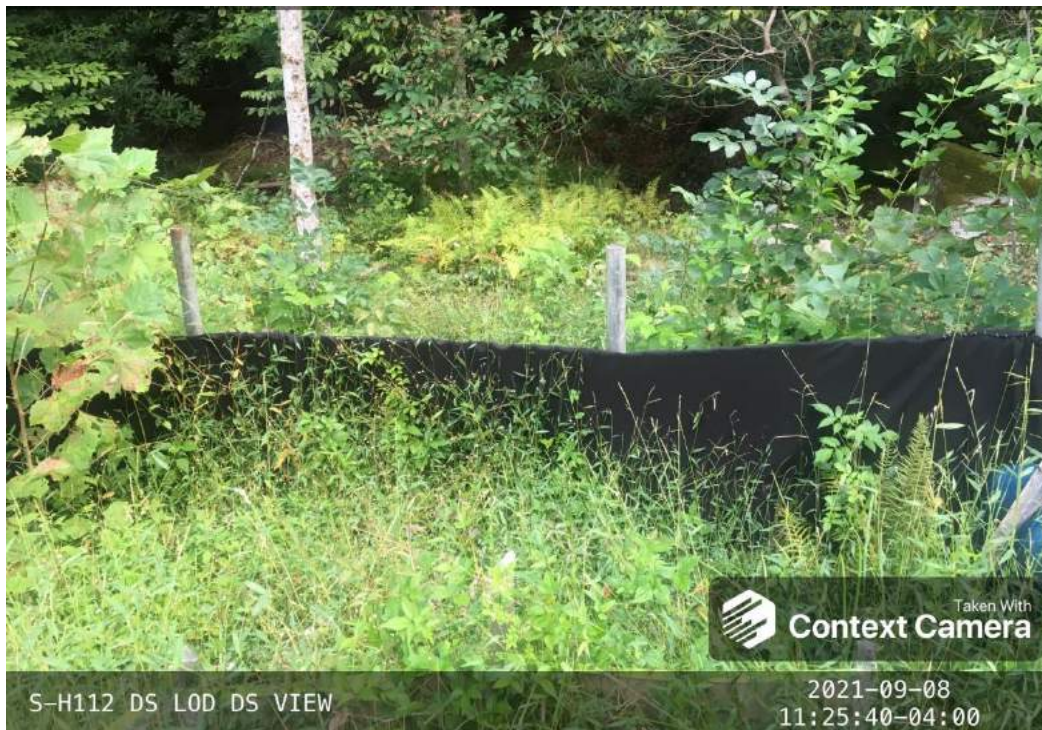
Photo Type: DS, DS View
Location, Orientation, Photographer Initials: Downstream Edge of ROW, Downstream View, AC/VM/HK
Lat: 38.613163 Long: -80.504012

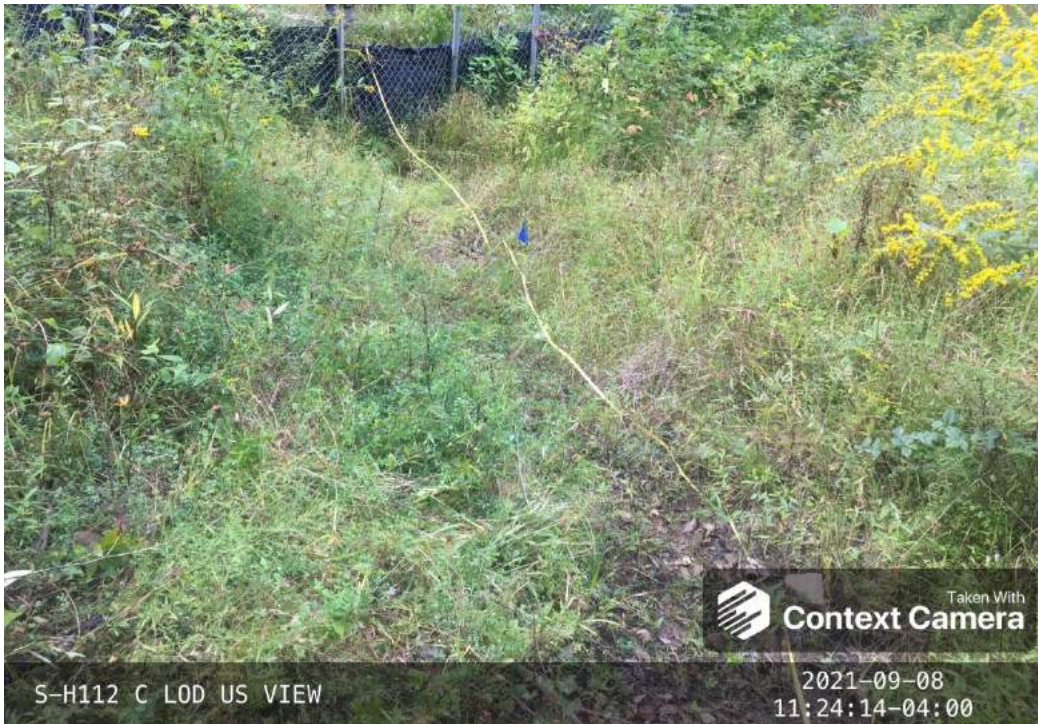
S-H112 C LOD US VIEW

Photo Type: US View at Center
Location, Orientation, Photographer Initials: Center ROW, Upstream View, AC/VM/HK
Lat: 38.613163 Long: -80.504012

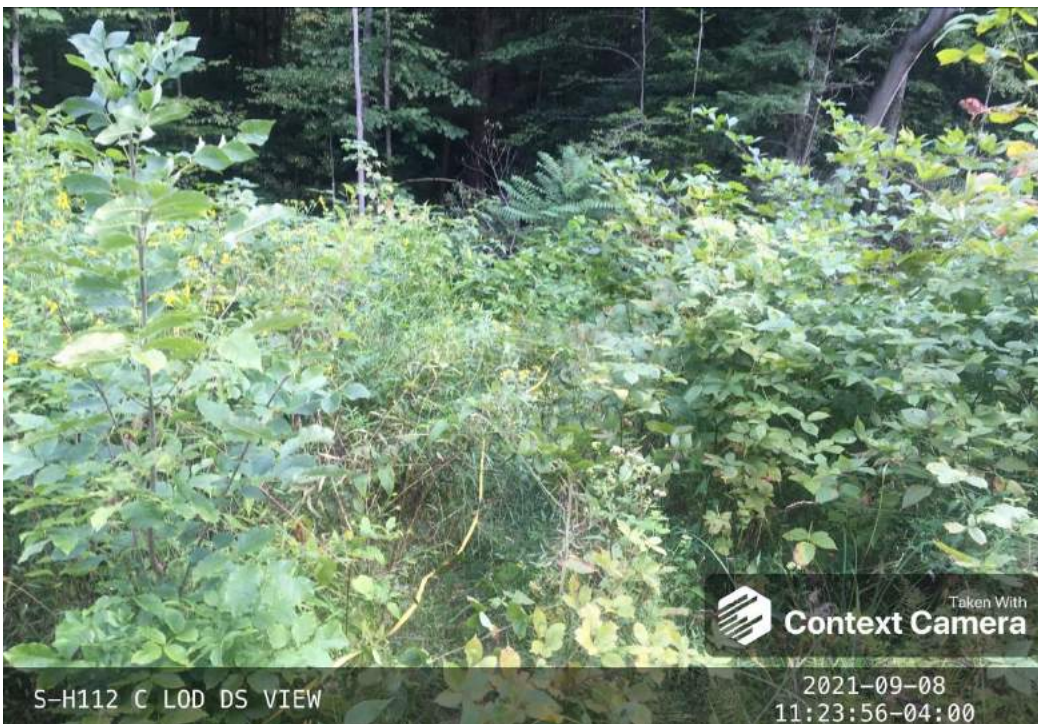
S-H112 C LOD DS VIEW

Photo Type: DS View at Center
Location, Orientation, Photographer Initials: ROW Center, Downstream View, AC/VM/HK
Lat: 38.613163 Long: -80.504012

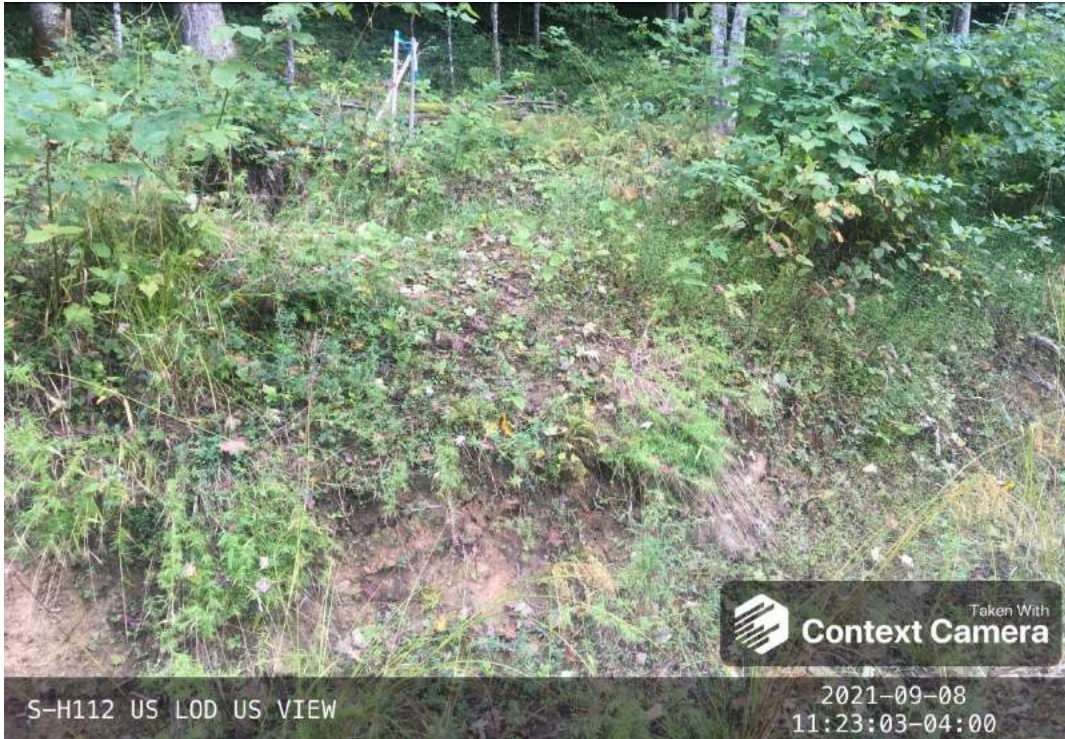
Photo Type: US, US View
Location, Orientation, Photographer Initials: Upstream Edge of ROW, Upstream View, AC/VM/HK
Lat: 38.613163 Long: -80.504012

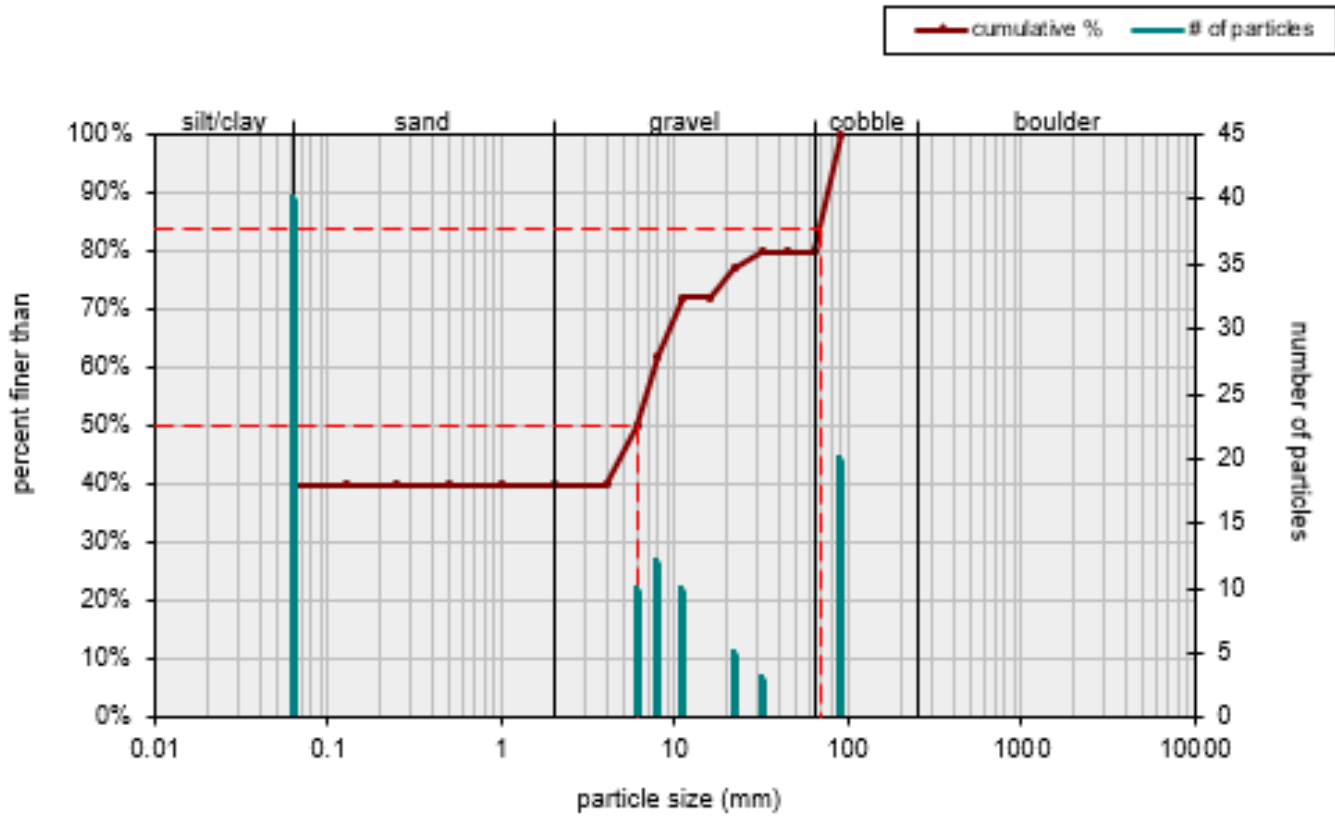
Bankfull Channel Pebble Count, S-H112

Size (mm)		Size Distribution		Type	
D16	0.062	mean	2.1	silt/clay	40%
D35	0.062	dispersion	54.1	sand	0%
D50	6	skewness	-0.26	gravel	40%
D65	8.8			cobble	20%
D84	69			boulder	0%
D95	83
