Baseline Assessment – Stream Attributes

Reach S-H95 (Temporary Access Road) Ephemeral Spread D Nicholas County, West Virginia

Spread D Stream S-H95(Temporary Access Road) Nicholas County

Title
PROFILE AND CROSS-SECTIONS
BASELINE SURVEY
CROSSING S-H95 - UNNAMED TRIB. TO BIG
BEAVER CREEK (MP 116.10)
NICHOLAS COUNTY, WV

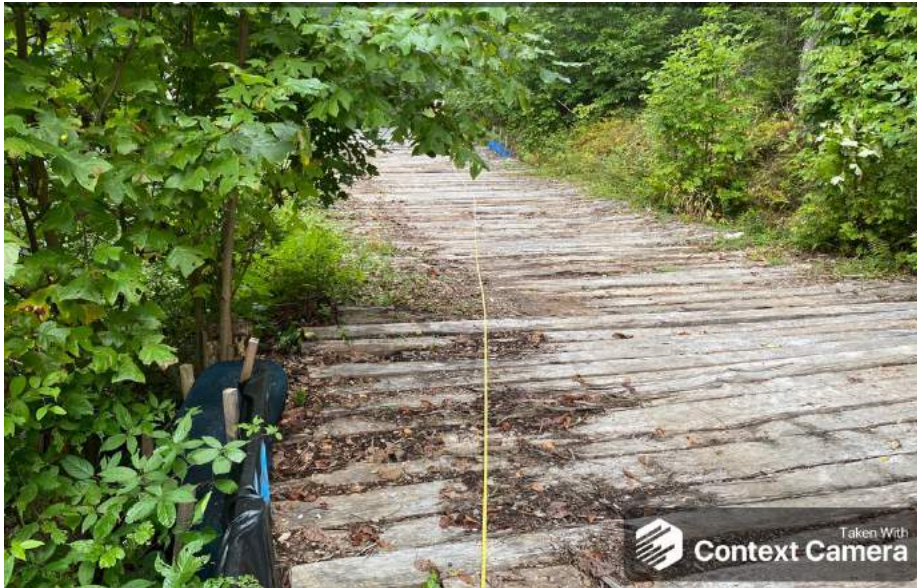
Photo Type: DS, US View

Location, Orientation, Photographer Initials: Downstream Edge of ROW, Upstream View, COC

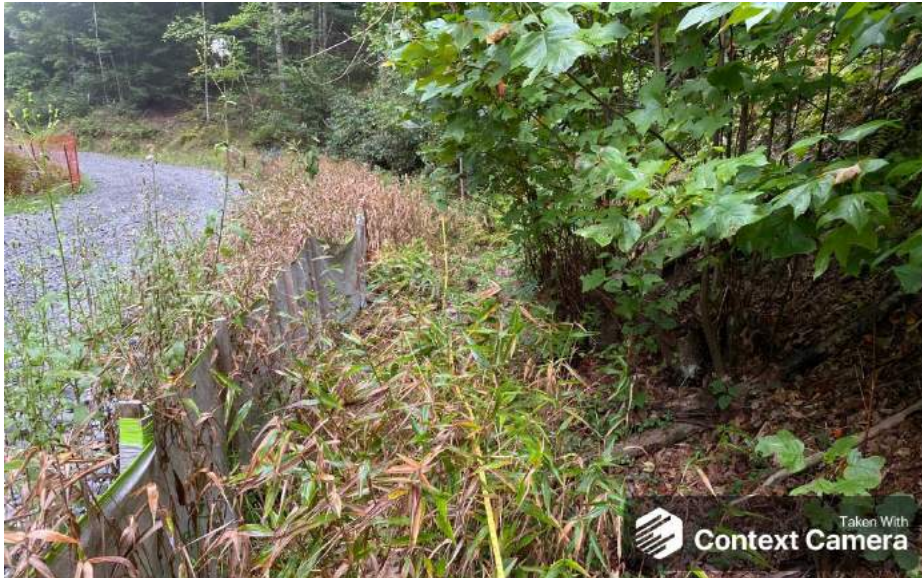
Photo Type: US View at Center
Location, Orientation, Photographer Initials: Center of stream, Upstream View, COC
Lat: 38.309738 Long: -80.675733

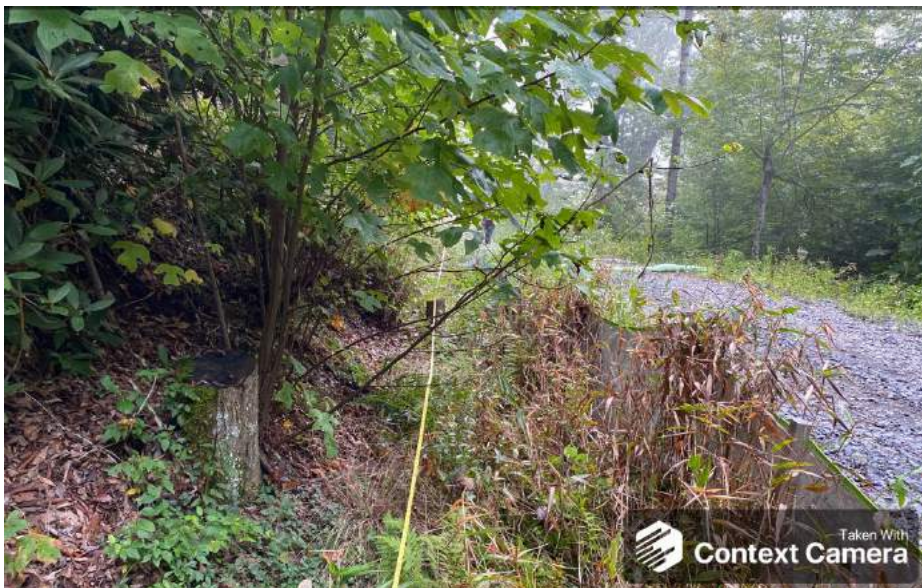
Photo Type: DS View at Center
Location, Orientation, Photographer Initials: Center of stream, Downstream View, COC
Lat: 38.309738 Long: -80.675733

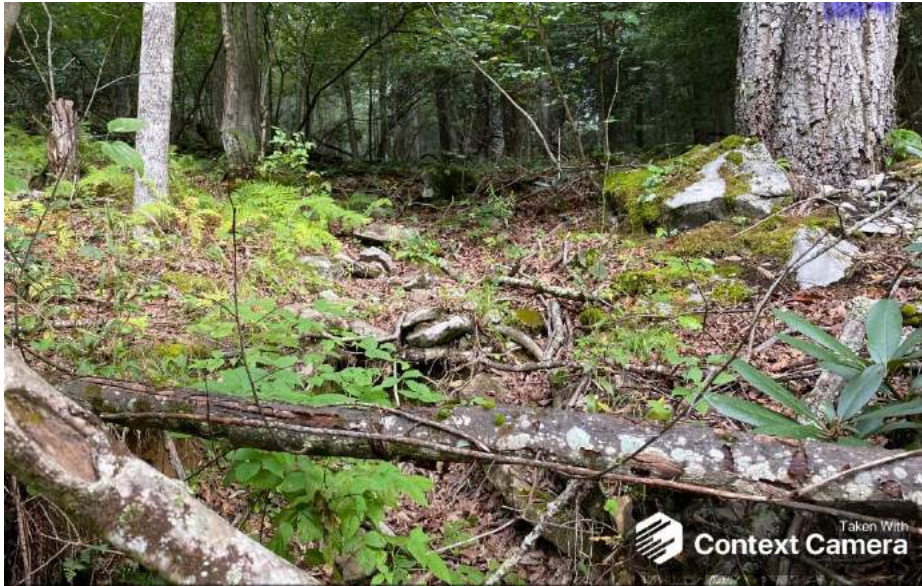
Photo Type: US, US View
Location, Orientation, Photographer Initials: Upstream Edge of ROW, Upstream View, COC
Lat: 38.309738 Long: -80.675733

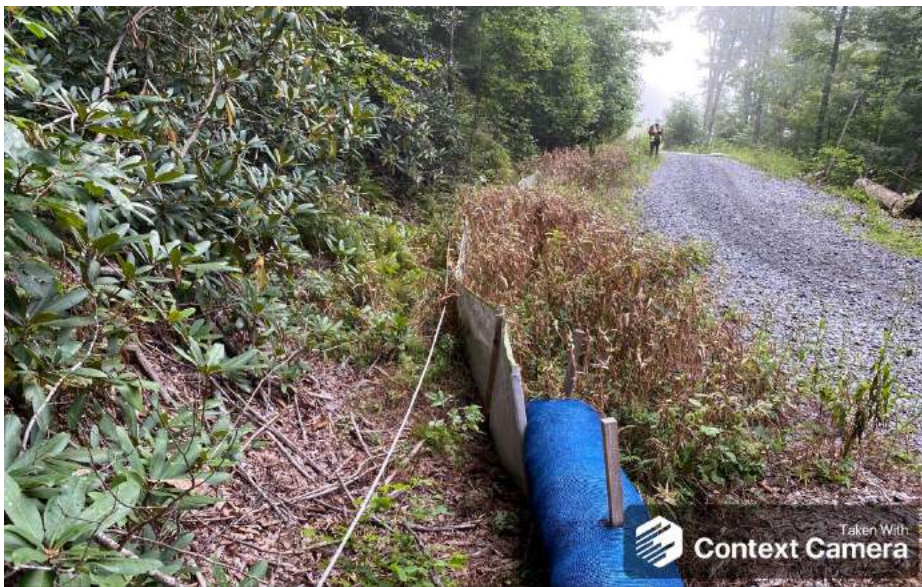
Photo Type: US, DS View
Location, Orientation, Photographer Initials: Upstream Edge of ROW, Downstream View, COC
Lat: 38.309738 Long: -80.675733

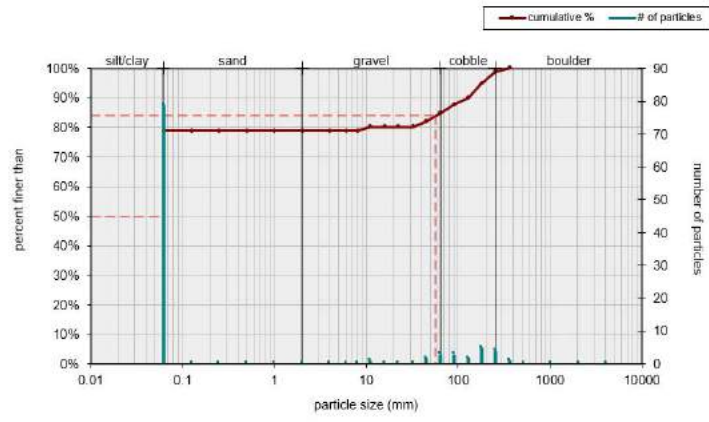
Bankfull Channel Pebble Count, S-H95

Size (mm)	Size Distribution	Type
D16	mean 1.9	silt/clay 79%
D35	dispersion 460.2	sand 0%
D50	skewness 0.86	gravel 6%
D65		cobble 14%
D84		boulder 1%
D95

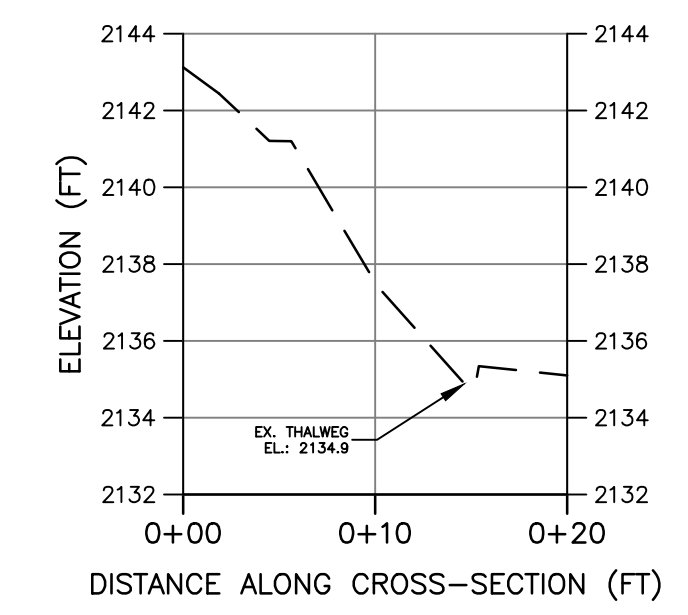
**S-H95 BASELINE CROSS-SECTION A
UPSTREAM FROM TIMBER MAT**

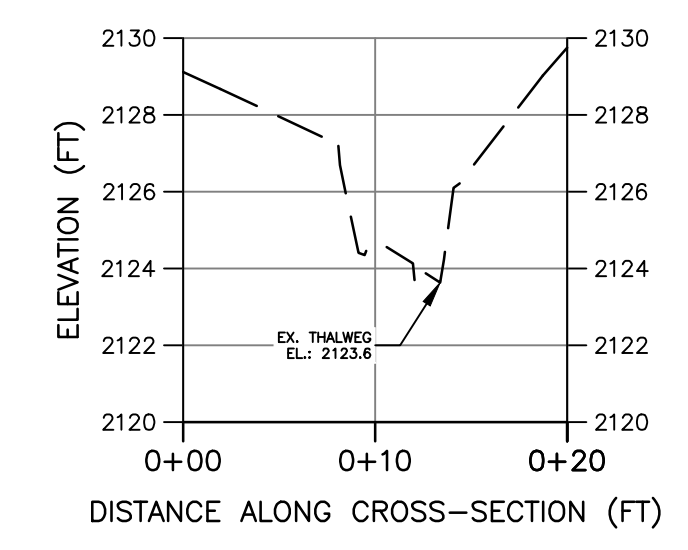
**S-H95 BASELINE CROSS-SECTION B
DOWNSTREAM FROM TIMBER MAT**

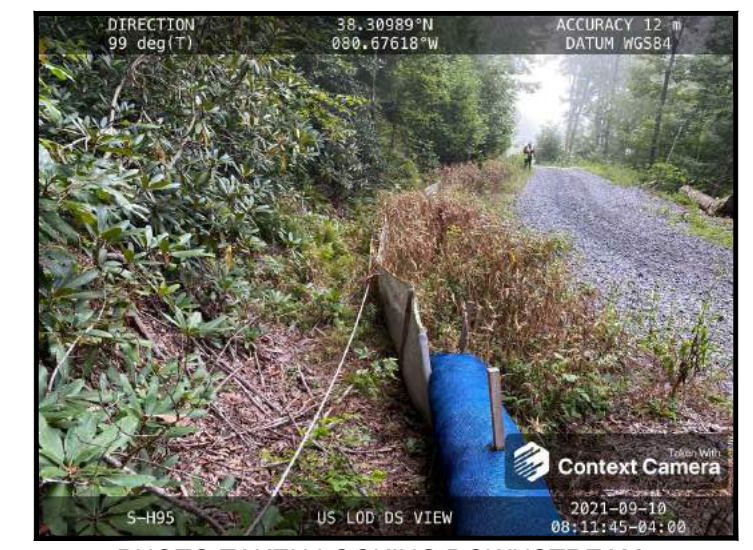
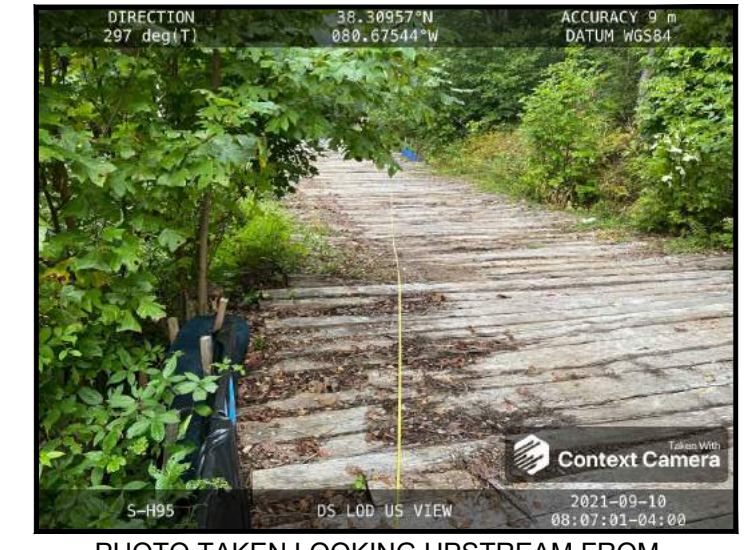
PRE-CROSSING PHOTOS

PHOTO TAKEN LOOKING UPSTREAM FROM DOWNSTREAM IMPACT LIMITS
