Baseline Assessment – Stream Attributes

Reach S-J13 (2) (Pipeline ROW) Ephemeral Spread F Summers County, West Virginia

Title: PROFILE AND CROSS-SECTIONS
 BASELINE SURVEY
 CROSSING S-J13 (2) - UNNAMED TRIB. TO
 PATTERSON CREEK (MP 160.55)
 SUMMERS COUNTY, WV

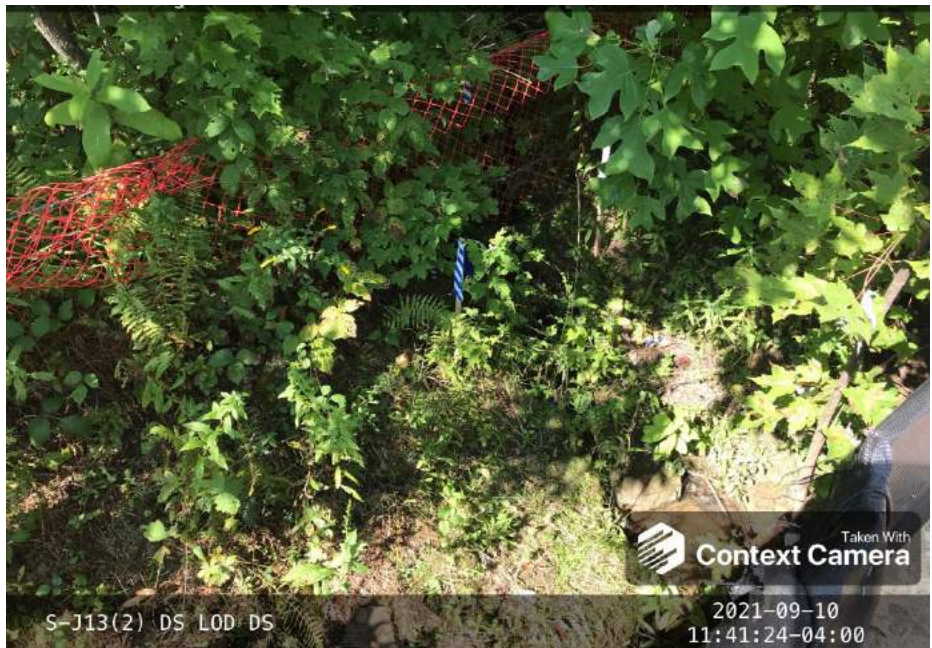
Photo Type: DS, DS View
Location, Orientation, Photographer Initials: Downstream Edge of ROW, Downstream View, AR/RH
Lat: 37.796572 Long: -80.732397

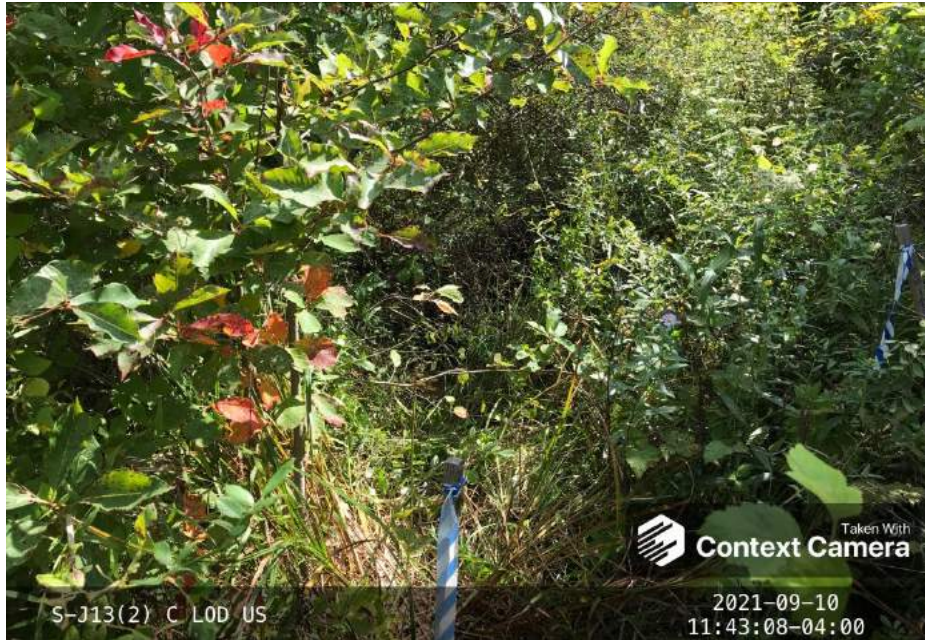
Photo Type: US View at Center
Location, Orientation, Photographer Initials: Center ROW, Upstream View, AR/RH
Lat: 37.796572 Long: -80.732397

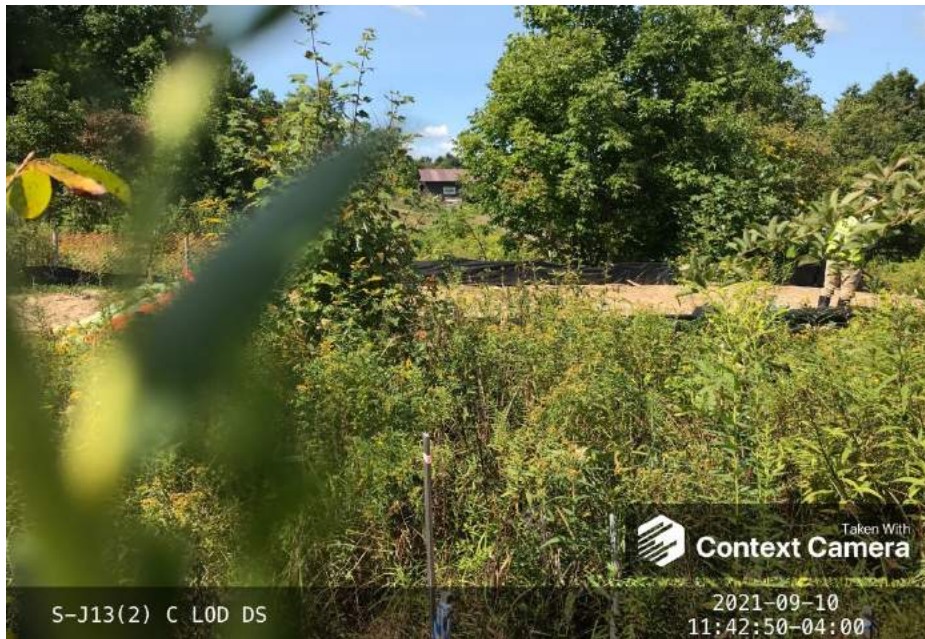
Photo Type: DS View at Center
Location, Orientation, Photographer Initials: ROW Center, Downstream View, AR/RH
Lat: 37.796572 Long: -80.732397

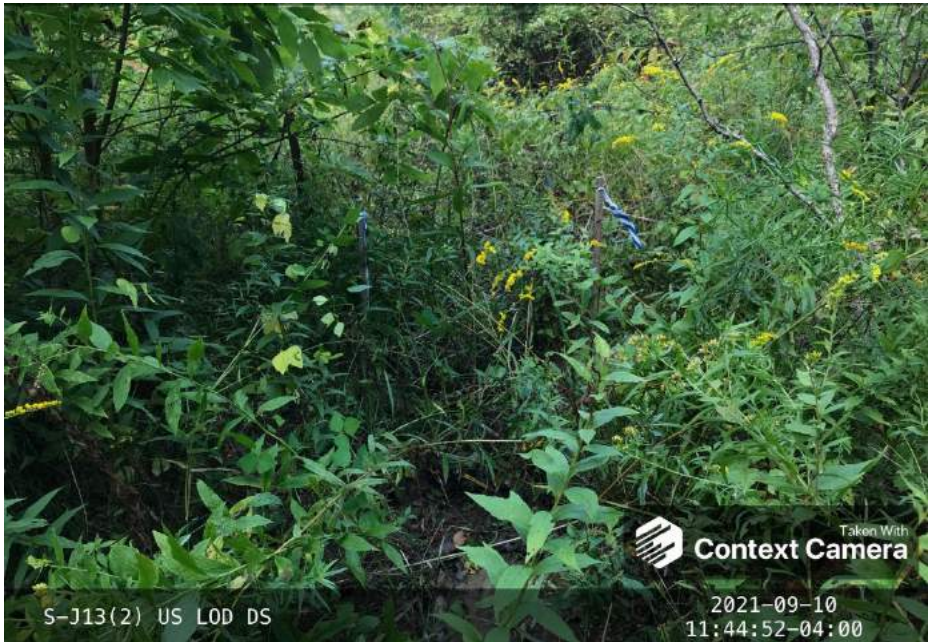
Photo Type: US, DS View
Location, Orientation, Photographer Initials: Upstream Edge of ROW, Downstream View, AR/RH
Lat: 37.796572 Long: -80.732397

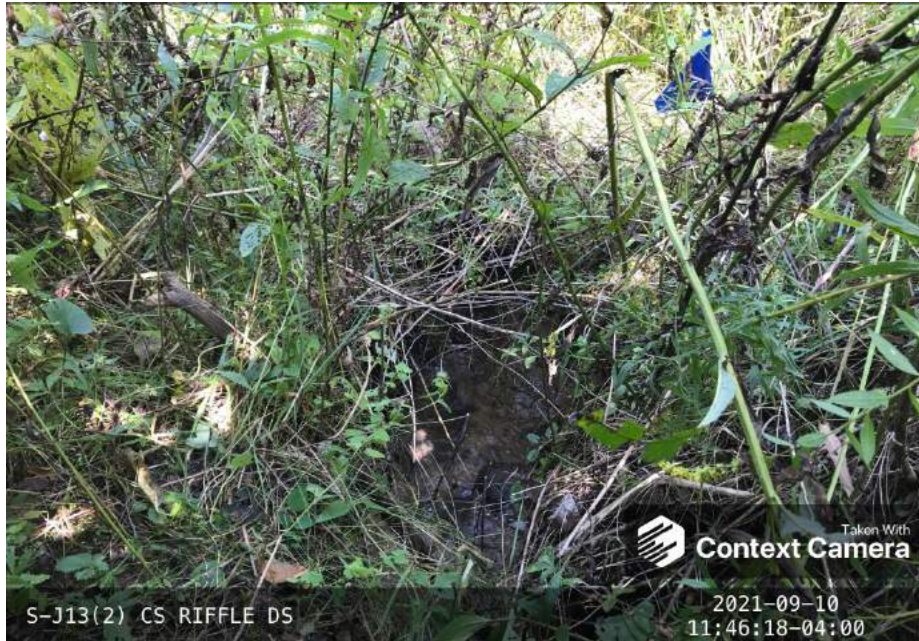
Photo Type: Riffle, DS View
Location, Orientation, Photographer Initials: Upstream of Riffle, Downstream View, AR/RH
Lat: 37.796572 Long: -80.732397

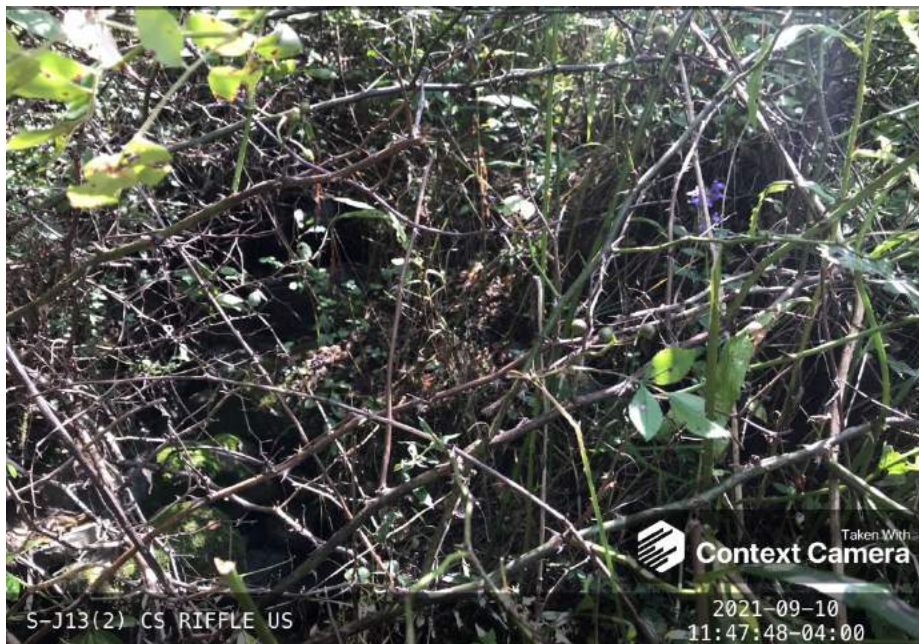
Photo Type: Riffle, US View
Location, Orientation, Photographer Initials: Downstream of Riffle, Upstream View, AR/RH
Lat: 37.796572 Long: -80.732397

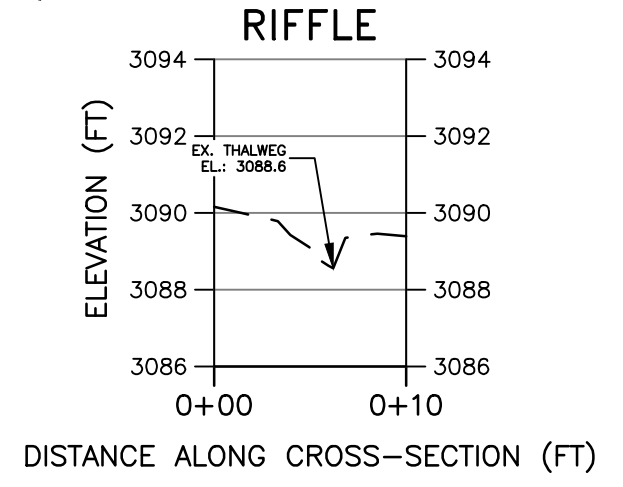
S-J13 (2) BASELINE CROSS-SECTION A

NOTE: ALL SECTIONS VIEWS SHOWN LEFT TO RIGHT FACING DOWNSTREAM.

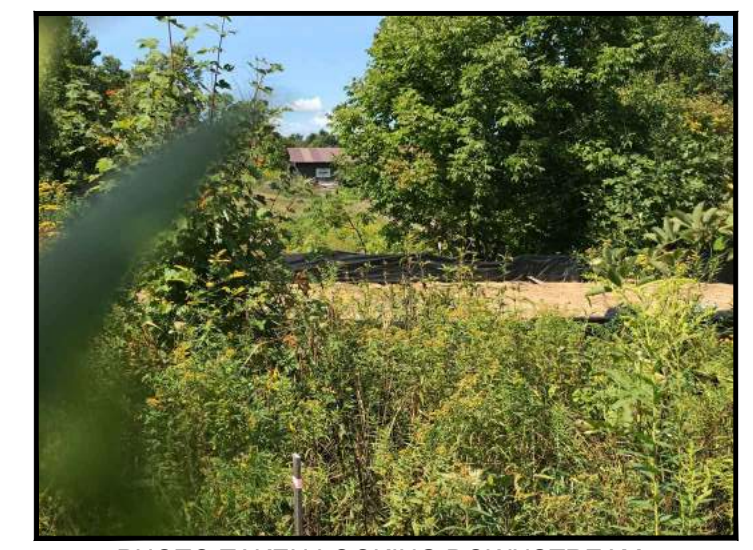
PHOTO TAKEN LOOKING DOWNSTREAM FROM UPSTREAM IMPACT LIMITS

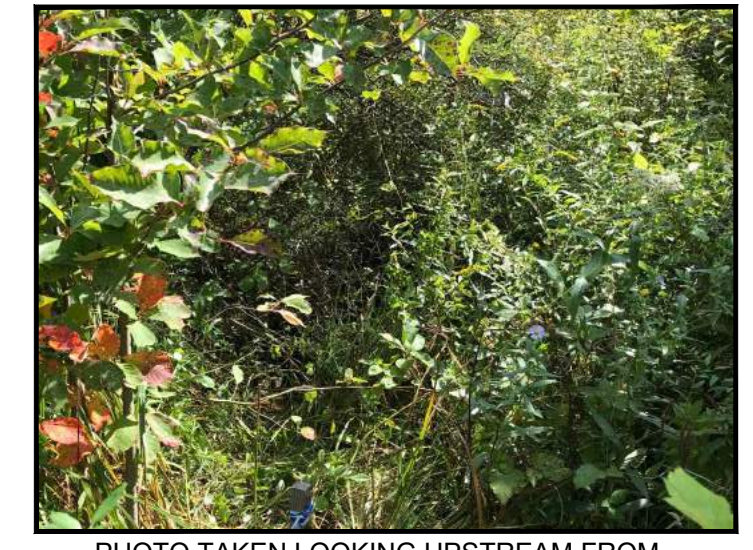
PHOTO TAKEN LOOKING UPSTREAM FROM DOWNSTREAM IMPACT LIMITS
