## Baseline Assessment – Stream Attributes

### Reach S-S1 (Pipeline ROW) Ephemeral Spread C Webster County, West Virginia

**Spread C      Stream S-S1 (Pipeline ROW)      Webster County**

Project: PROFILE AND CROSS-SECTIONS  
BASELINE SURVEY  
CROSSING S-S1 - UNNAMED TRIBUTARY  
TO OLDLICK CREEK (MP 82.35)  
WEBSTER COUNTY, WV

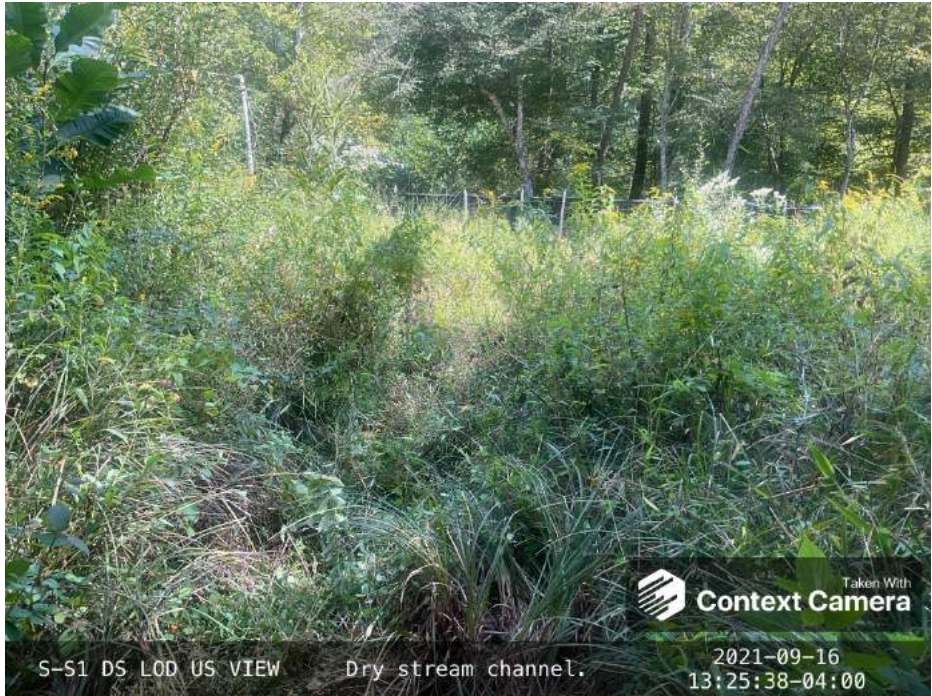
Photo Type: DS, US View  
Location, Orientation, Photographer Initials: Downstream Edge of ROW, Upstream View, KY/ZS  
Lat: 38.66702 Long: -80.478624

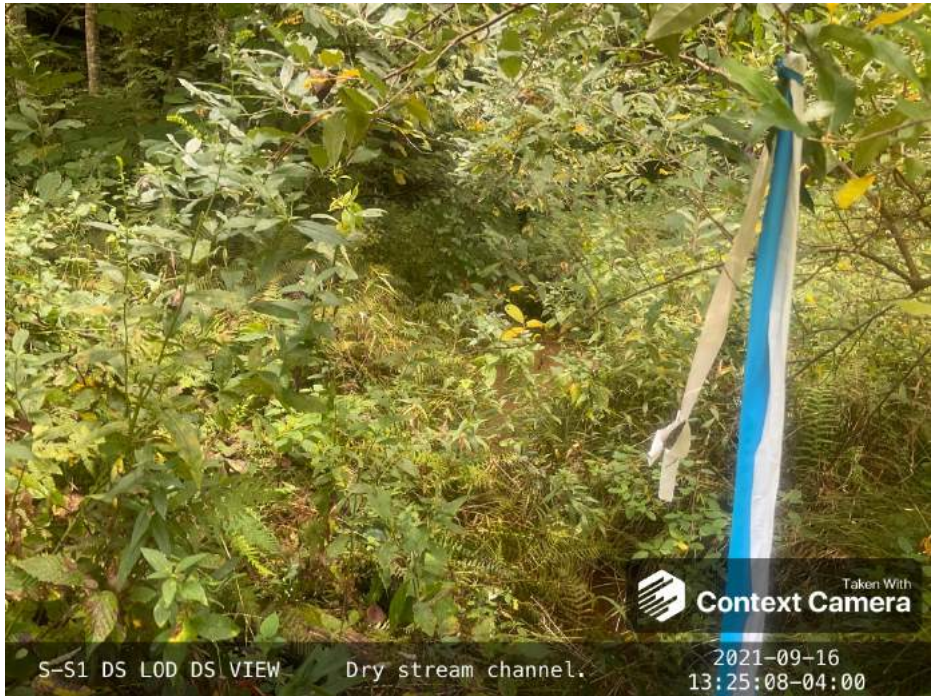
Photo Type: DS, DS View  
Location, Orientation, Photographer Initials: Downstream Edge of ROW, Downstream View, KY/ZS  
Lat: 38.66702 Long: -80.478624

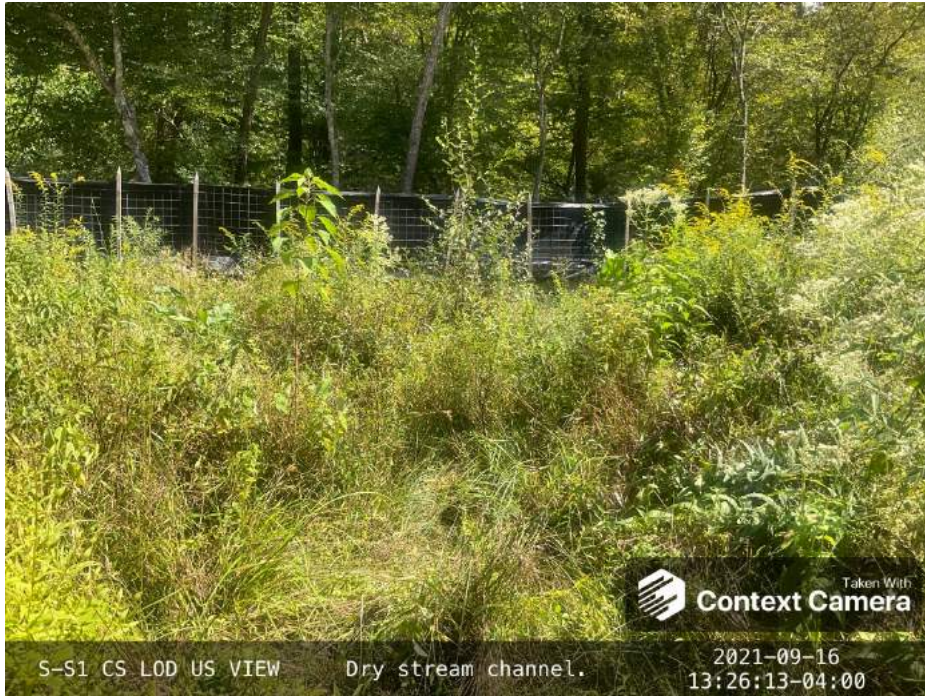
Photo Type: US View at Center  
Location, Orientation, Photographer Initials: Center ROW, Upstream View, KY/ZS  
Lat: 38.66702 Long: -80.478624

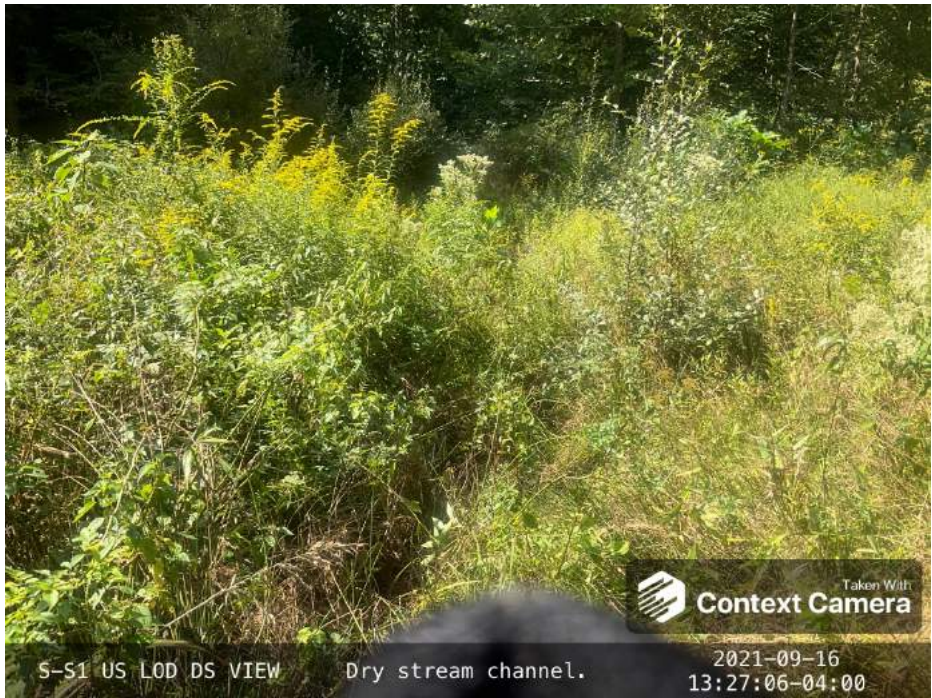
S-S1 US LOD DS VIEW

Dry stream channel.

Photo Type: US, DS View

Location, Orientation, Photographer Initials: Upstream Edge of ROW, Downstream View, KY/ZS

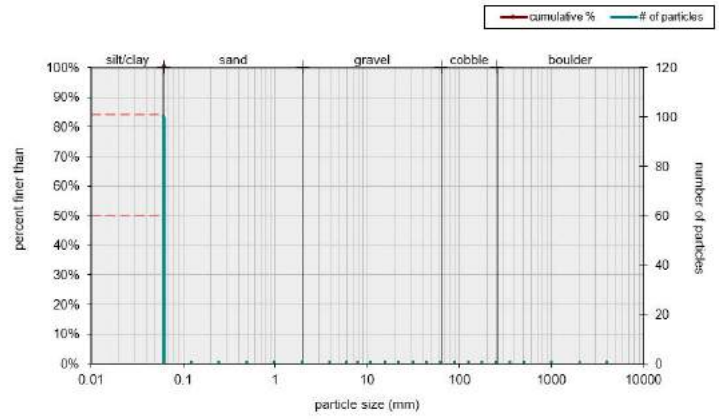
Bankfull Channel Pebble Count, S-S1

Size (mm)	Size Distribution	Type
D16	mean 0.1	silt/clay 100%
D35	dispersion 1.0	sand 0%
D50	skewness ---	gravel 0%
D65		cobble 0%
D84		boulder 0%
D95

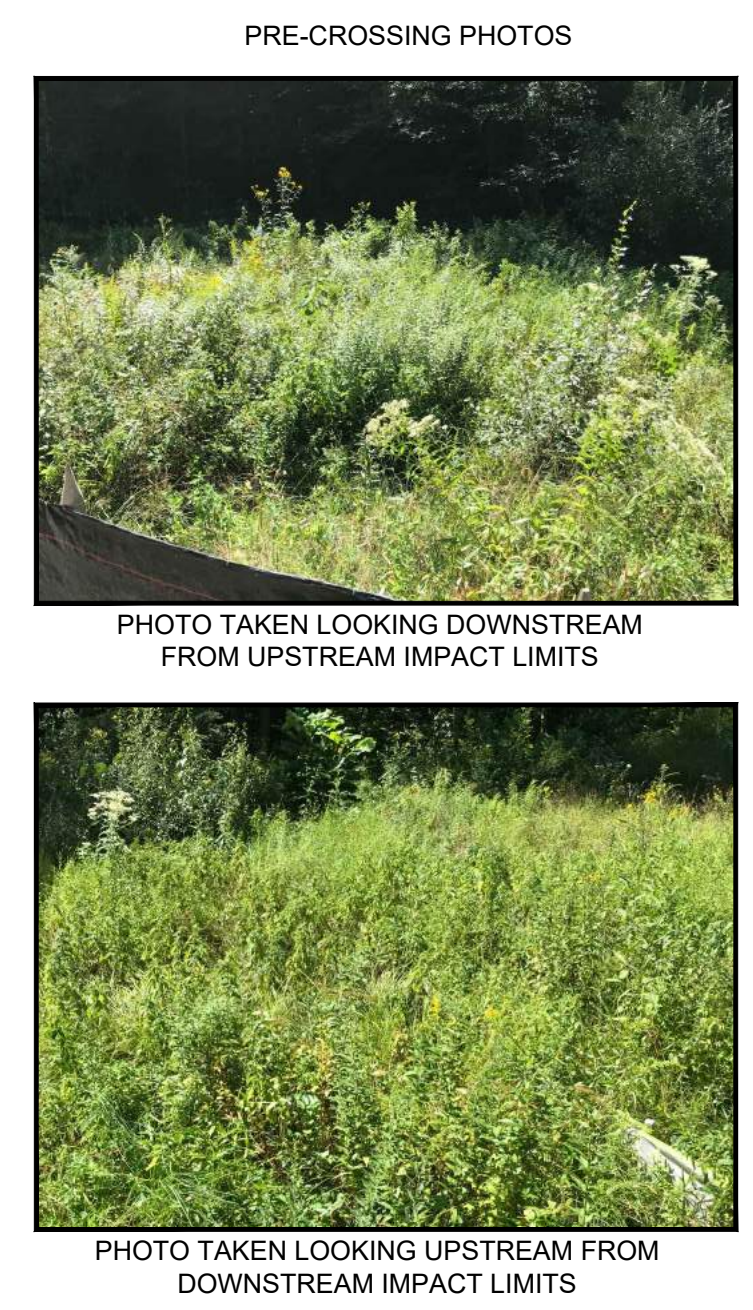
AS-BUILT TABLE: S-S1 CROSS SECTION A					
PT. LOC.	PRE-CROSSING			AS-BUILT	
	NORTHING	EASTING	ELEV.	VERT. DIFF.	HORZ. DIFF.
TS-L	14041800.8900	1789264.1210	1057.640'		
BS-L	14041814.2200	1789255.1850	1055.765'		
THW	14041820.2000	1789257.0420	1054.266'		
BS-R	14041834.2100	1789252.2990	1055.350'		
TS-R	14041857.3800	1789243.5850	1055.952'

NOTE: ALL SECTIONS VIEWS SHOWN LEFT TO RIGHT FACING DOWNSTREAM.
