# Baseline Assessment – Stream Attributes

## Reach S-U22 (Pipeline ROW) Intermittent Spread F Greenbrier County, West Virginia

Title: PROFILE AND CROSS-SECTIONS  
BASELINE SURVEY  
CROSSING S-U22 - UNNAMED TRIB. TO  
MEADOW RIVER (MP 156.84)  
GREENBRIER COUNTY, WV

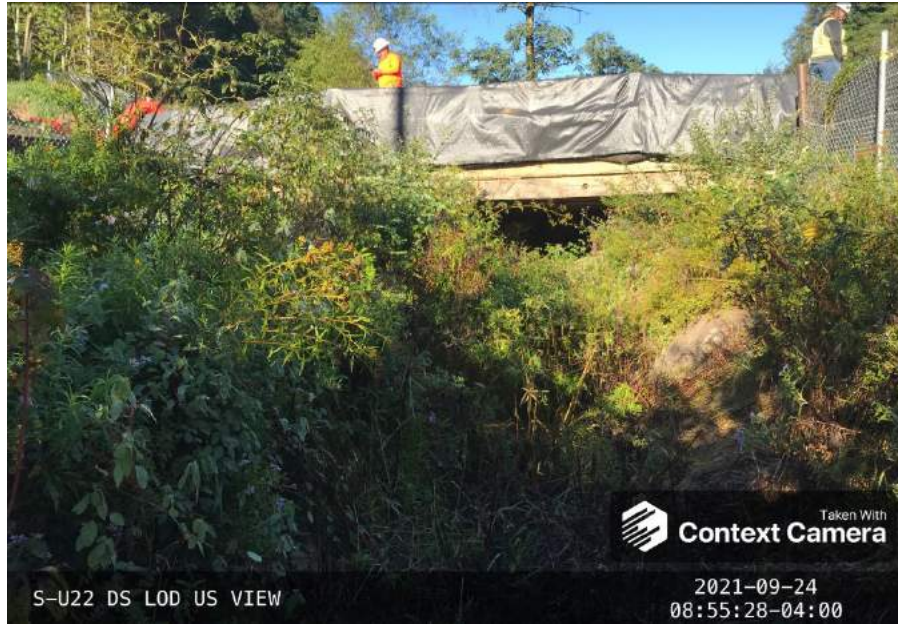
Photo Type: DS, US View

Location, Orientation, Photographer Initials: Downstream Edge of ROW, Upstream View, RH/VM  
Lat: 37.839558 Long: -80.748496

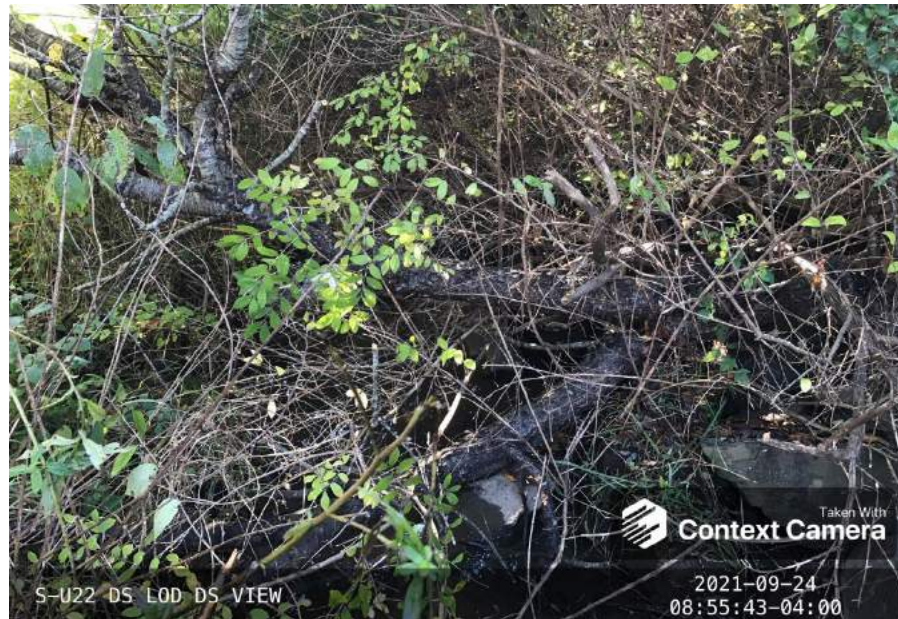
Photo Type: DS, DS View

Location, Orientation, Photographer Initials: Downstream Edge of ROW, Downstream View, RH/VM  
Lat: 37.839558 Long: -80.748496

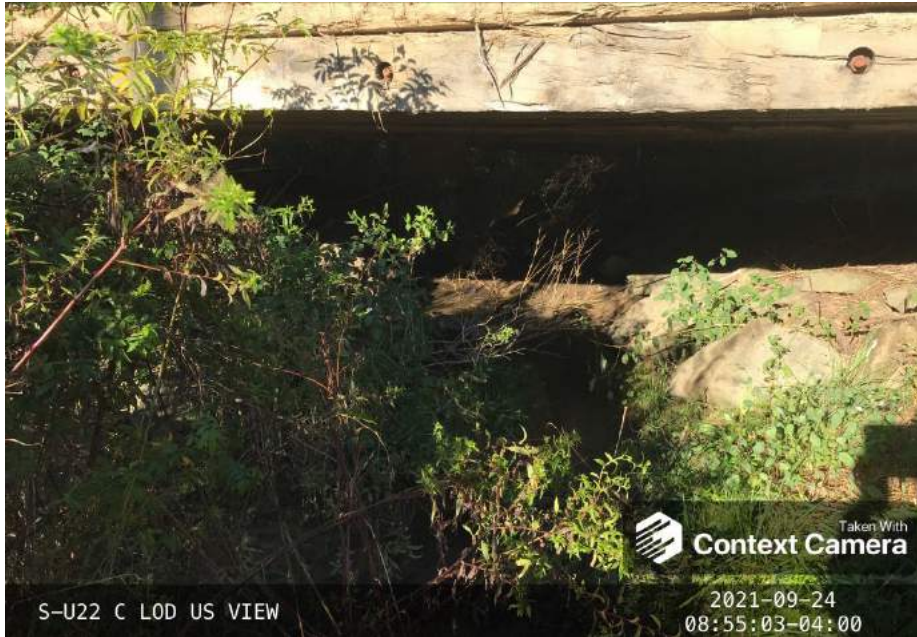
Photo Type: US View at Center  
Location, Orientation, Photographer Initials: Center ROW, Upstream View, RH/VM  
Lat: 37.839558 Long: -80.748496

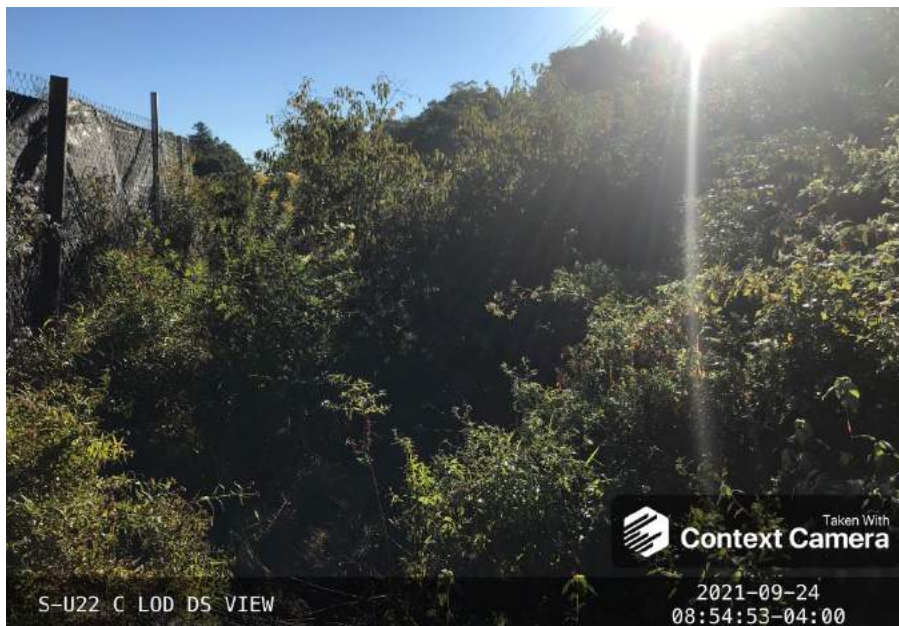
Photo Type: DS View at Center  
Location, Orientation, Photographer Initials: ROW Center, Downstream View, RH/VM  
Lat: 37.839558 Long: -80.748496

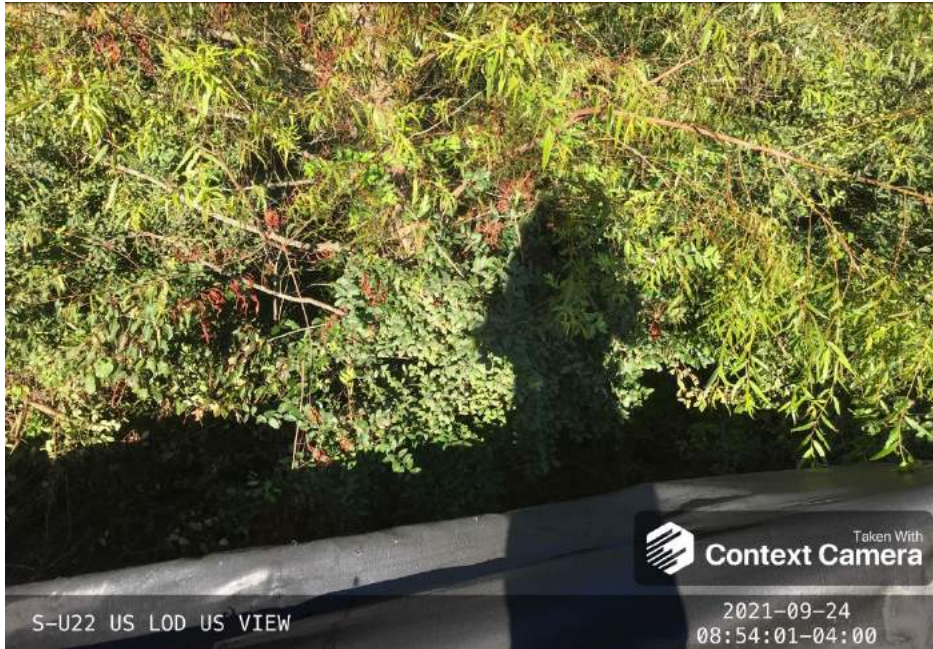
Photo Type: US, US View  
Location, Orientation, Photographer Initials: Upstream Edge of ROW, Upstream View, RH/VM  
Lat: 37.839558 Long: -80.748496

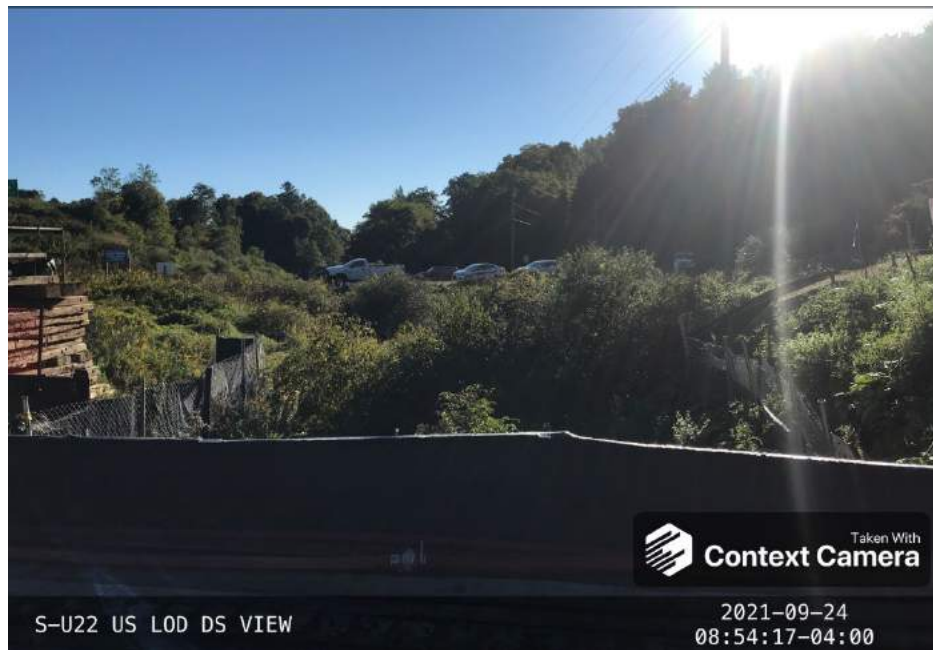
Photo Type: US, DS View  
Location, Orientation, Photographer Initials: Upstream Edge of ROW, Downstream View, RH/VM  
Lat: 37.839558 Long: -80.748496
