Baseline Assessment – Stream Attributes

Reach S-VV16 (2) (Temporary Access Road) Ephemeral Spread B Lewis County, West Virginia

Title
 PROFILE AND CROSS-SECTIONS
 BASELINE SURVEY
 CROSSING S-VV16 (2) - UNNAMED
 TRIBUTARY TO SECOND BIG RUN (MP 61.50)
 LEWIS COUNTY, WV

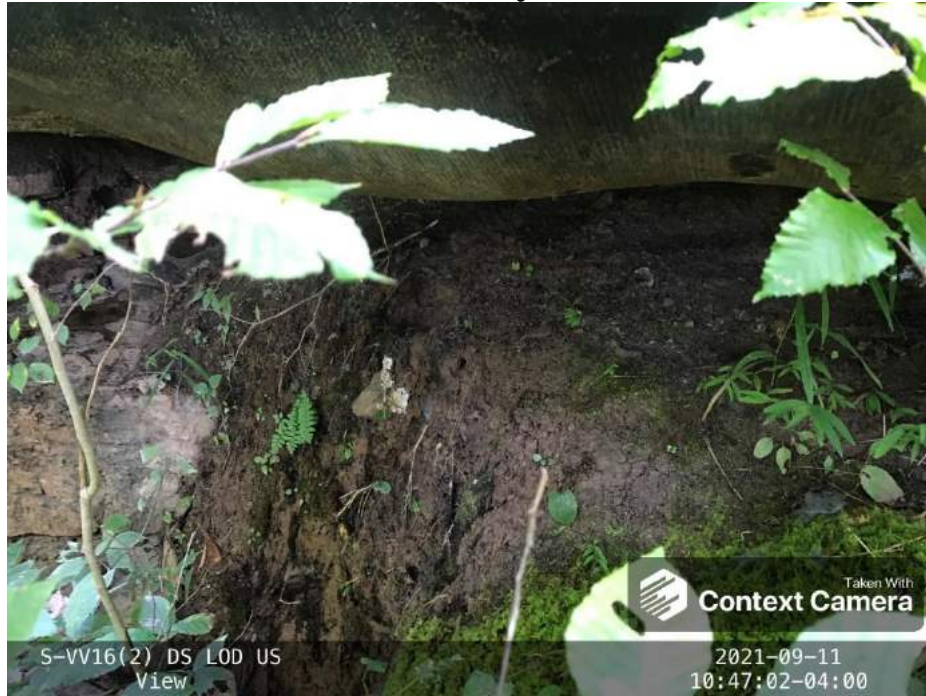
Photo Type: DS, US View

Location, Orientation, Photographer Initials: Downstream Edge of ROW, Upstream View, AJE/MAG
Lat: 38.895455 Long: -80.566432

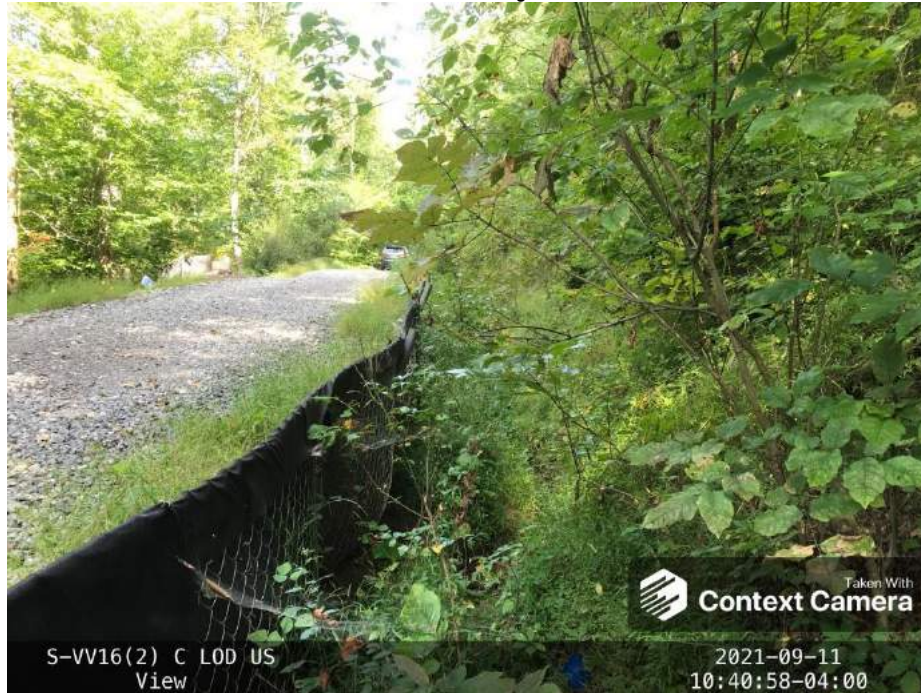
Photo Type: US View at Center
Location, Orientation, Photographer Initials: Center ROW, Upstream View, AJE/MAG
Lat: 38.895455 Long: -80.566432

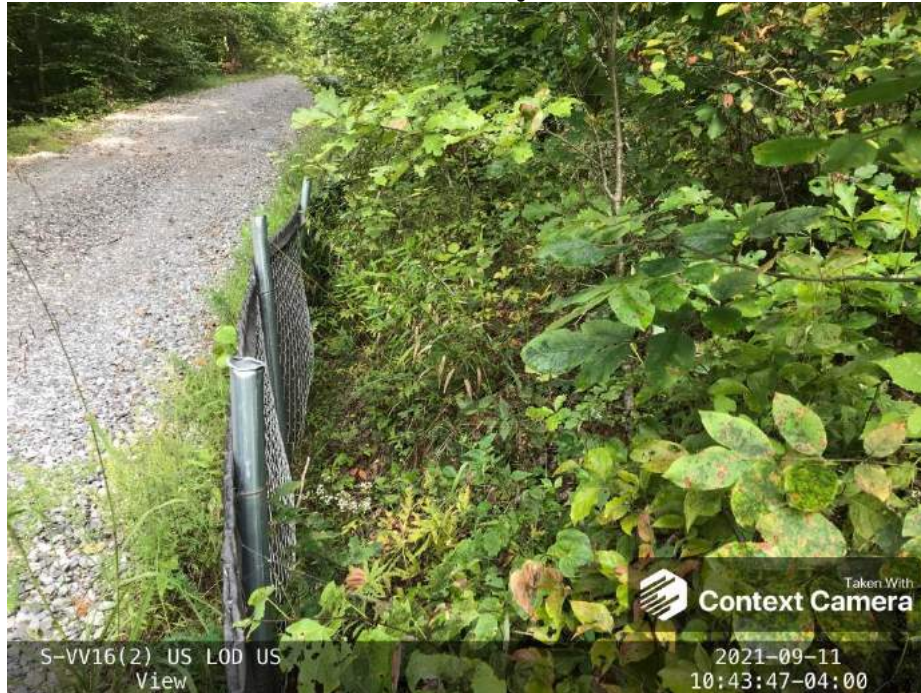
Photo Type: US, US View
Location, Orientation, Photographer Initials: Upstream Edge of ROW, Upstream View, AJE/MAG
Lat: 38.895455 Long: -80.566432

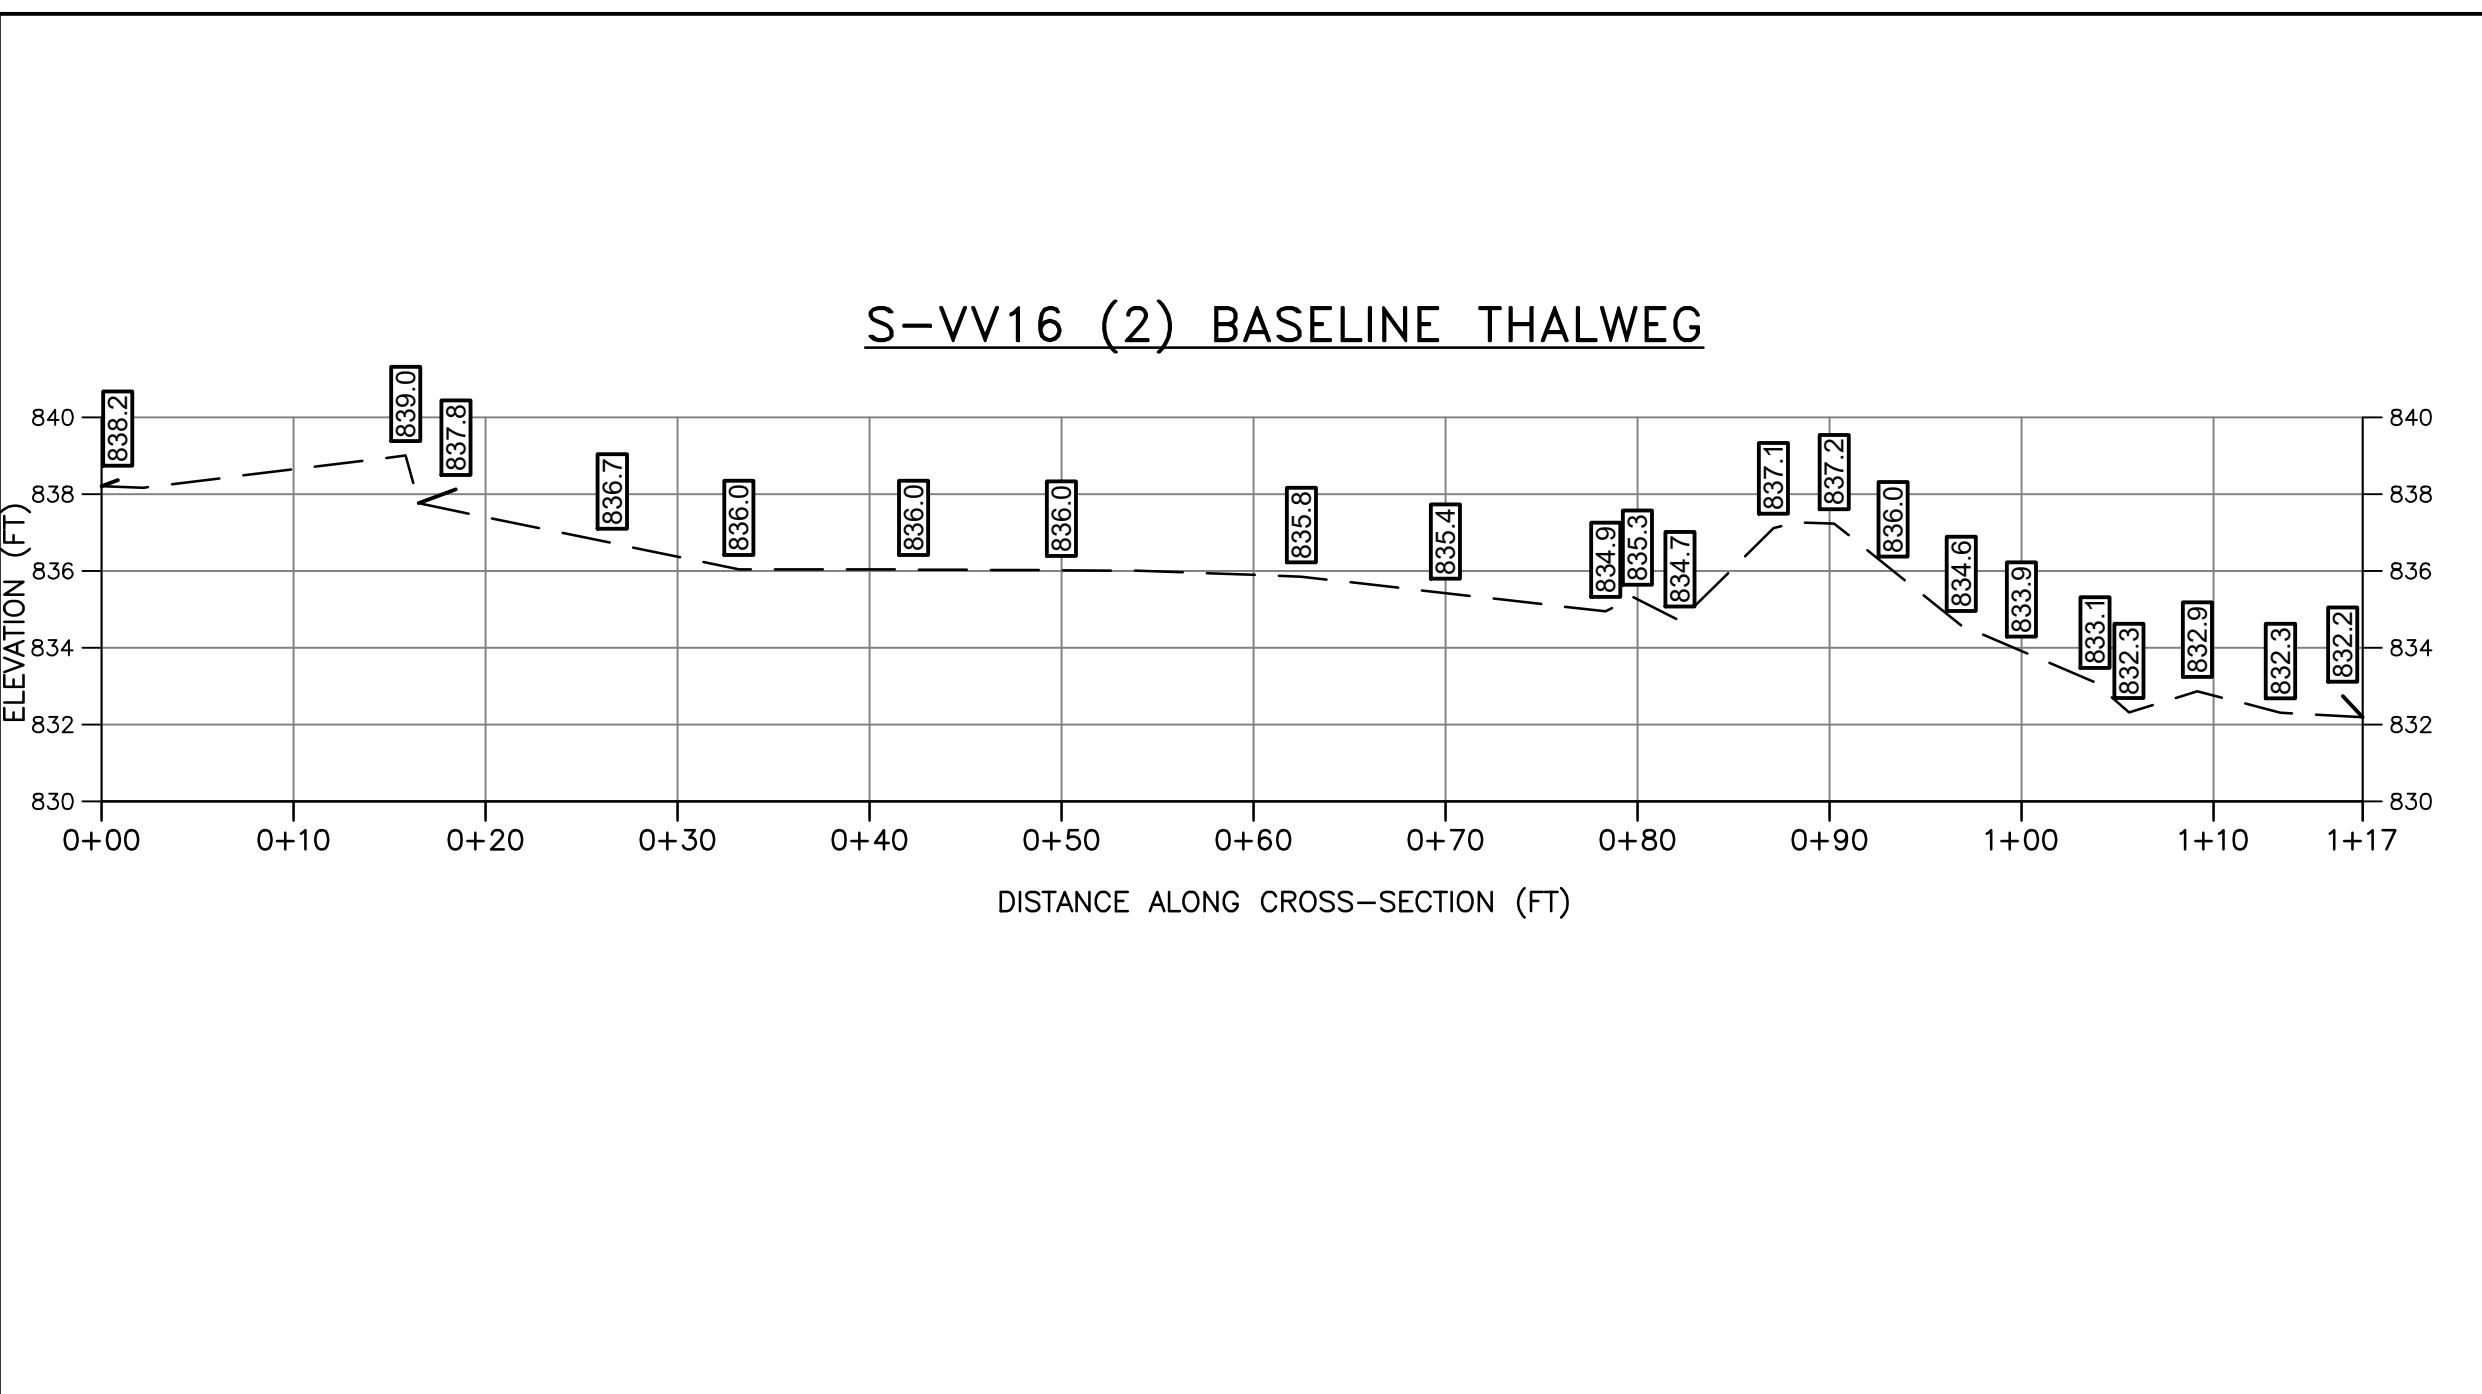
- ALL SECTION VIEWS SHOWN LEFT TO RIGHT FACING DOWNSTREAM.
 - POST-CROSSING SURVEY INFORMATION SHOWN IN RED. DATA PENDING.
 - POST-CROSSING SURVEY POINTS FOR CROSS SECTIONS AND THALWEG ARE PROJECTED ONTO PRE-CROSSING SECTION AND PROFILE VIEWS FOR COMPARISON.

PHOTO TAKEN LOOKING DOWNSTREAM FROM UPSTREAM IMPACT LIMITS

PHOTO TAKEN LOOKING UPSTREAM FROM DOWNSTREAM IMPACT LIMITS
