## Baseline Assessment – Stream Attributes

### Reach S-VV20 (Temporary Access Road) Ephemeral Spread B Lewis County, West Virginia

# Spread B Stream S-VV20 (Temporary Access Road) Lewis County

Client  
 MOUNTAIN VALLEY PIPELINE, LLC  
 2200 ENERGY DRIVE, 2ND FLOOR  
 CANONSBURG, PA 15317  
 Title  
 PROFILE AND CROSS-SECTIONS  
 BASELINE SURVEY  
 CROSSING S-VV20 - UNNAMED TRIBUTARY  
 TO SECOND BIG RUN (MP 61.50)  
 LEWIS COUNTY, WV

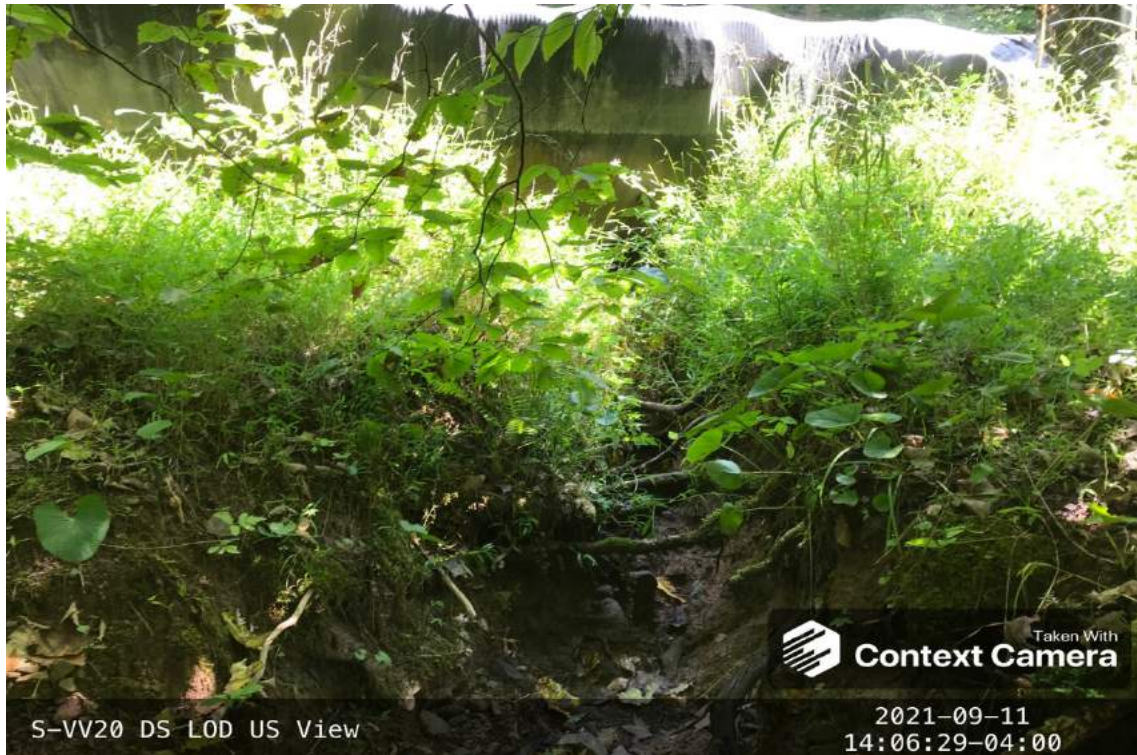
Photo Type: DS, US View  
Location, Orientation, Photographer Initials: Downstream Edge of ROW, Upstream View, MAG, AJE  
Lat: 38.900233 Long: -80.563491

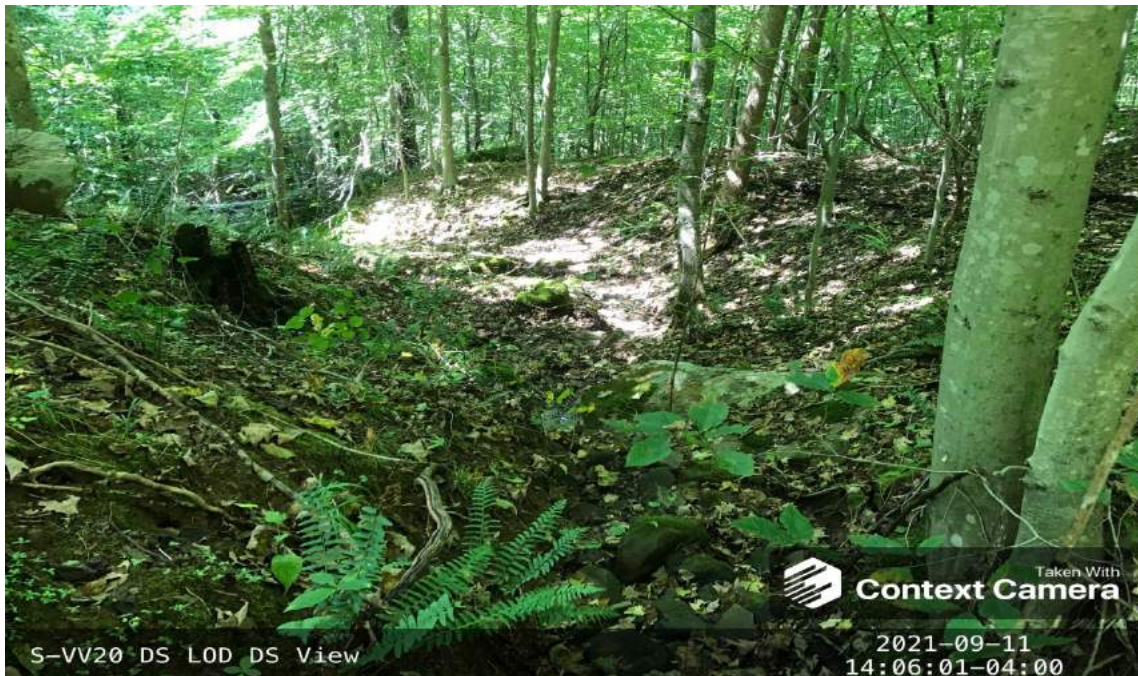
Photo Type: DS, DS View  
Location, Orientation, Photographer Initials: Downstream Edge of ROW, Downstream View, MAG, AJE  
Lat: 38.900233 Long: -80.563491

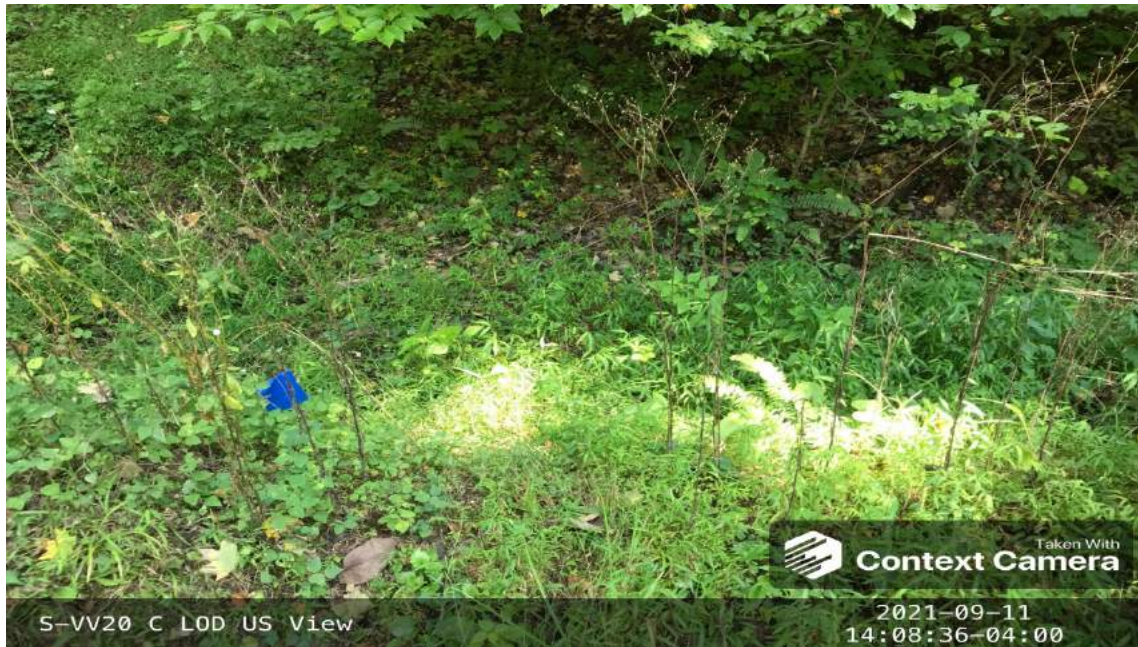
Photo Type: US View at Center  
Location, Orientation, Photographer Initials: Center ROW, Upstream View, MAG, AJE  
Lat: 38.900233 Long: -80.563491

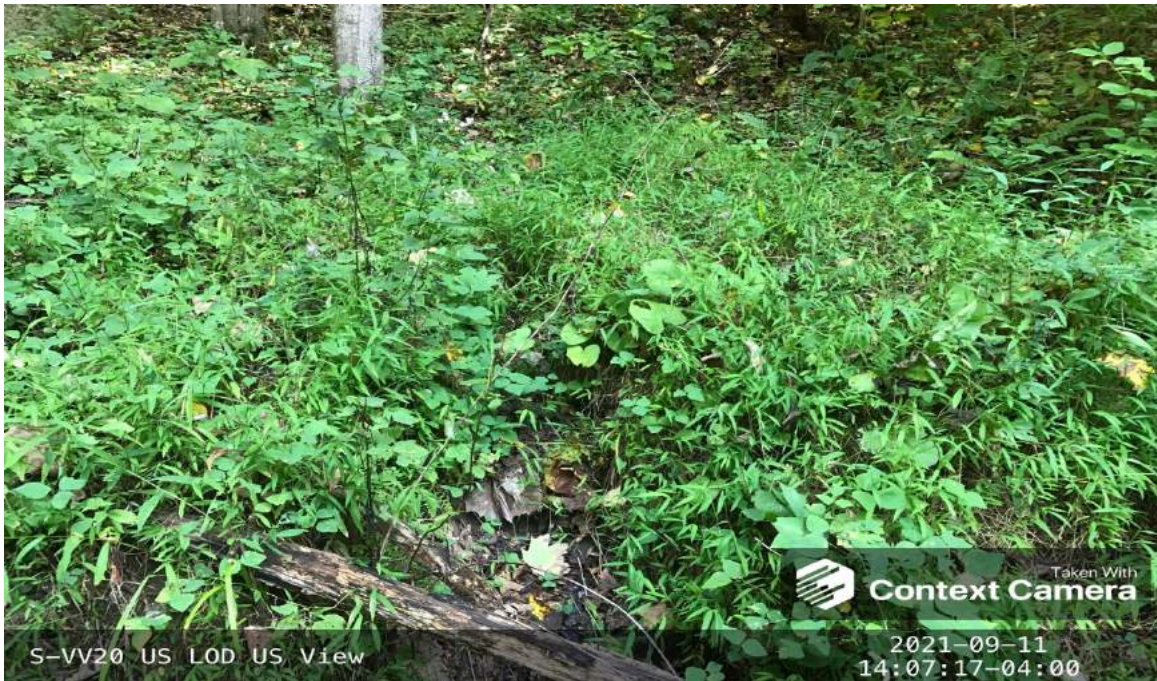
Photo Type: US, US View  
Location, Orientation, Photographer Initials: Upstream Edge of ROW, Upstream View, MAG, AJE  
Lat: 38.900233 Long: -80.563491

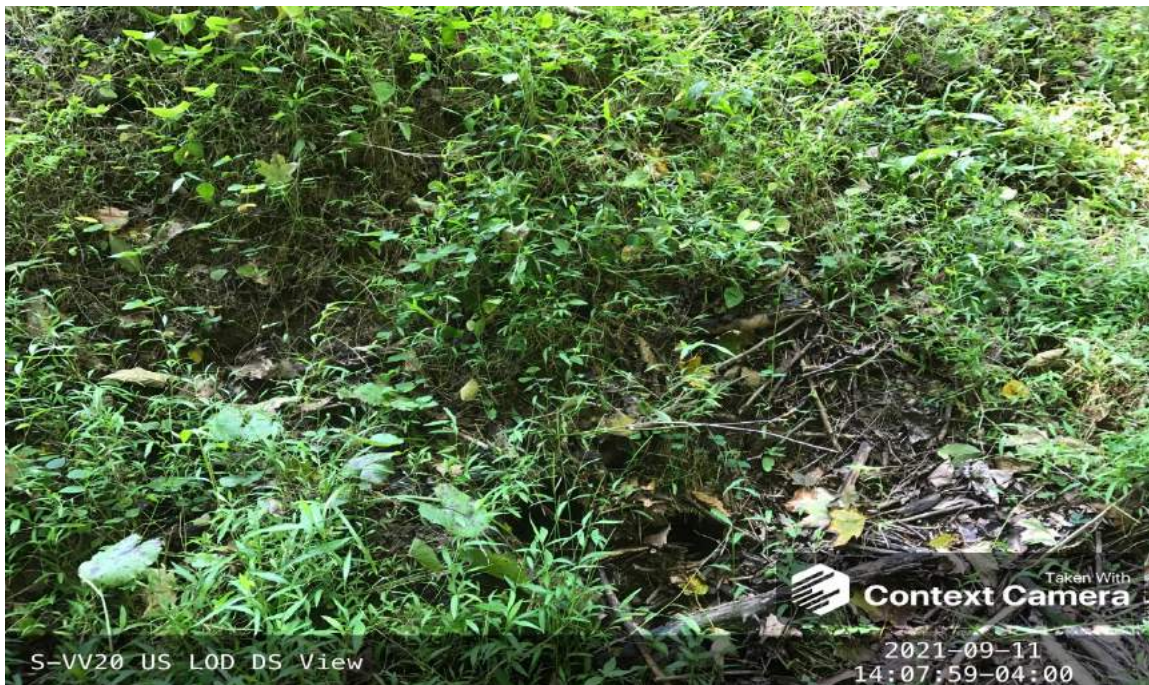
Photo Type: US, DS View  
Location, Orientation, Photographer Initials: Upstream Edge of ROW, Downstream View, MAG, AJE  
Lat: 38.900233 Long: -80.563491
