Baseline Assessment – Stream Attributes

Reach S-GH9 (Pipeline ROW)

Spread H

Franklin County, Virginia

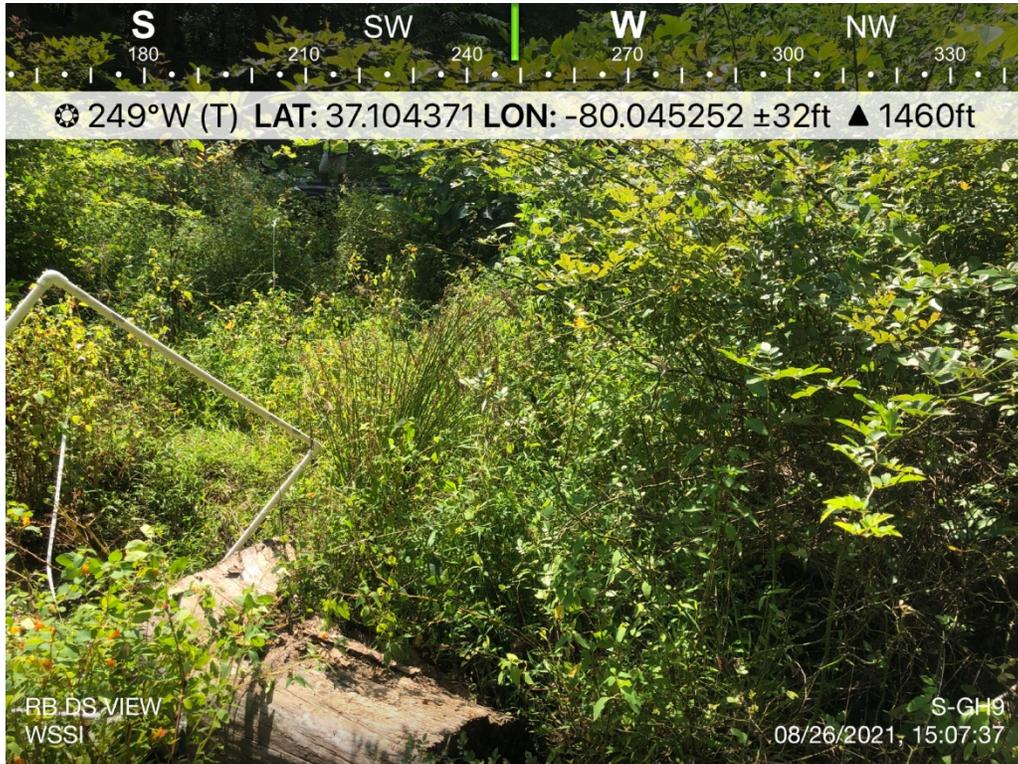
Photo Type: RB DS VIEW

Location, Orientation, Photographer Initials: Standing on RB looking downstream along the ROW looking E, AO

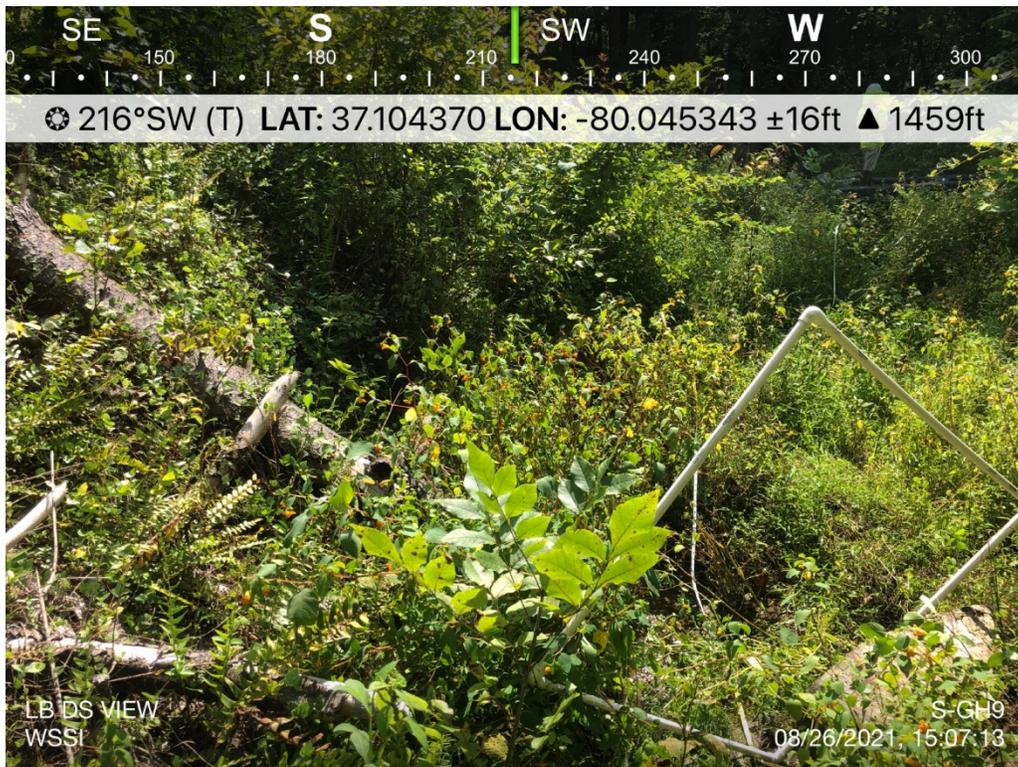
Photo Type: LB DS VIEW

Location, Orientation, Photographer Initials: Standing on LB looking downstream along the ROW looking SW, AO

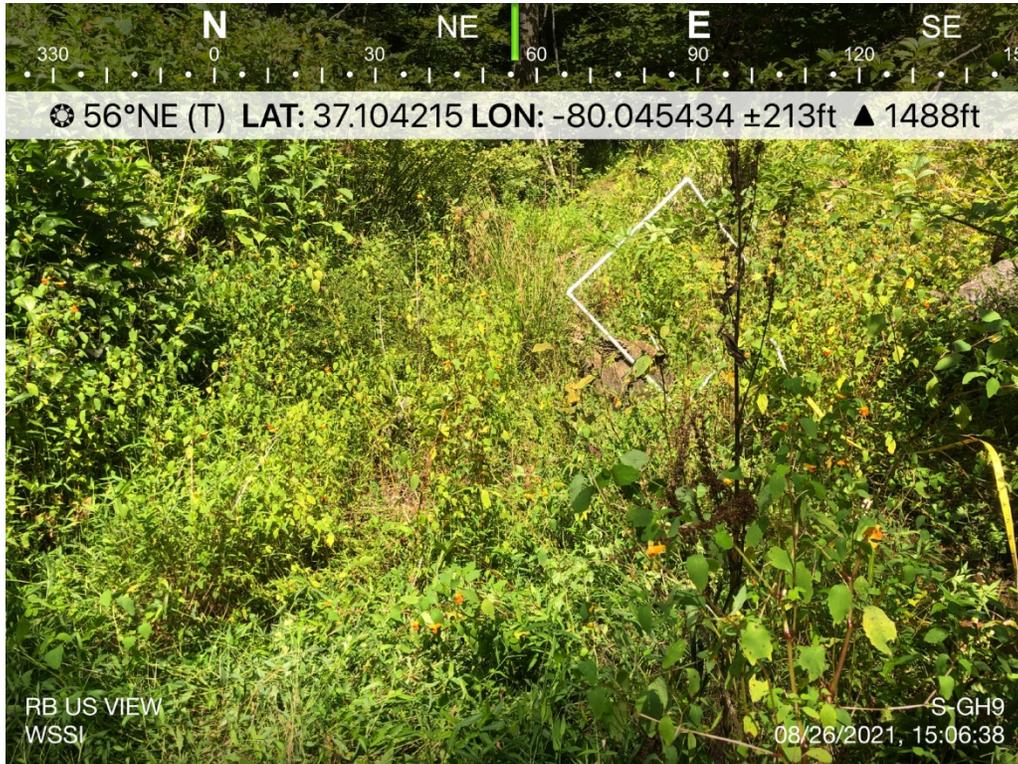
Photo Type: RB US VIEW

Location, Orientation, Photographer Initials: Standing on RB looking upstream along the ROW looking NE, AO

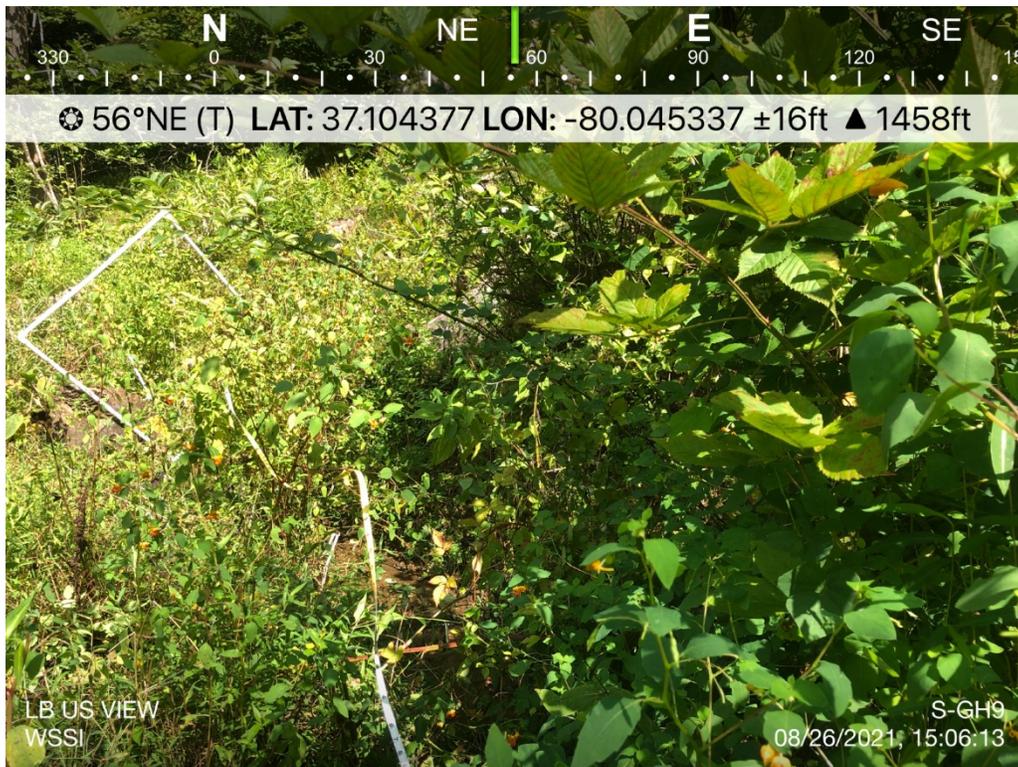
Photo Type: LB US VIEW

Location, Orientation, Photographer Initials: Standing on LB looking upstream along the ROW looking NE, AO

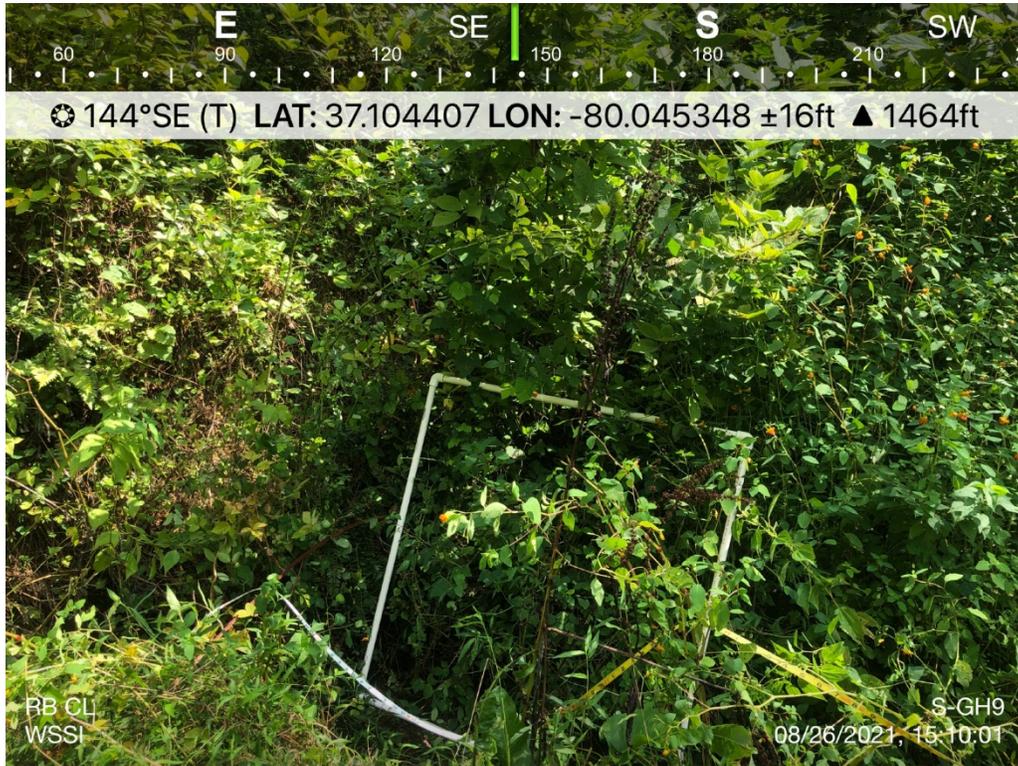
Photo Type: RB CL

Location, Orientation, Photographer Initials: Standing on RB looking at LB along pipe centerline looking SE, AO

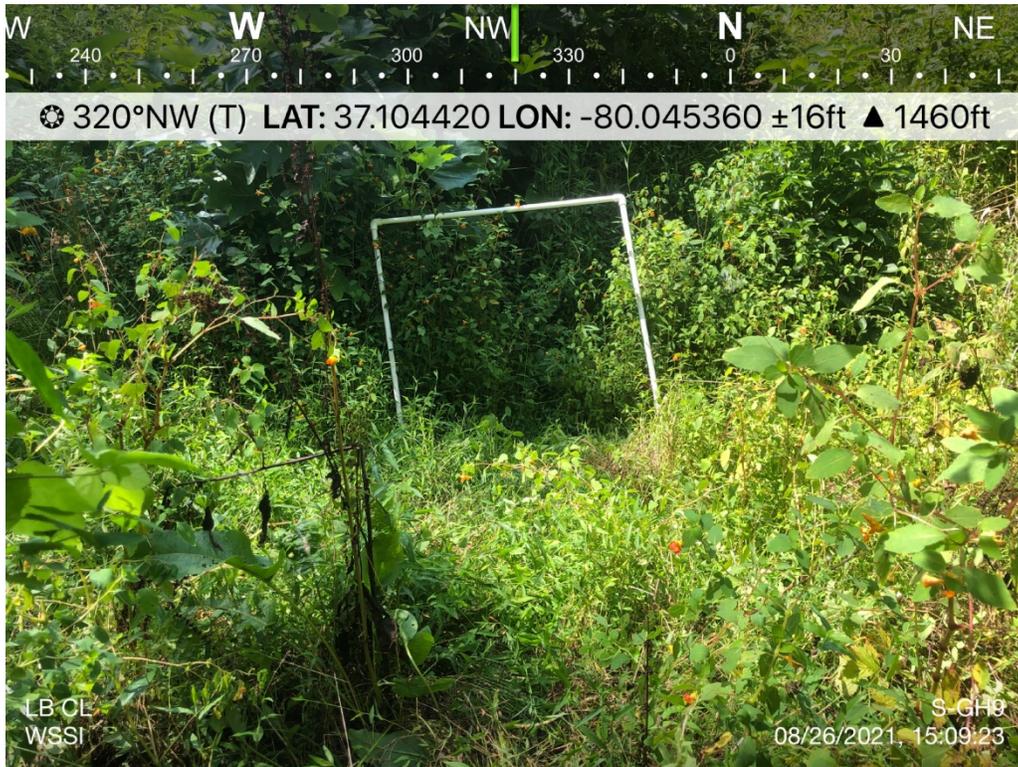
Photo Type: LB CL

Location, Orientation, Photographer Initials: Standing on LB looking at RB along pipe centerline looking NW, AO

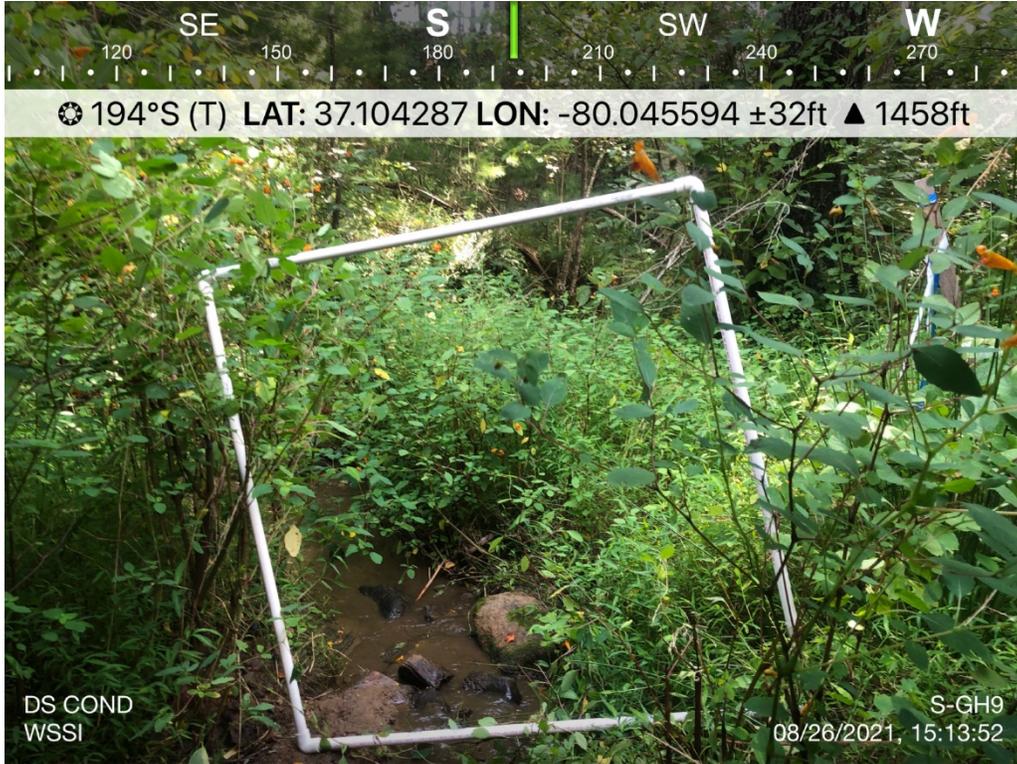
Photo Type: DS COND

Location, Orientation, Photographer Initials: Downstream conditions outside of ROW looking SW, AO

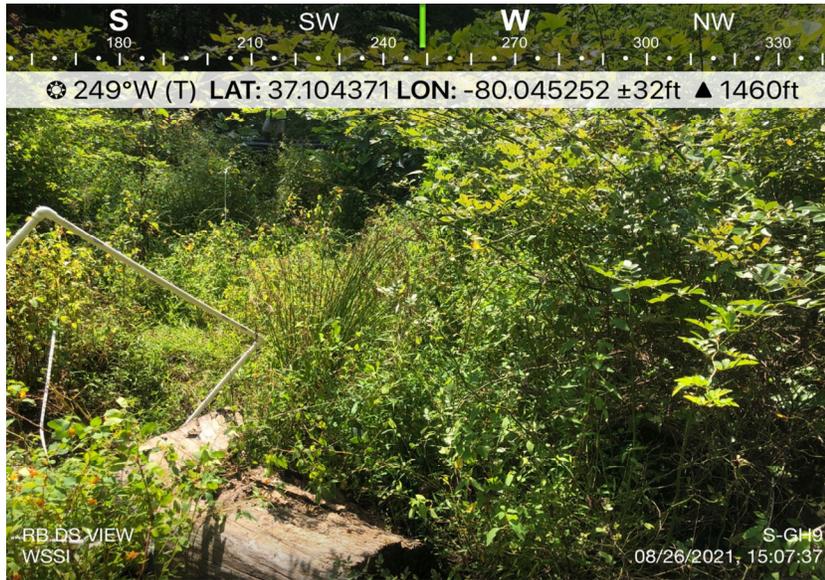
Downstream view on right bank within the LOD. Assessment is limited to areas within the temporary ROW.
