Baseline Assessment - Stream Attributes

Revisit

Reach S-MM22 (Pipeline ROW) Perennial Spread H Montgomery County, Virginia

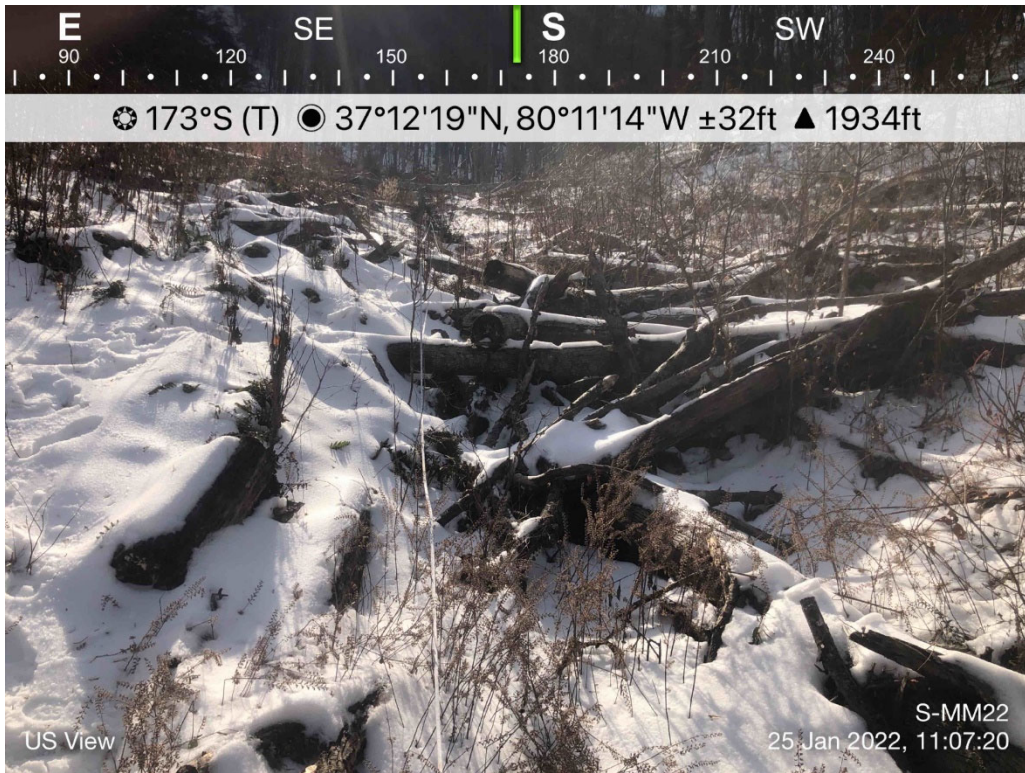
Photo Type: US VIEW
Location, Orientation, Photographer Initials: Upstream view of LOC looking S, KB

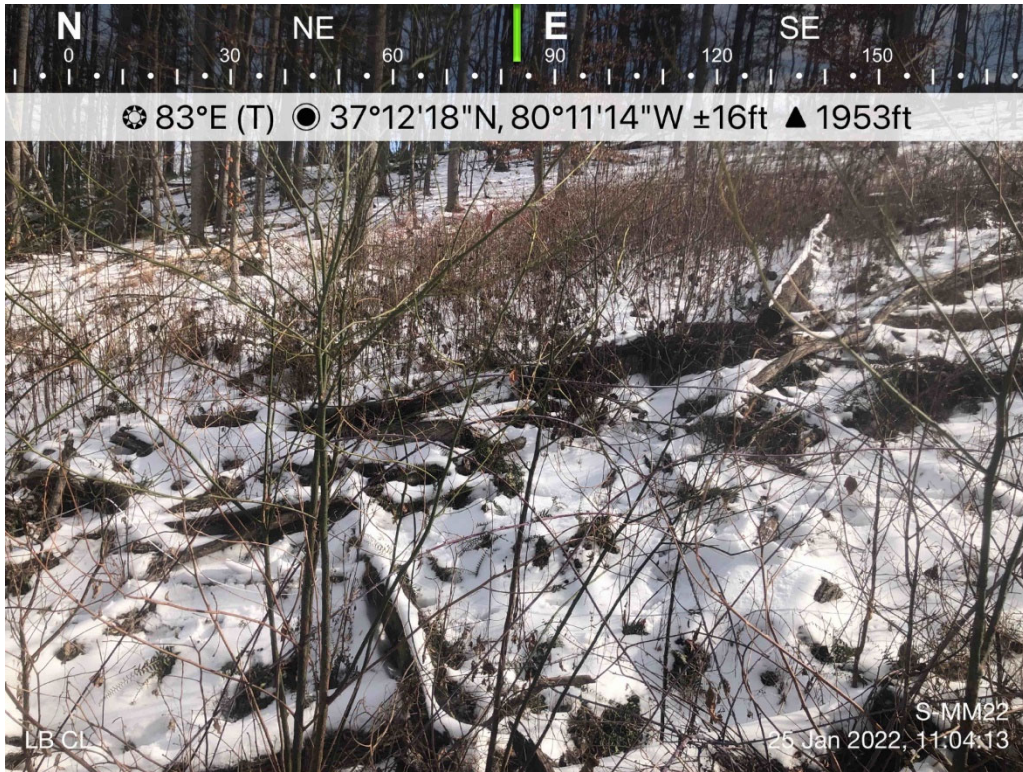
Photo Type: LB CL

Location, Orientation, Photographer Initials: Standing on LB looking at RB along pipe centerline looking E, KB

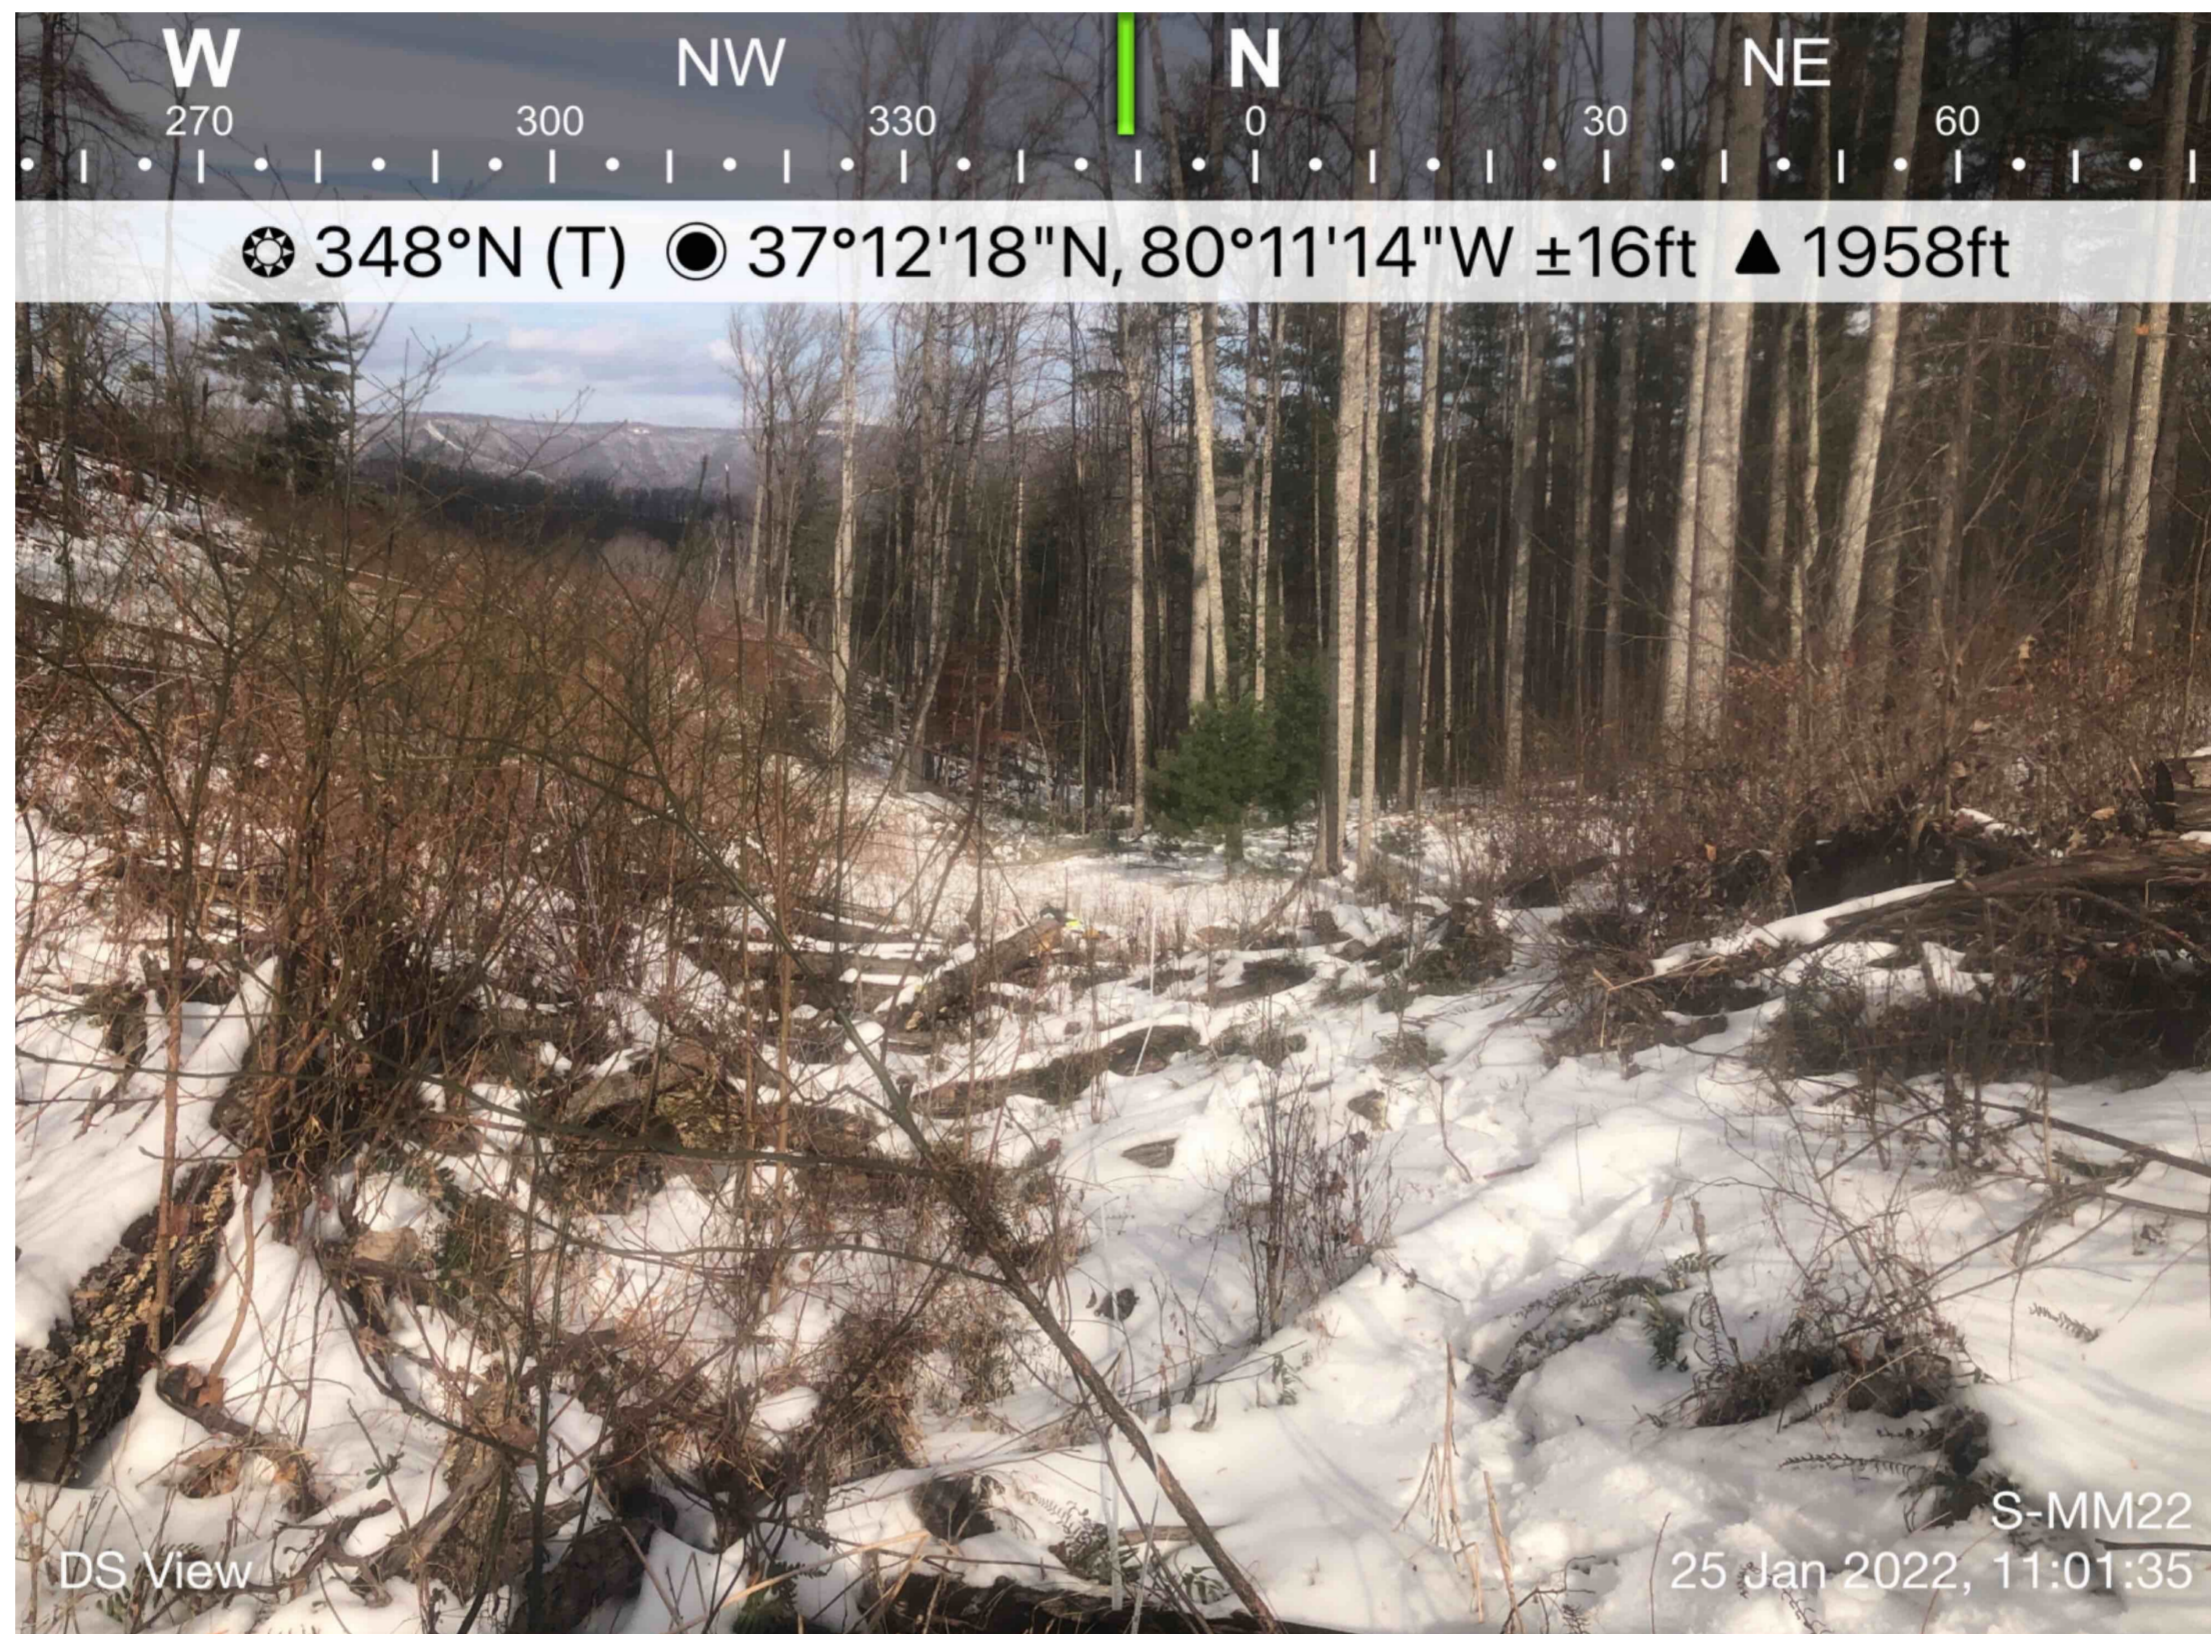
Downstream view of the LOC facing N
