Baseline Assessment – Stream Attributes

Reach S-D20 (Pipeline ROW) Intermittent Spread I Franklin County, Virginia

USACE FILE NO/ Project Name: <small>(V2.1, Sept 2015)</small>		Mountain Valley Pipeline		IMPACT COORDINATES: (in Decimal Degrees)		Lat.	37.069485	Lon.	-79.92623	WEATHER:		Sunny		DATE:		August 28, 2021			
IMPACT STREAM/SITE ID AND SITE DESCRIPTION: <small>(watershed size (acreage), unaltered or impairments)</small>				S-D20				MITIGATION STREAM CLASS/SITE ID AND SITE DESCRIPTION: <small>(watershed size (acreage), unaltered or impairments)</small>				Comments:							
STREAM IMPACT LENGTH:		76		FORM OF MITIGATION:		RESTORATION (Levels I-III)		MIT COORDINATES: (in Decimal Degrees)		Lat.		Lon.		PRECIPITATION PAST 48 HRS:		None		Mitigation Length:	
Column No. 1- Impact Existing Condition (Debit)				Column No. 2- Mitigation Existing Condition - Baseline (Credit)				Column No. 3- Mitigation Projected at Five Years Post Completion (Credit)				Column No. 4- Mitigation Projected at Ten Years Post Completion (Credit)				Column No. 5- Mitigation Projected at Maturity (Credit)

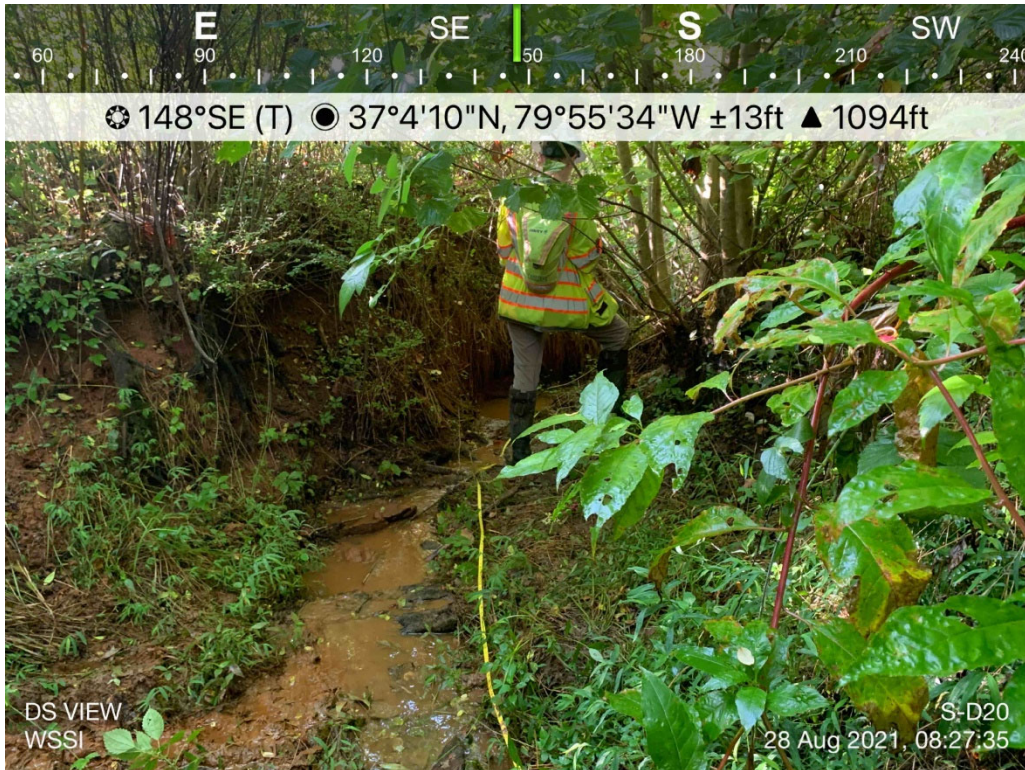
Photo Type: DS VIEW

Location, Orientation, Photographer Initials: Downstream view of ROW looking SE, AW

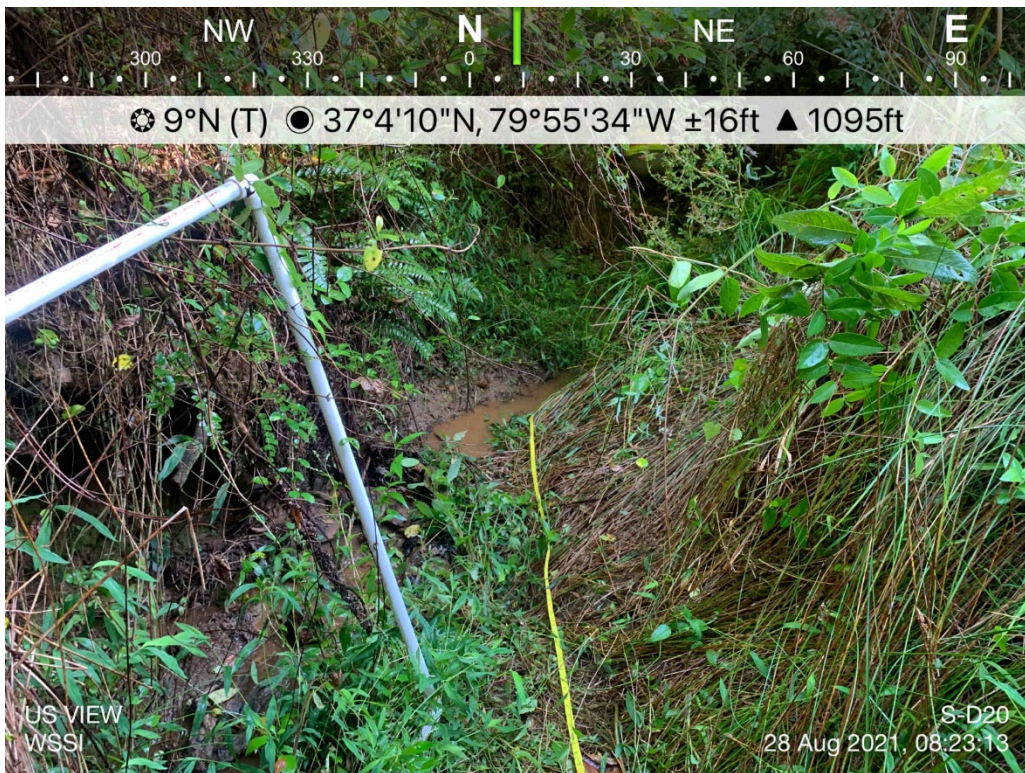
Photo Type: US VIEW

Location, Orientation, Photographer Initials: Upstream view of ROW looking N, AW

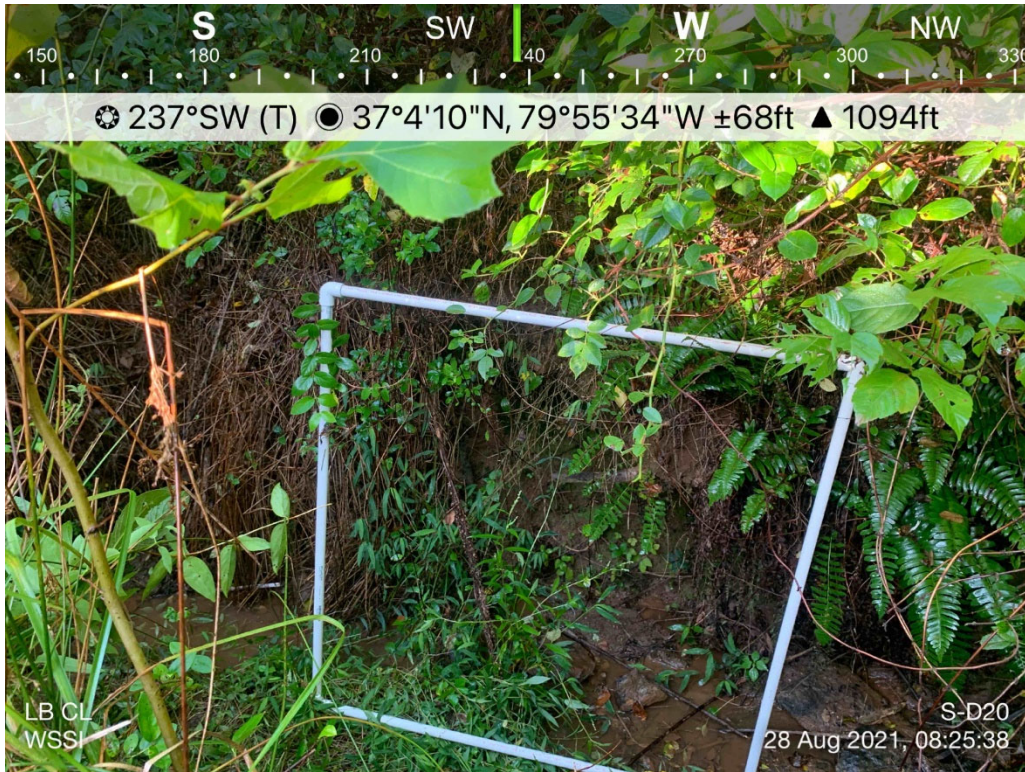
Photo Type: LB CL

Location, Orientation, Photographer Initials: Standing on LB looking at RB along pipe centerline looking SW, AW

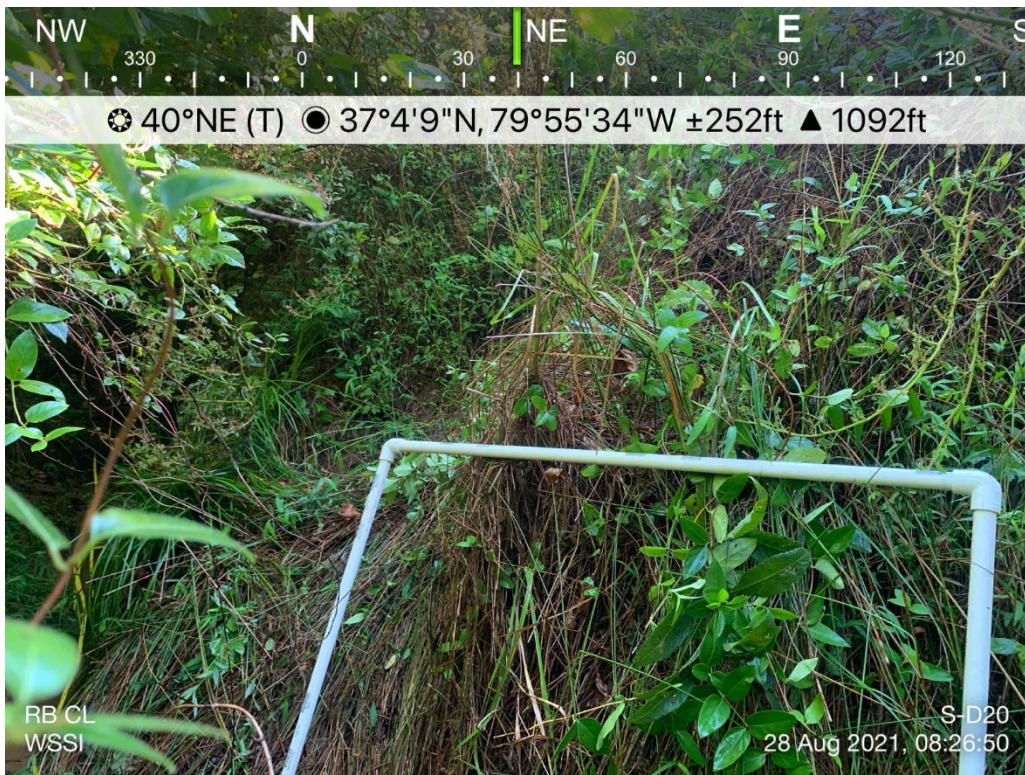
Photo Type: RB CL

Location, Orientation, Photographer Initials: Standing on RB looking at LB along pipe centerline looking NE, AW

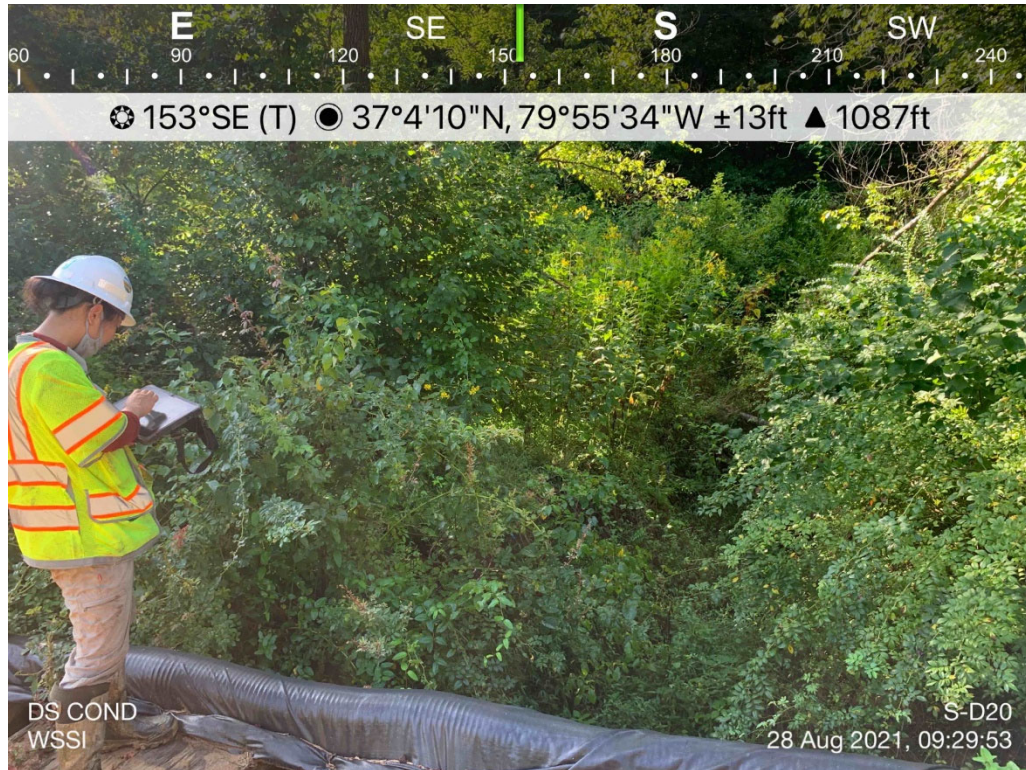
Photo Type: DS COND

Location, Orientation, Photographer Initials: Downstream conditions outside of ROW looking SE, AW

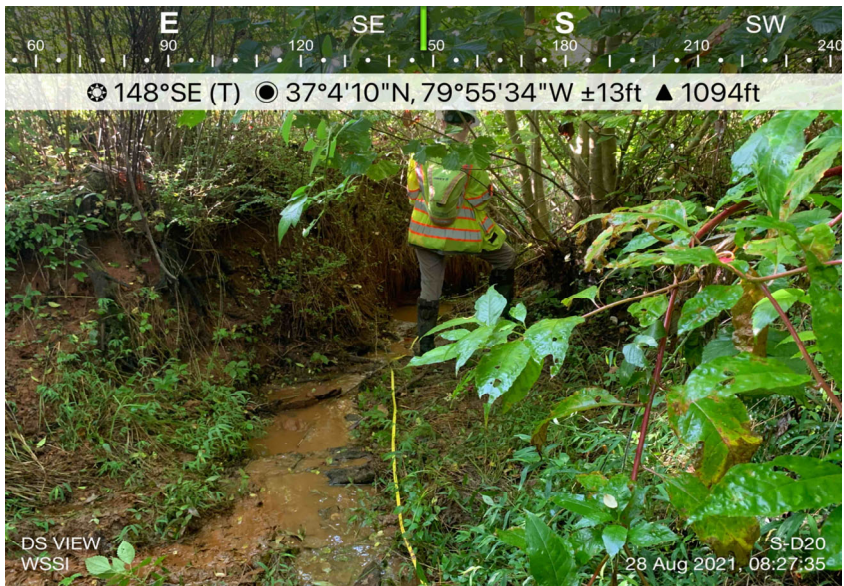
(WSSI Photo Location "L:\22000s\22800\22865.06\Admin\05-ENVR\Field Data\Spread I\Field Forms\S-D20\Photos\DS VIEW.jpg")

Downstream view within the ROW. Assessment is limited to areas within the temporary ROW.

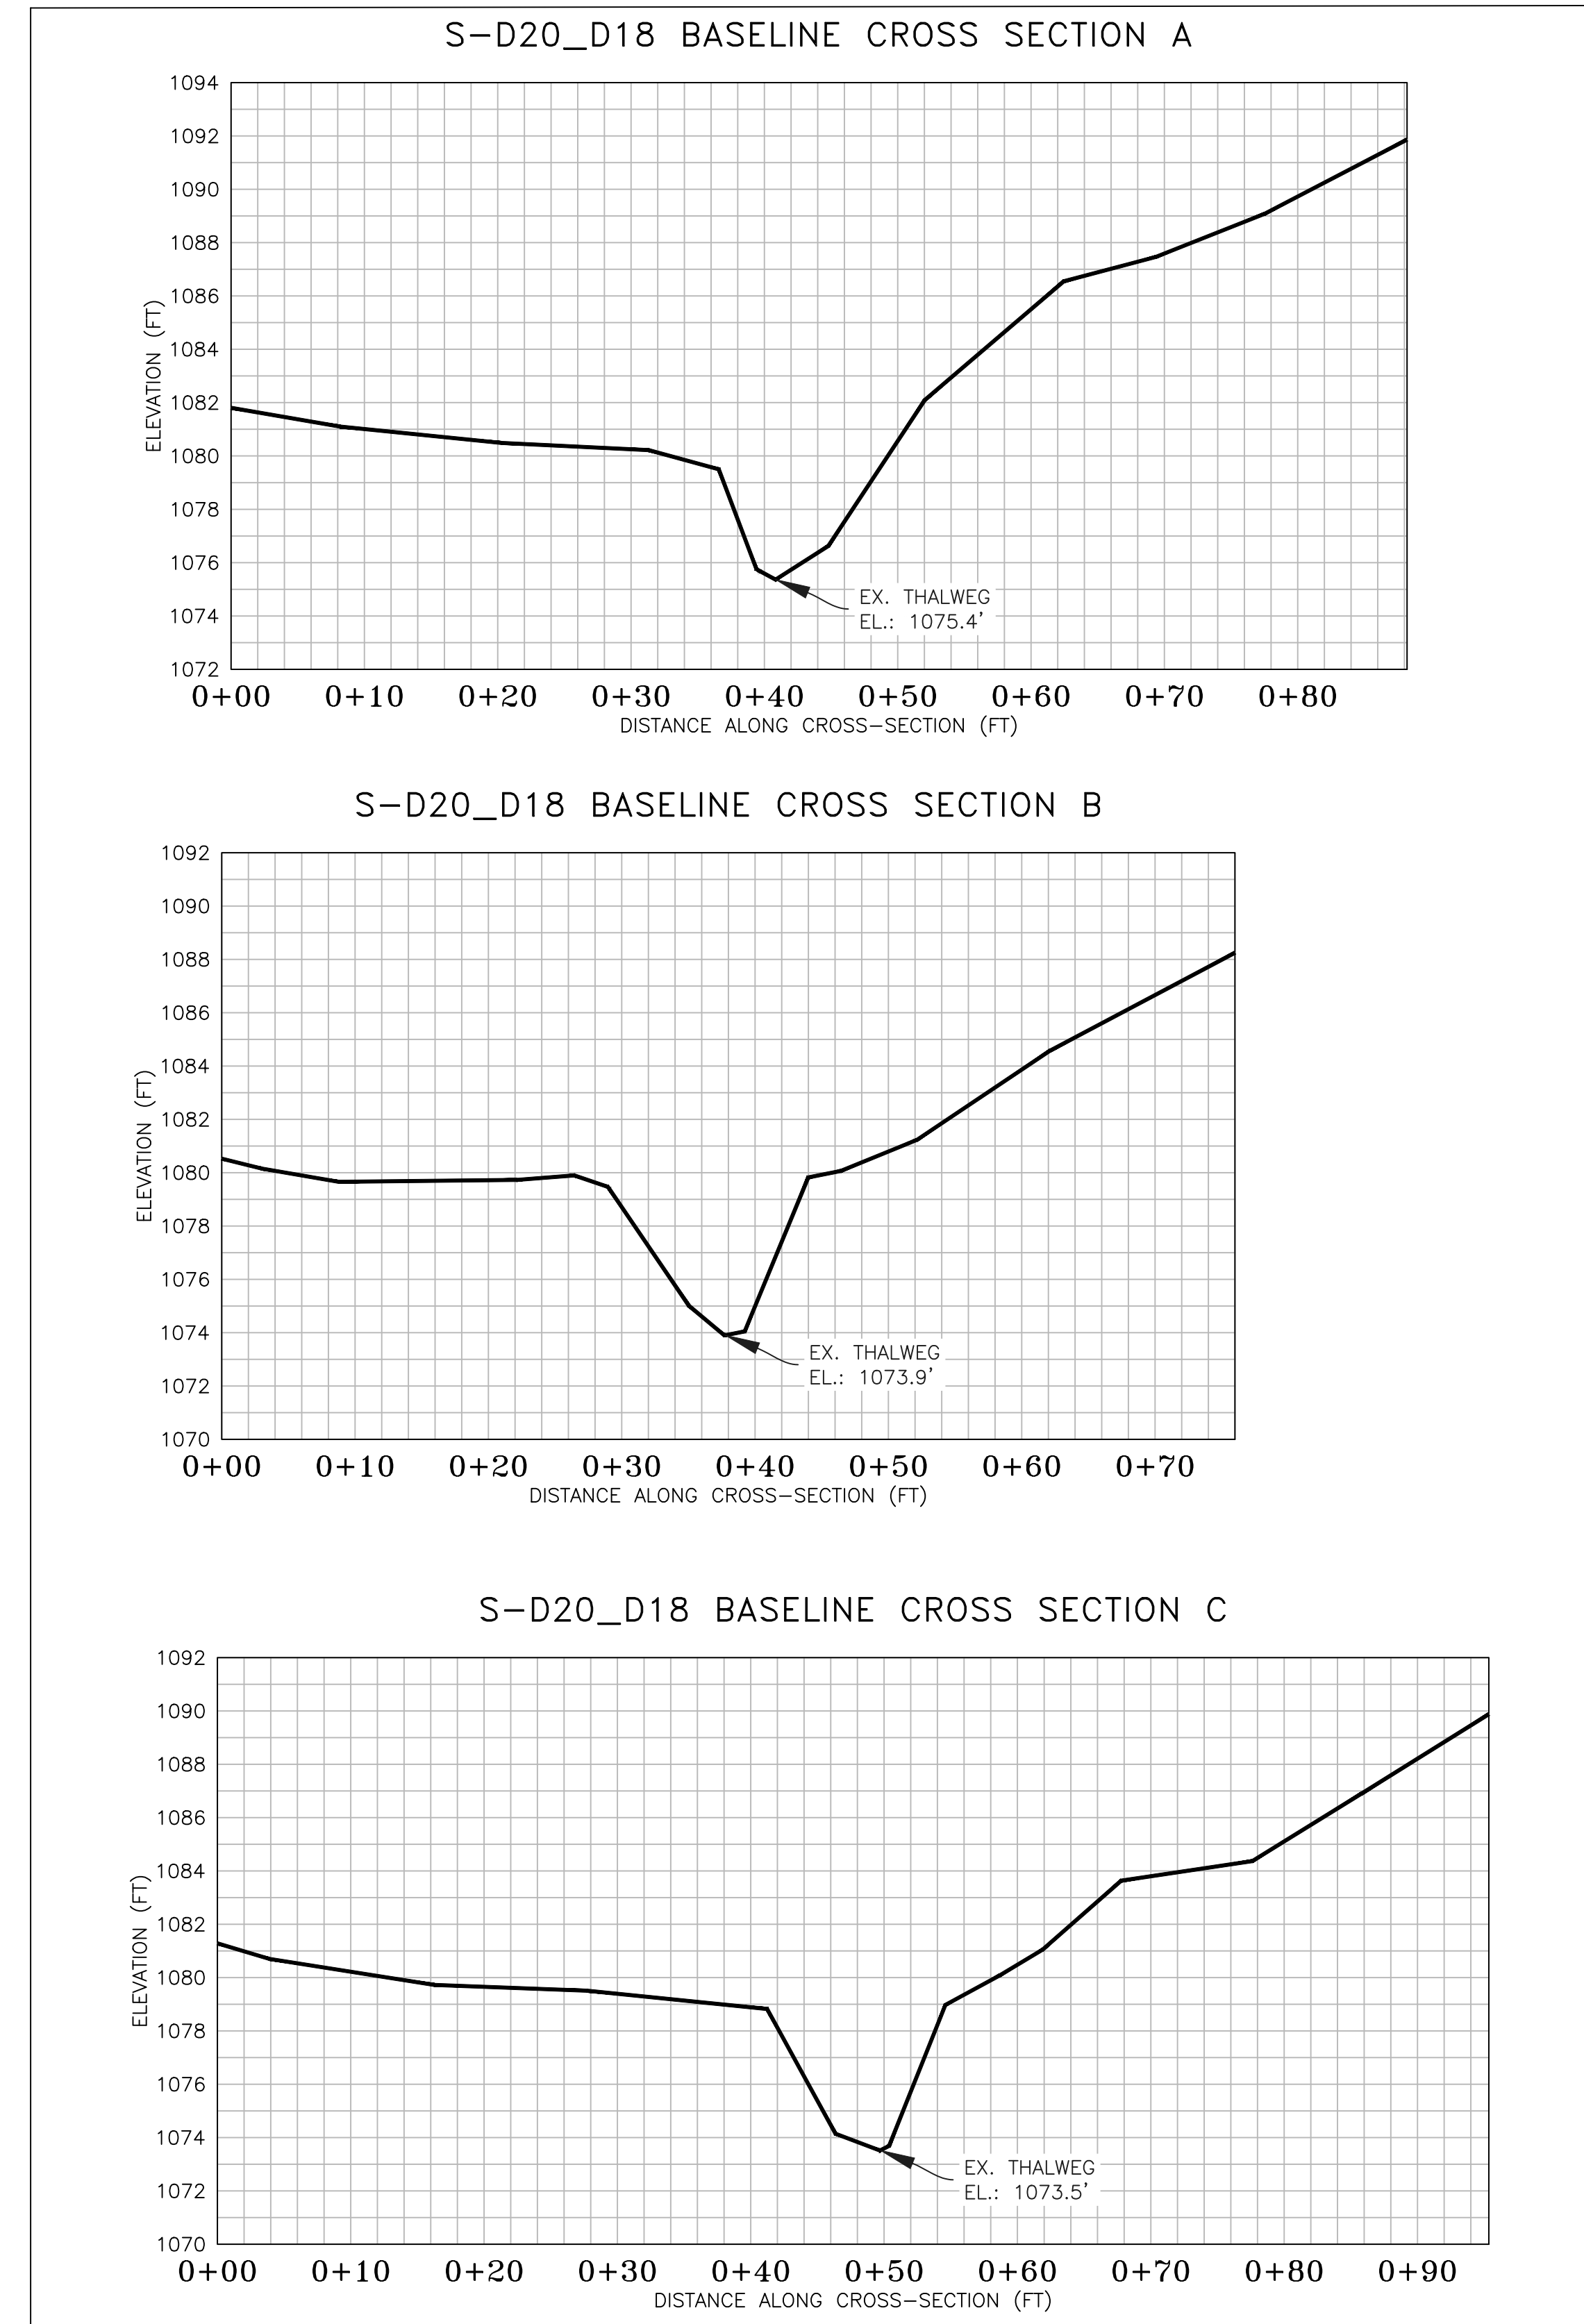
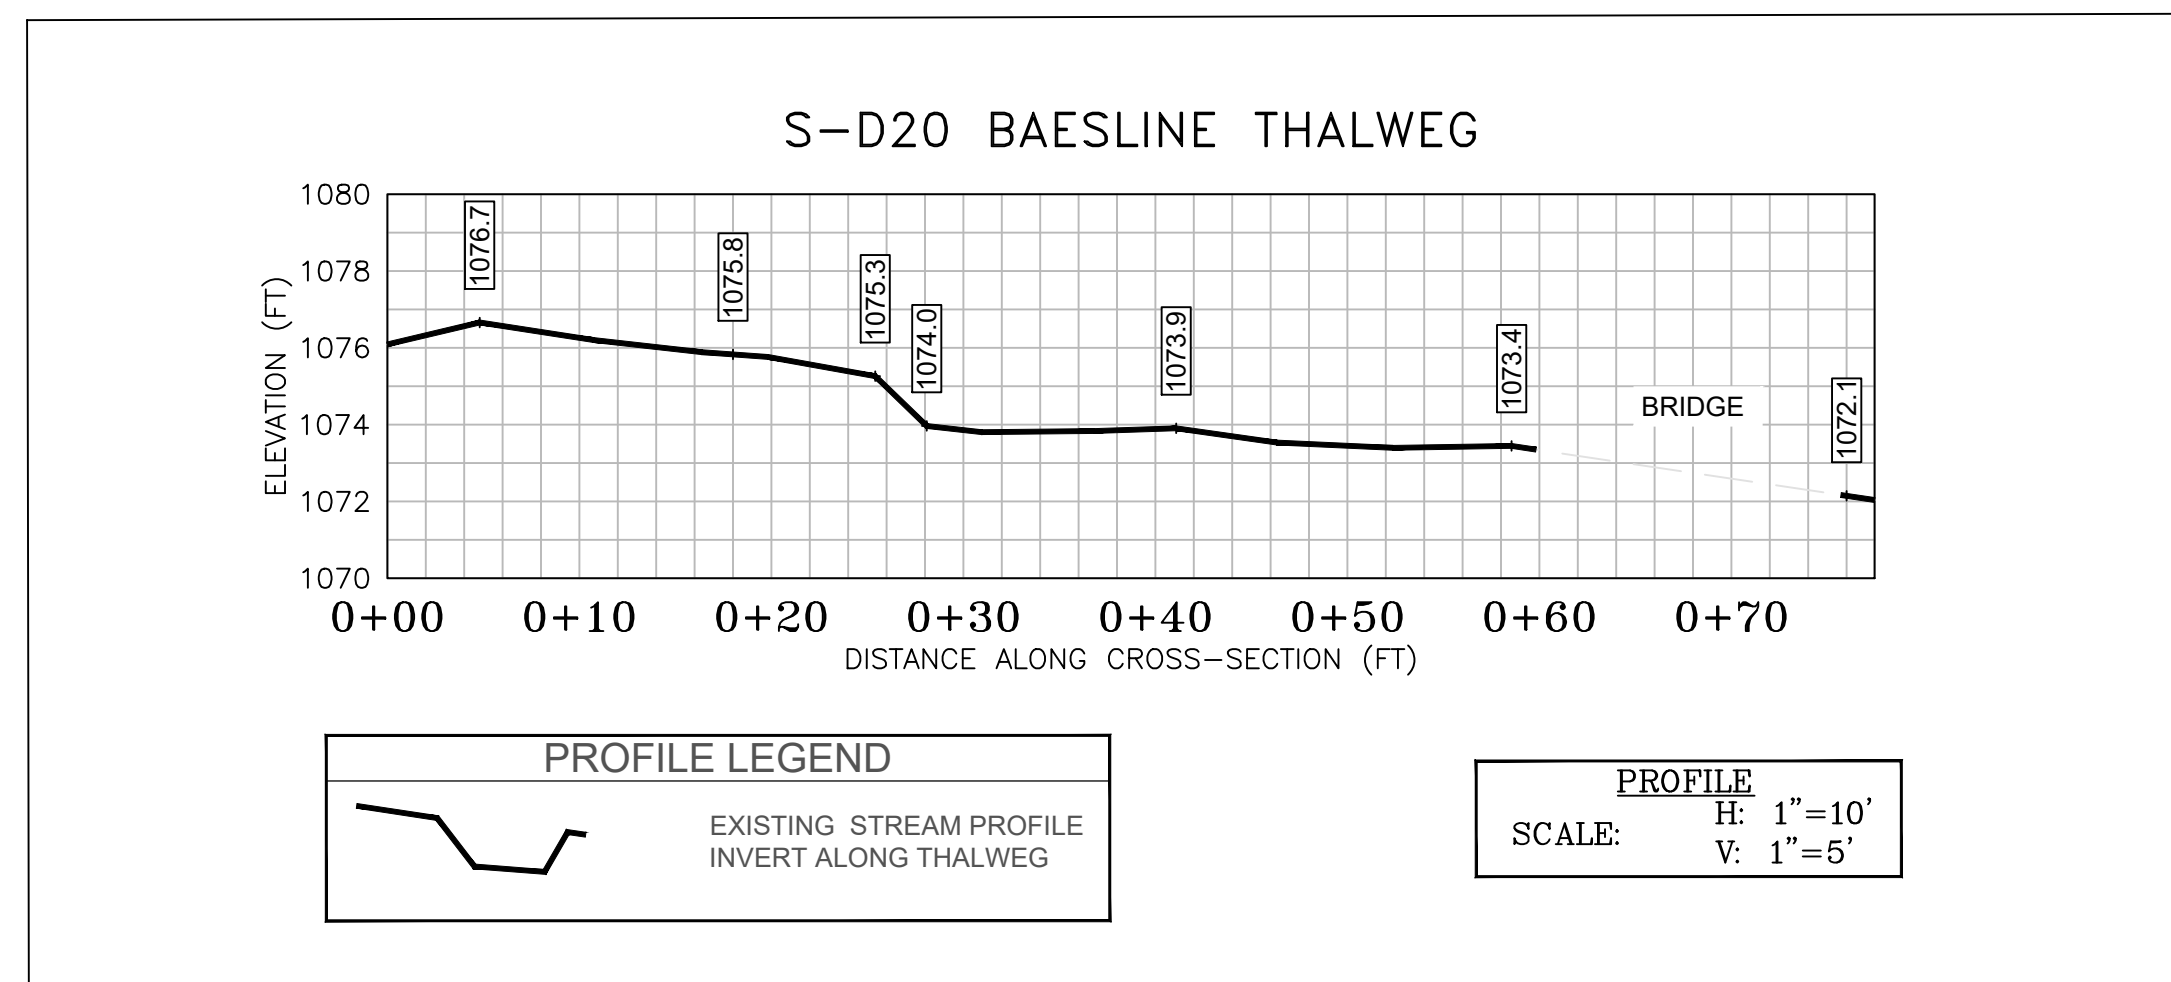
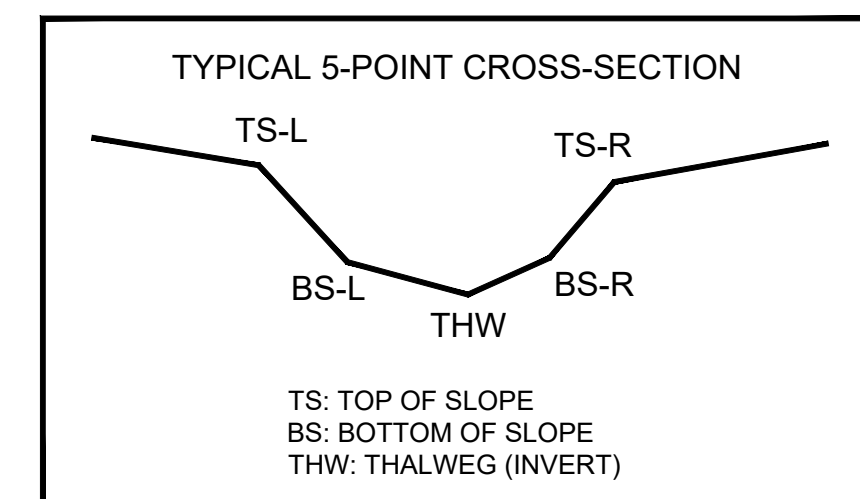
1. This map has been oriented to NAD 1983 UTM ZONE 17N, and vertically to The North American Vertical Datum of 1988 (NAVD 88), using a Real Time Network (RTN) GPS. Field locations were completed on December 18, 2018.
2. Monumentation, including traverse stations and fly points, shown on this drawing should be used to orient any future boundary, topographic, or location survey.
3. Easement lines shown on plan view were provided by Mountain Valley Pipeline.
4. WSSI Contour Interval = 2.0'. Contours within the channel were interpolated using stream channel breaklines (i.e. top of slopes, toe of slopes, thalweg) and cross-sectional points. Contours outside the channel were interpolated using cross-sectional spot shots.
5. All section views shown are left to right facing downstream.

CROSS SECTION
SCALE: H: 1"=10'
V: 1"=5'
