## Baseline Assessment – Stream Attributes

### Reach S-II2 (Pipeline ROW) Perennial Spread I Franklin County, Virginia

**Spread I    Stream S-II2 (Pipeline ROW)    Franklin County**

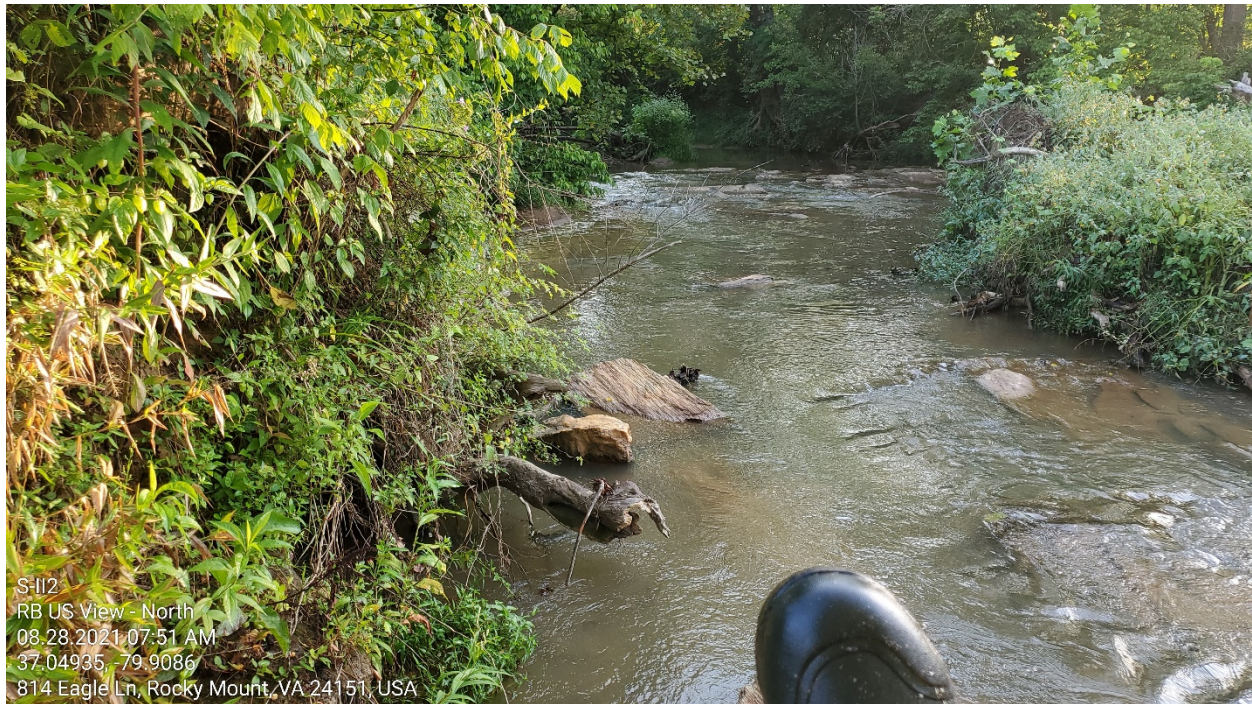
Photo Type: RB US VIEW

Location, Orientation, Photographer Initials: Downstream at ROW/LOD on right bank looking N upstream, DW

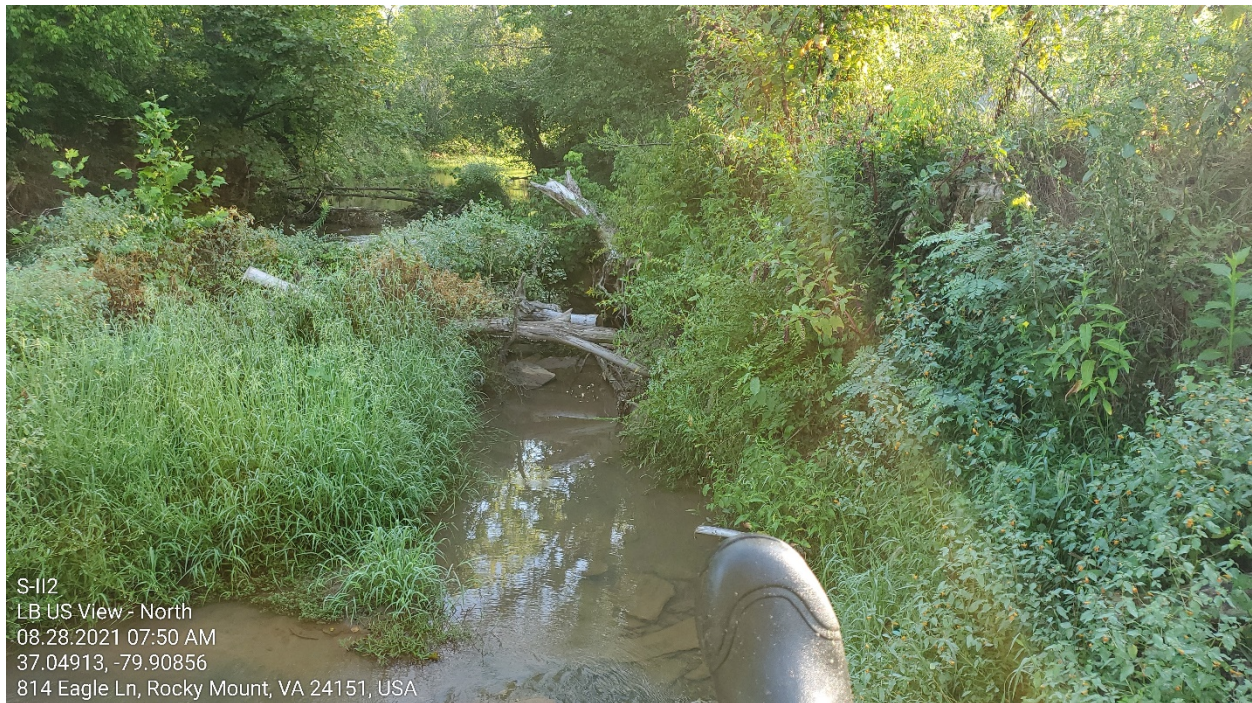
Photo Type: LB US VIEW

Location, Orientation, Photographer Initials: Downstream at ROW/LOD on left bank looking N upstream, DW

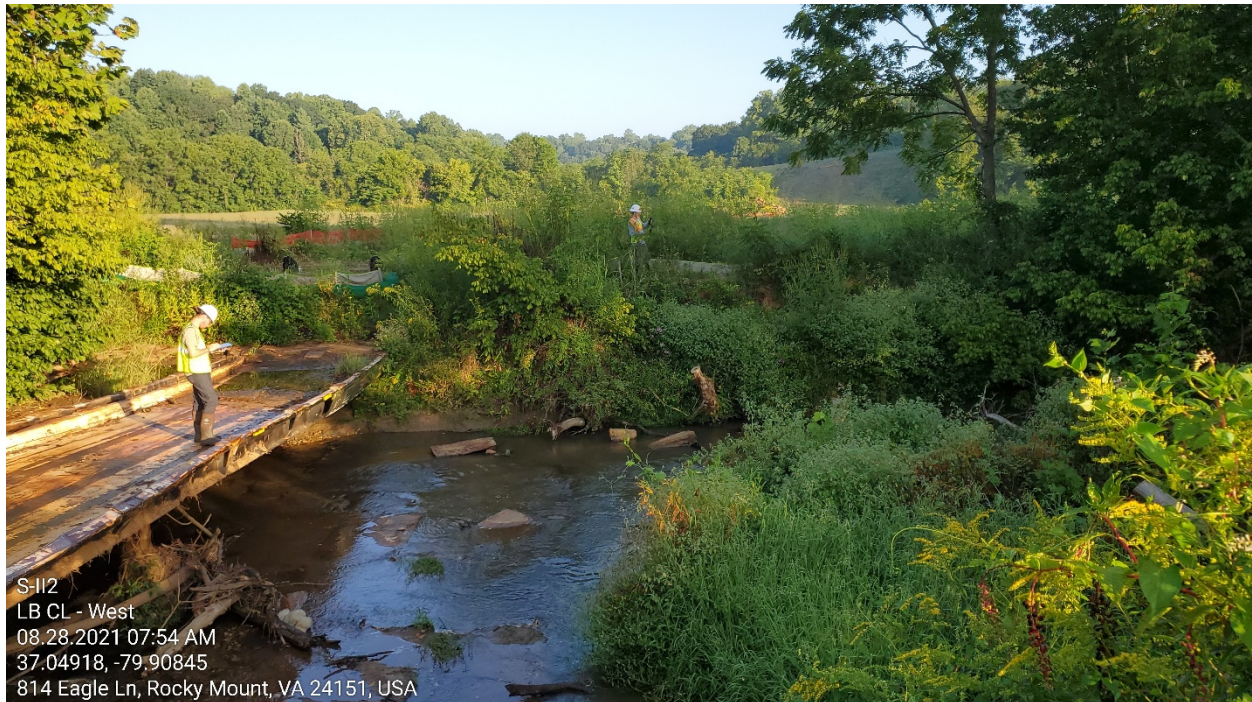
Photo Type: LB CL

Location, Orientation, Photographer Initials: On thalweg at pipe centerline looking W at right streambank, DW

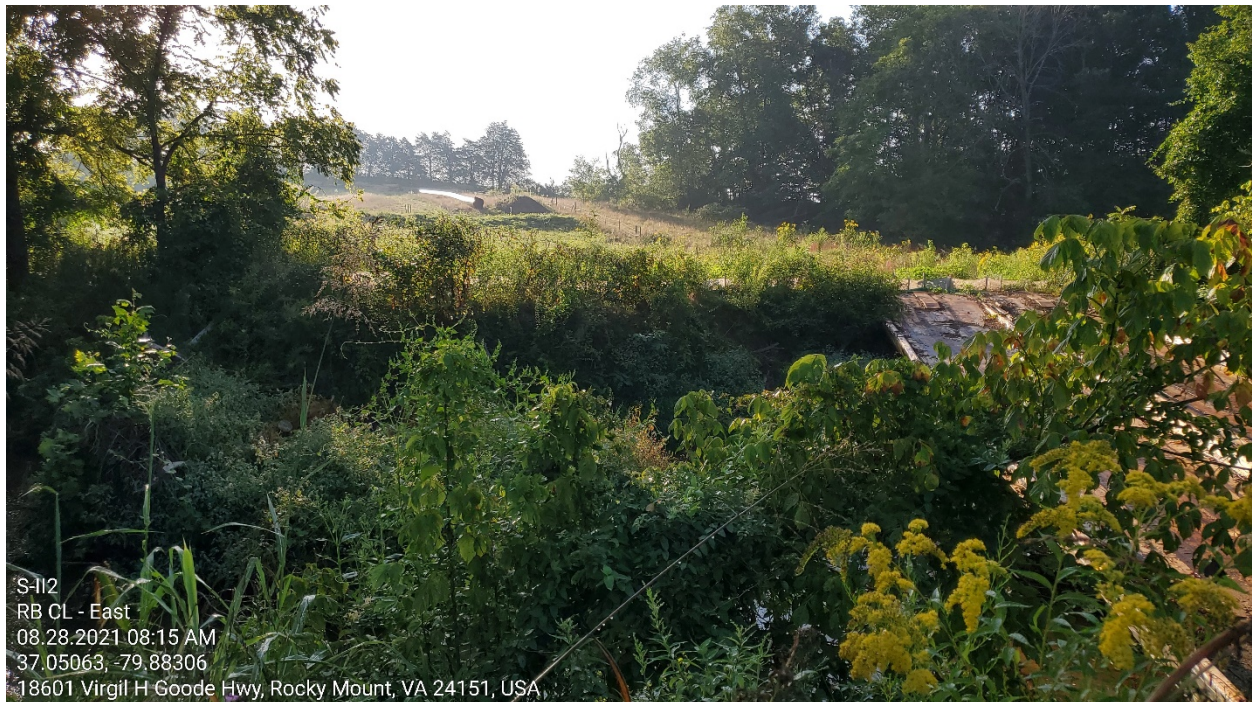
Photo Type: RB CL

Location, Orientation, Photographer Initials: On thalweg at pipe centerline looking E at left streambank, DW

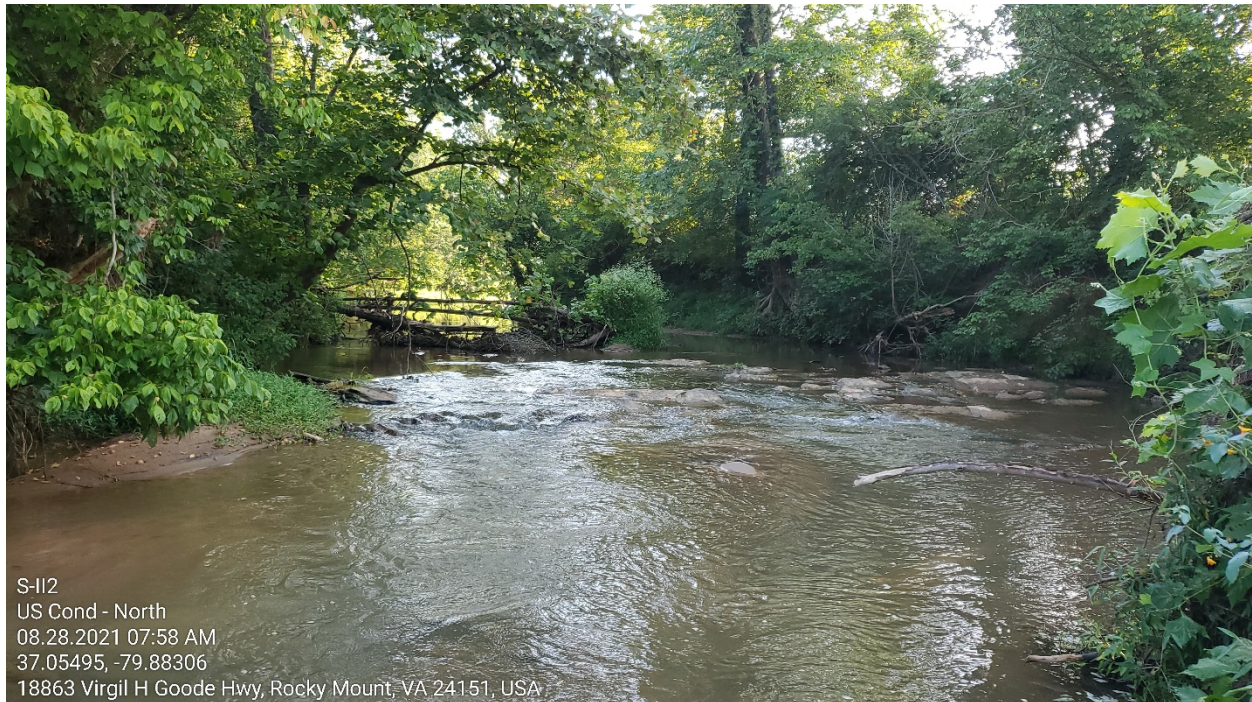
Photo Type: US COND

S-II2  
US Cond - North  
08.28.2021 07:58 AM  
37.05495, -79.88306  
18863 Virgil H Goode Hwy, Rocky Mount, VA 24151, USA

Location, Orientation, Photographer Initials: Upstream at ROW/LOD looking N upstream, DW

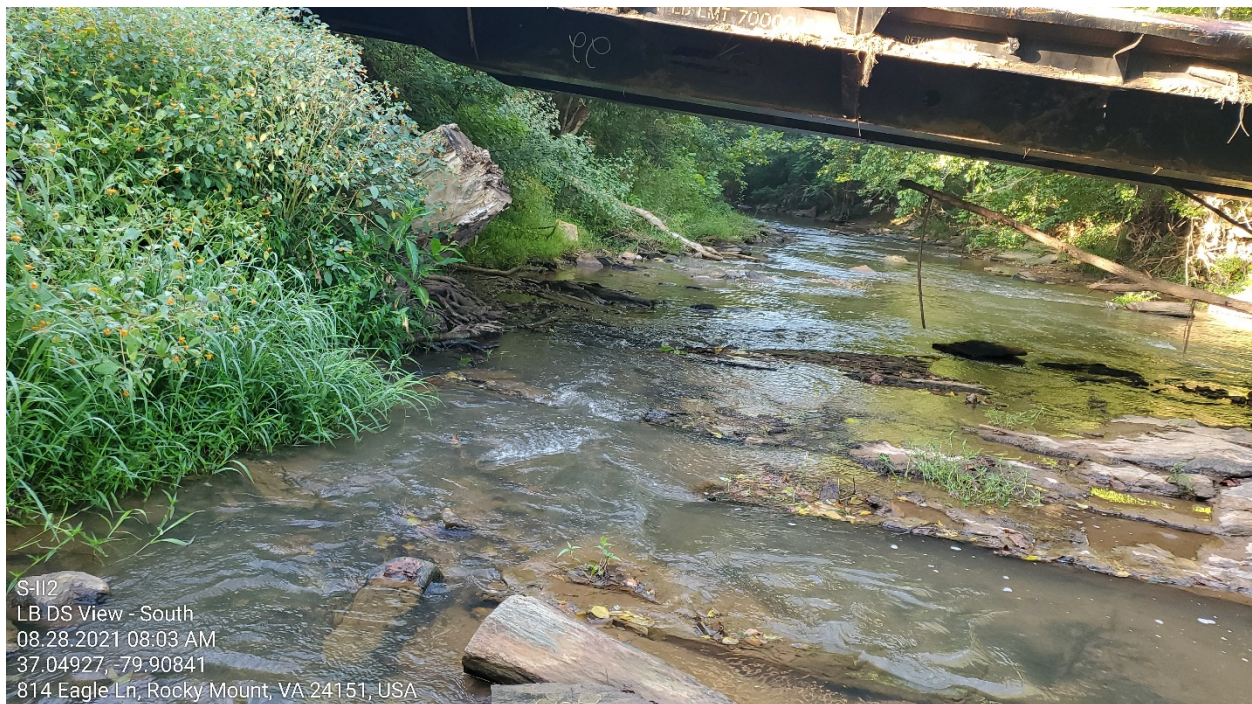
Photo Type: LB DS VIEW

S-II2  
LB DS View - South  
08.28.2021 08:03 AM  
37.04927, -79.90841  
814 Eagle Ln, Rocky Mount, VA 24151, USA

Location, Orientation, Photographer Initials: Upstream at ROW/LOD on left bank looking S downstream, DW

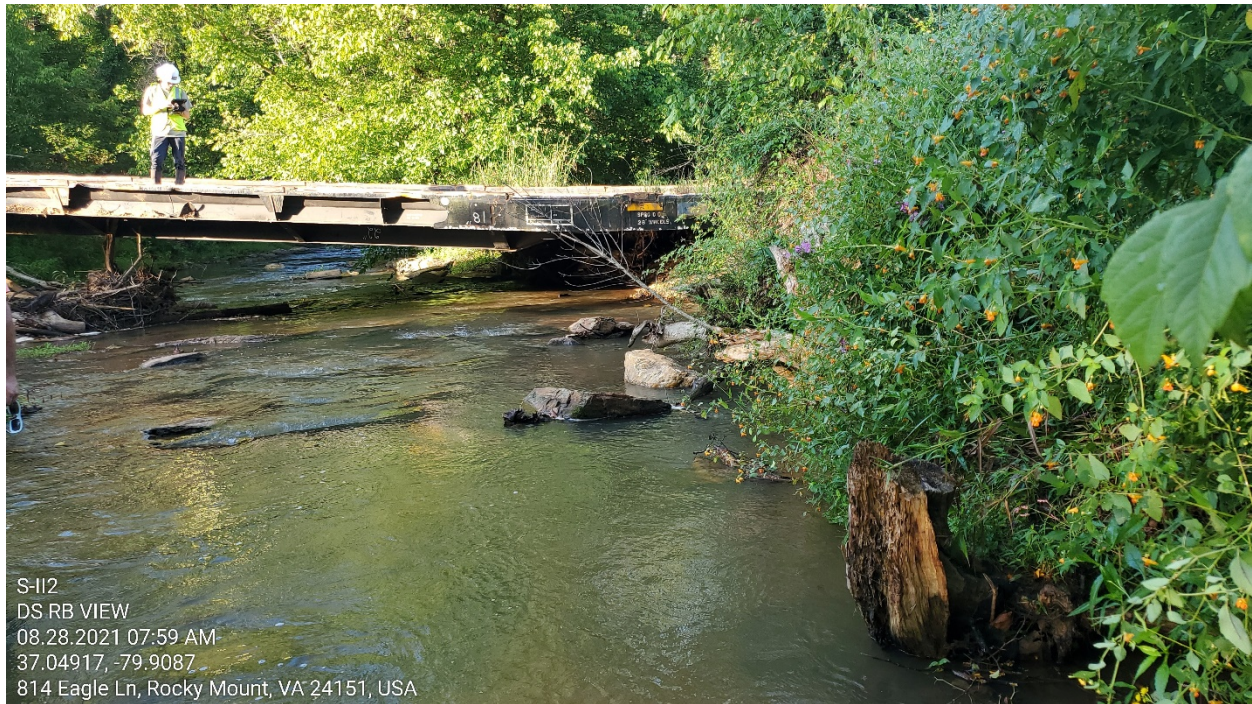
Photo Type: RB DS VIEW

Location, Orientation, Photographer Initials: Upstream at ROW/LOD on right bank looking S downstream, DW

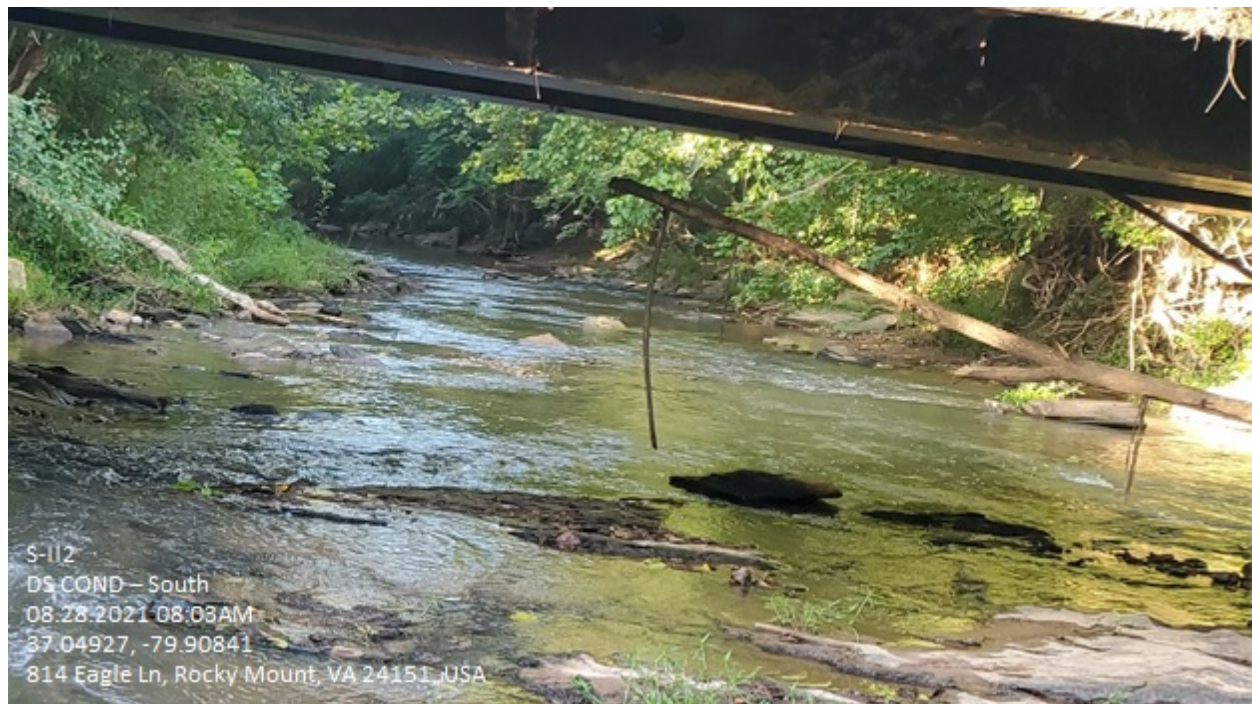
Photo Type: DS COND

Location, Orientation, Photographer Initials: Downstream at ROW/LOD looking S downstream, DW

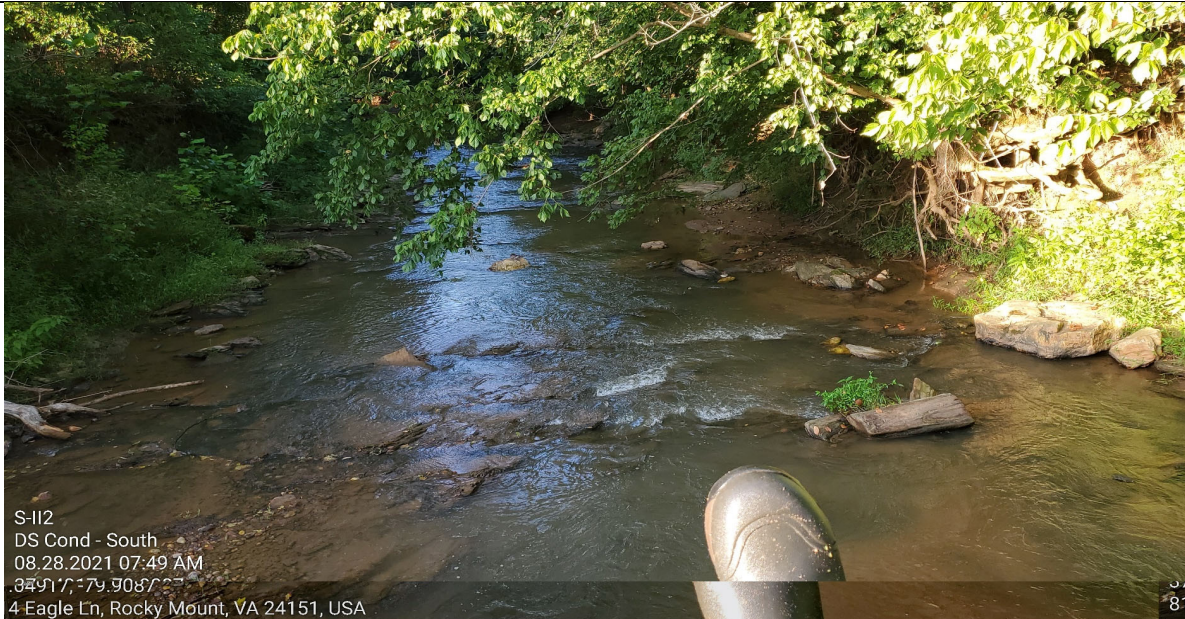
**CAPTION.** Assessment is limited to areas within the temporary ROW.

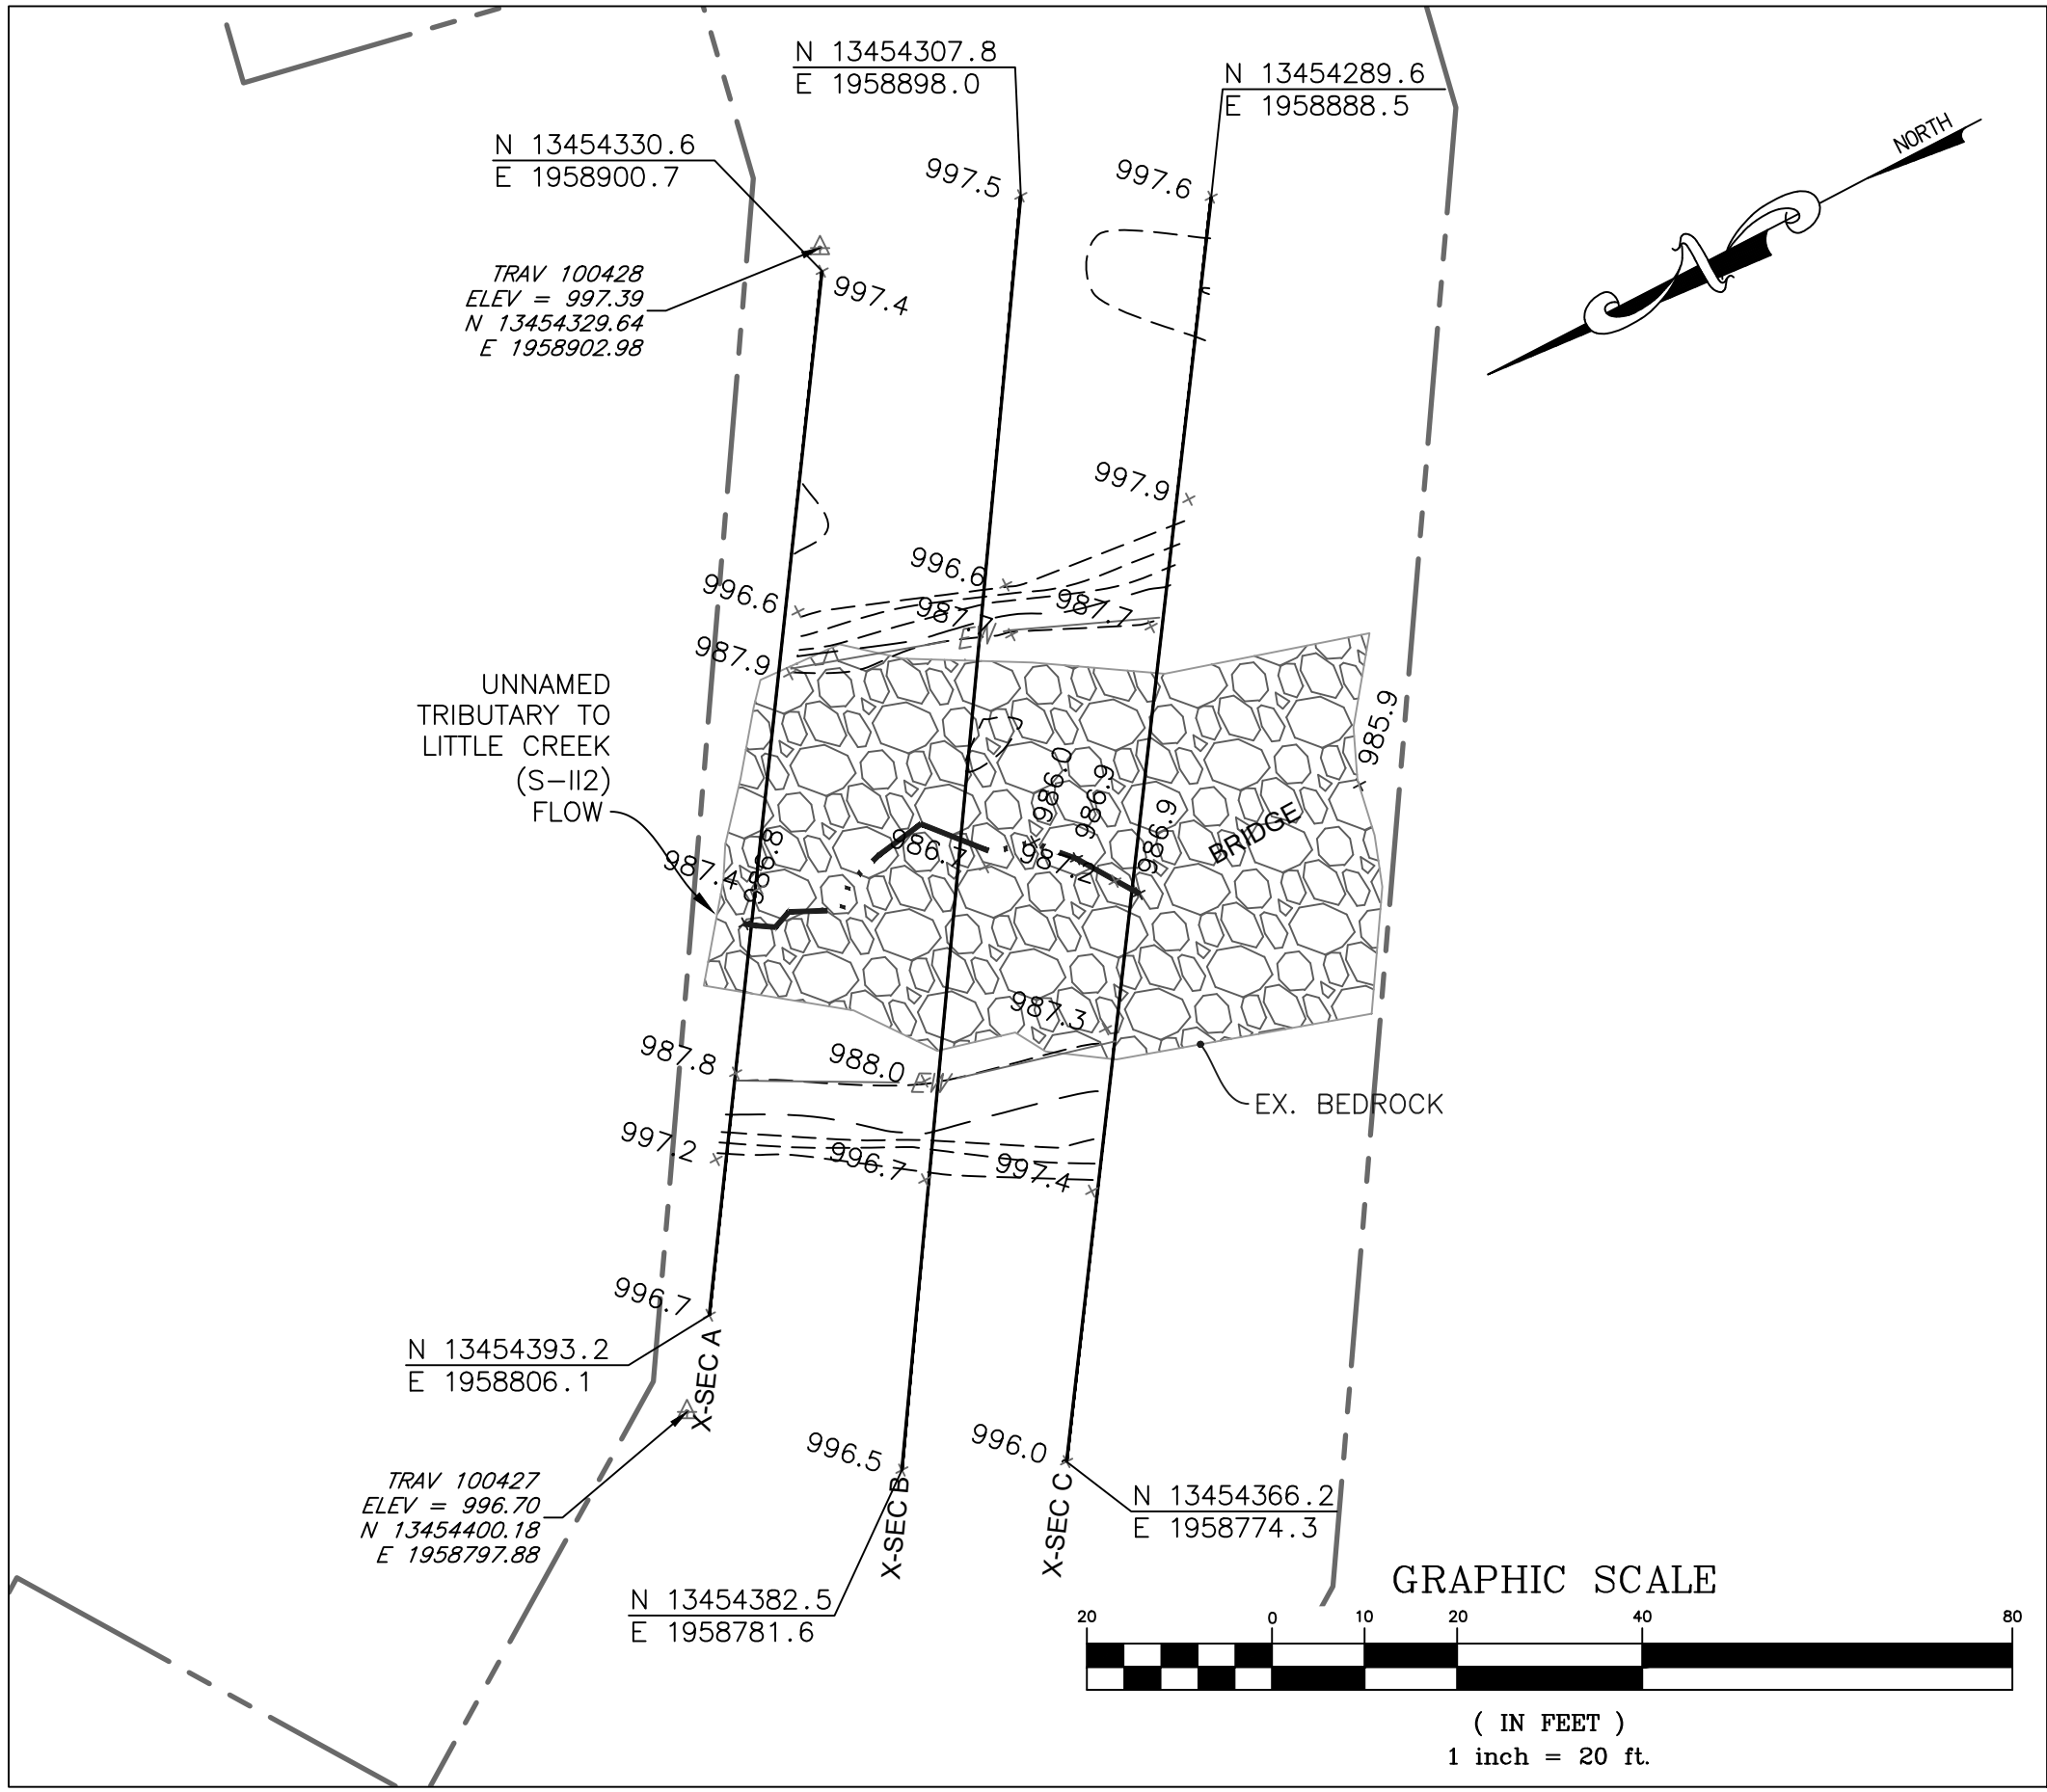
SURVEY NOTES:

- This map has been oriented to NAD 1983 UTM ZONE 17N, and vertically to The North American Vertical Datum of 1988 (NAVD 88), using a Real Time Network (RTN) GPS. Field locations were completed on August 30, 2018.
- Monumentation, including traverse stations and fly points, shown on this drawing should be used to orient any future boundary, topographic, or location survey.
- Easement lines shown on plan view were provided by Mountain Valley Pipeline (MVP).
- WSSI Contour Interval = 2.0'. Contours within the channel were interpolated using stream channel breaklines (i.e. top of slopes, toe of slopes, thalweg) and cross-sectional points. Contours outside the channel were interpolated using cross-sectional spot shots.
- All section views shown are left to right facing downstream.
- Cross-section B shot at location of pipe centerline (based on field stakes).

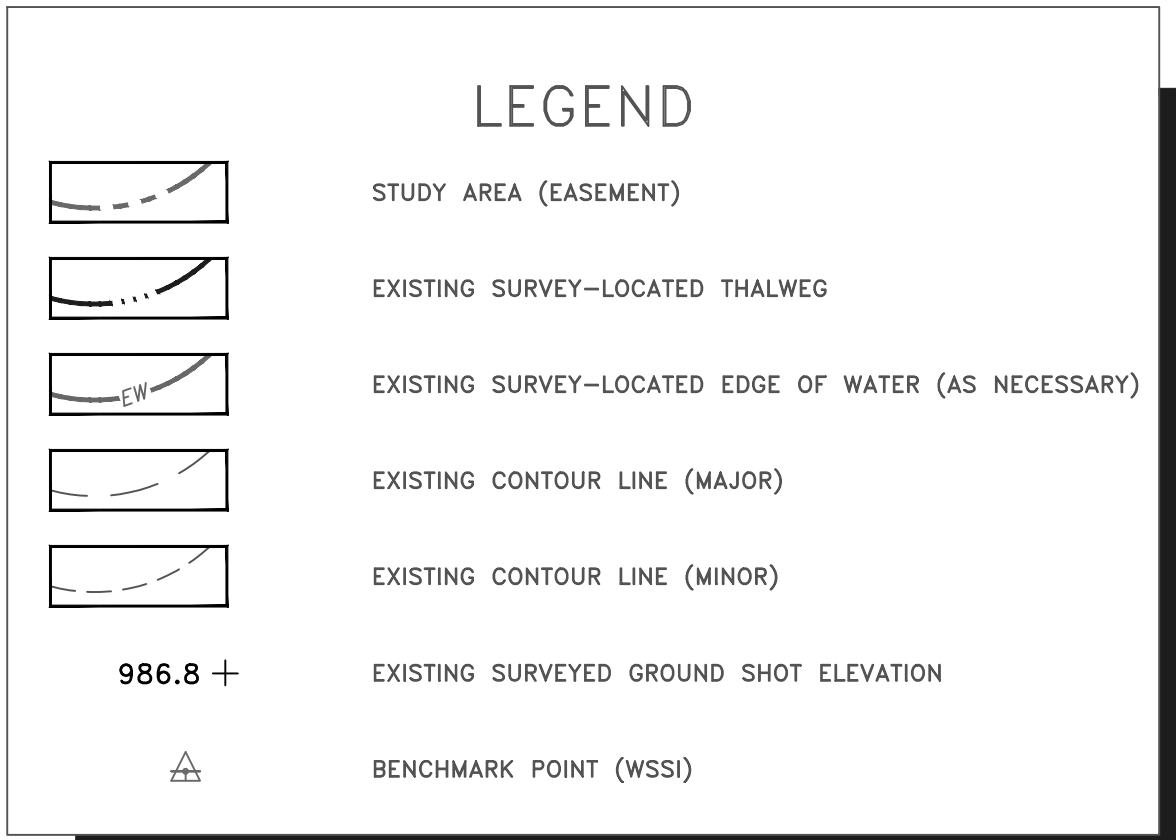
S-II2 BASELINE THALWEG PROFILE

NOTE: ALL SECTIONS VIEWS SHOWN FACING LEFT TO RIGHT FACING DOWNSTREAM.

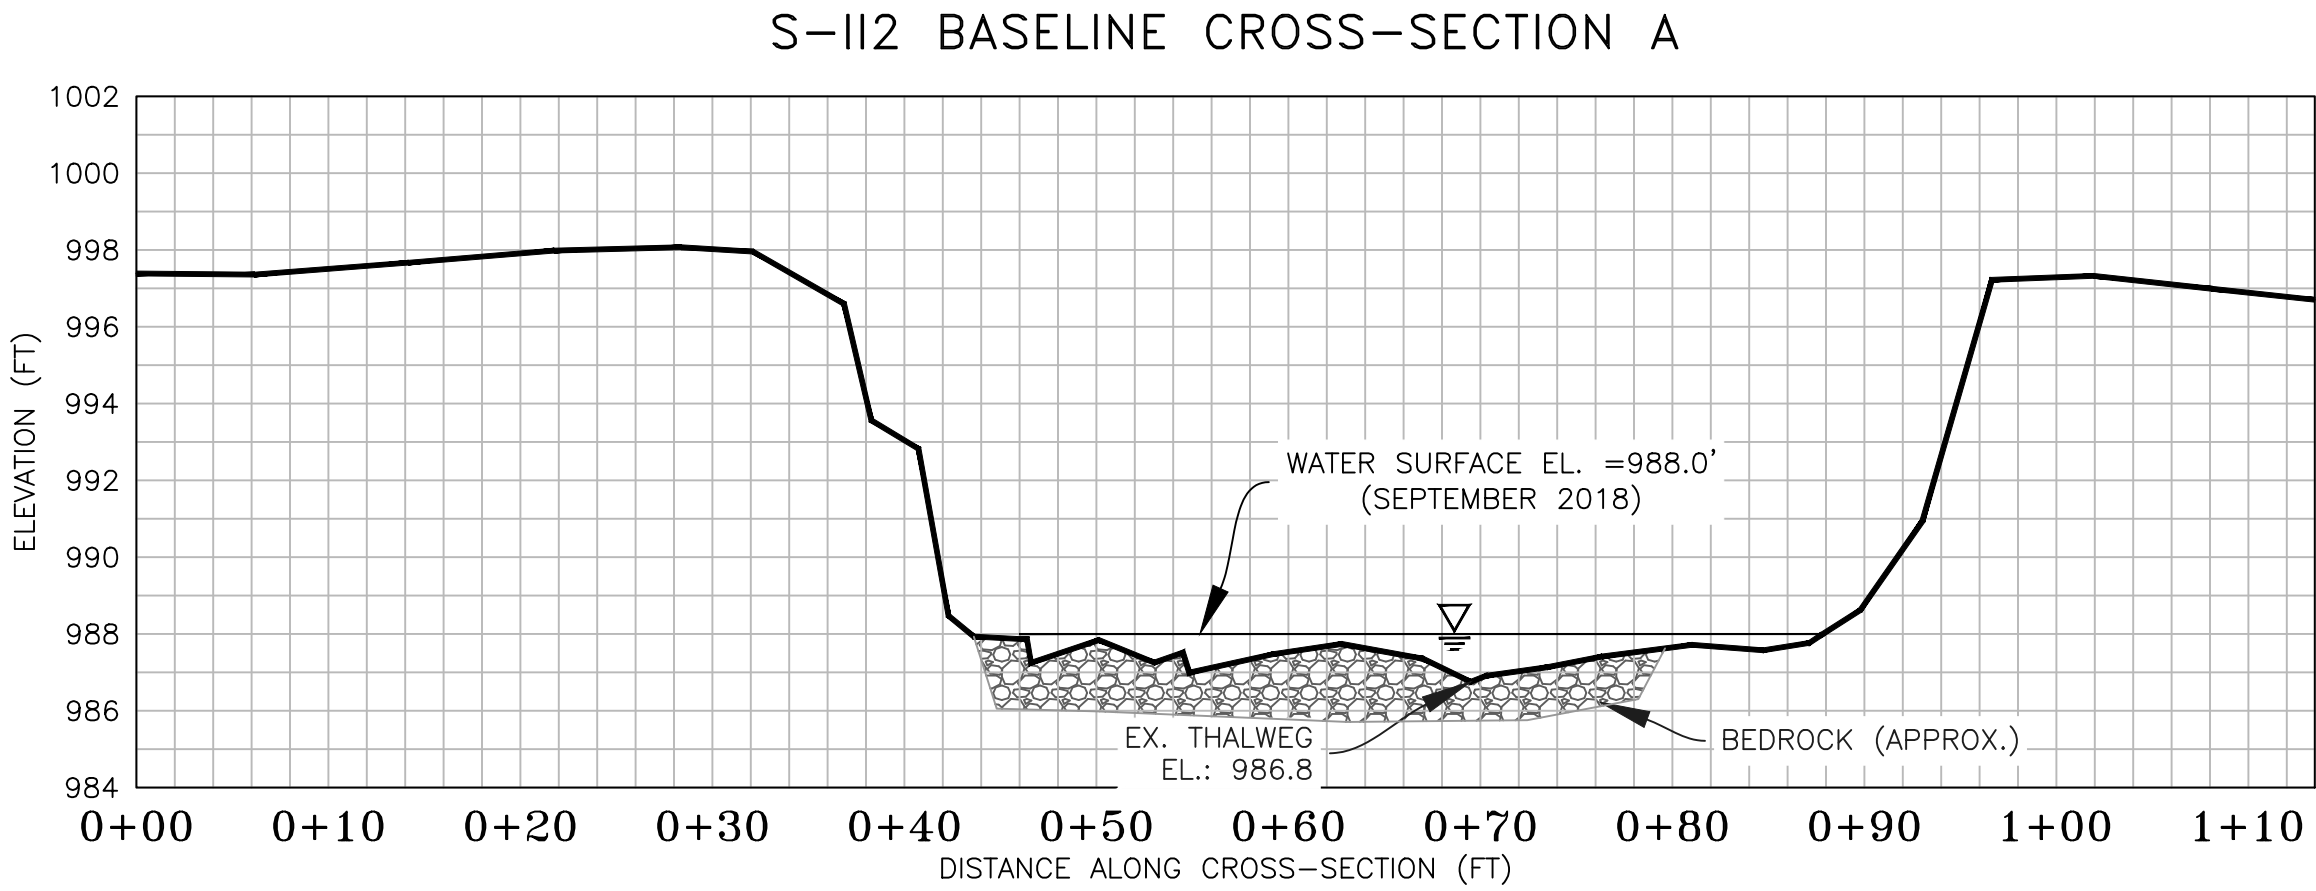
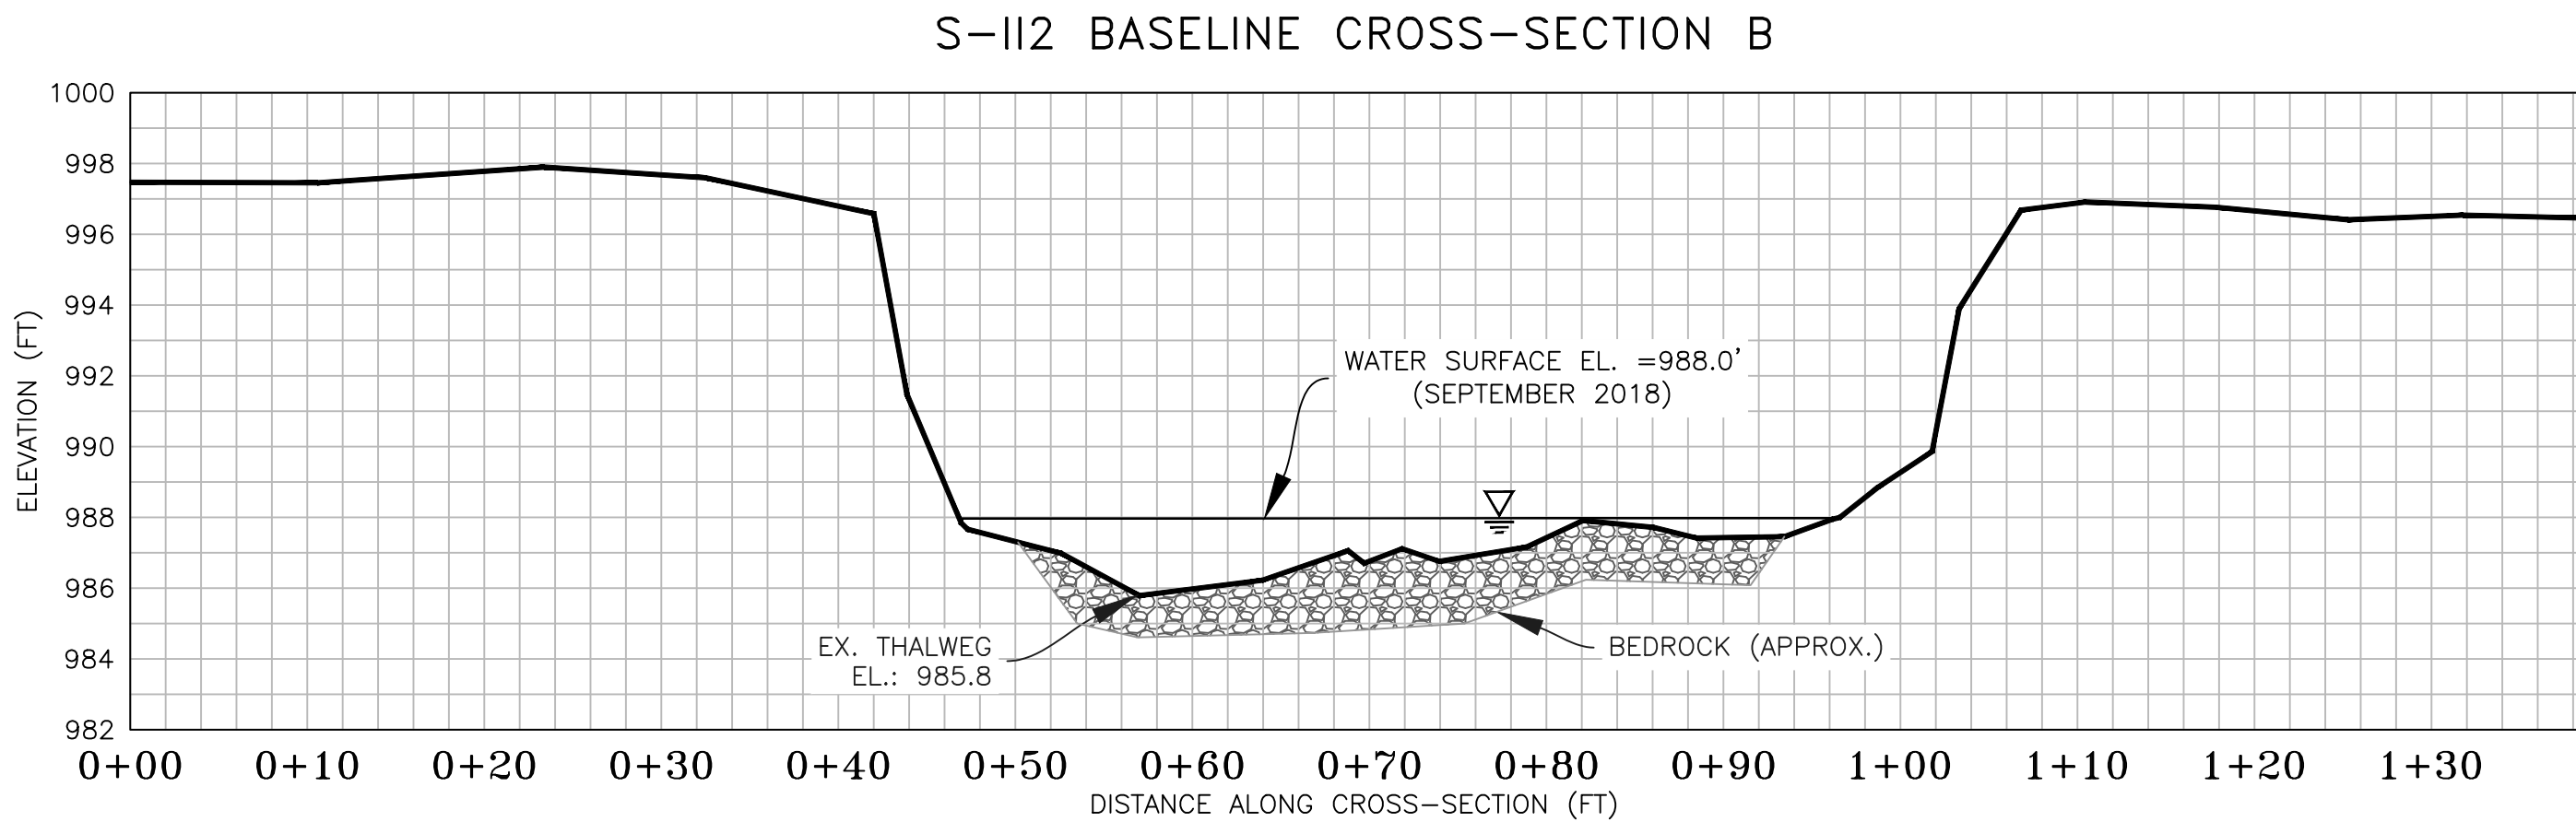
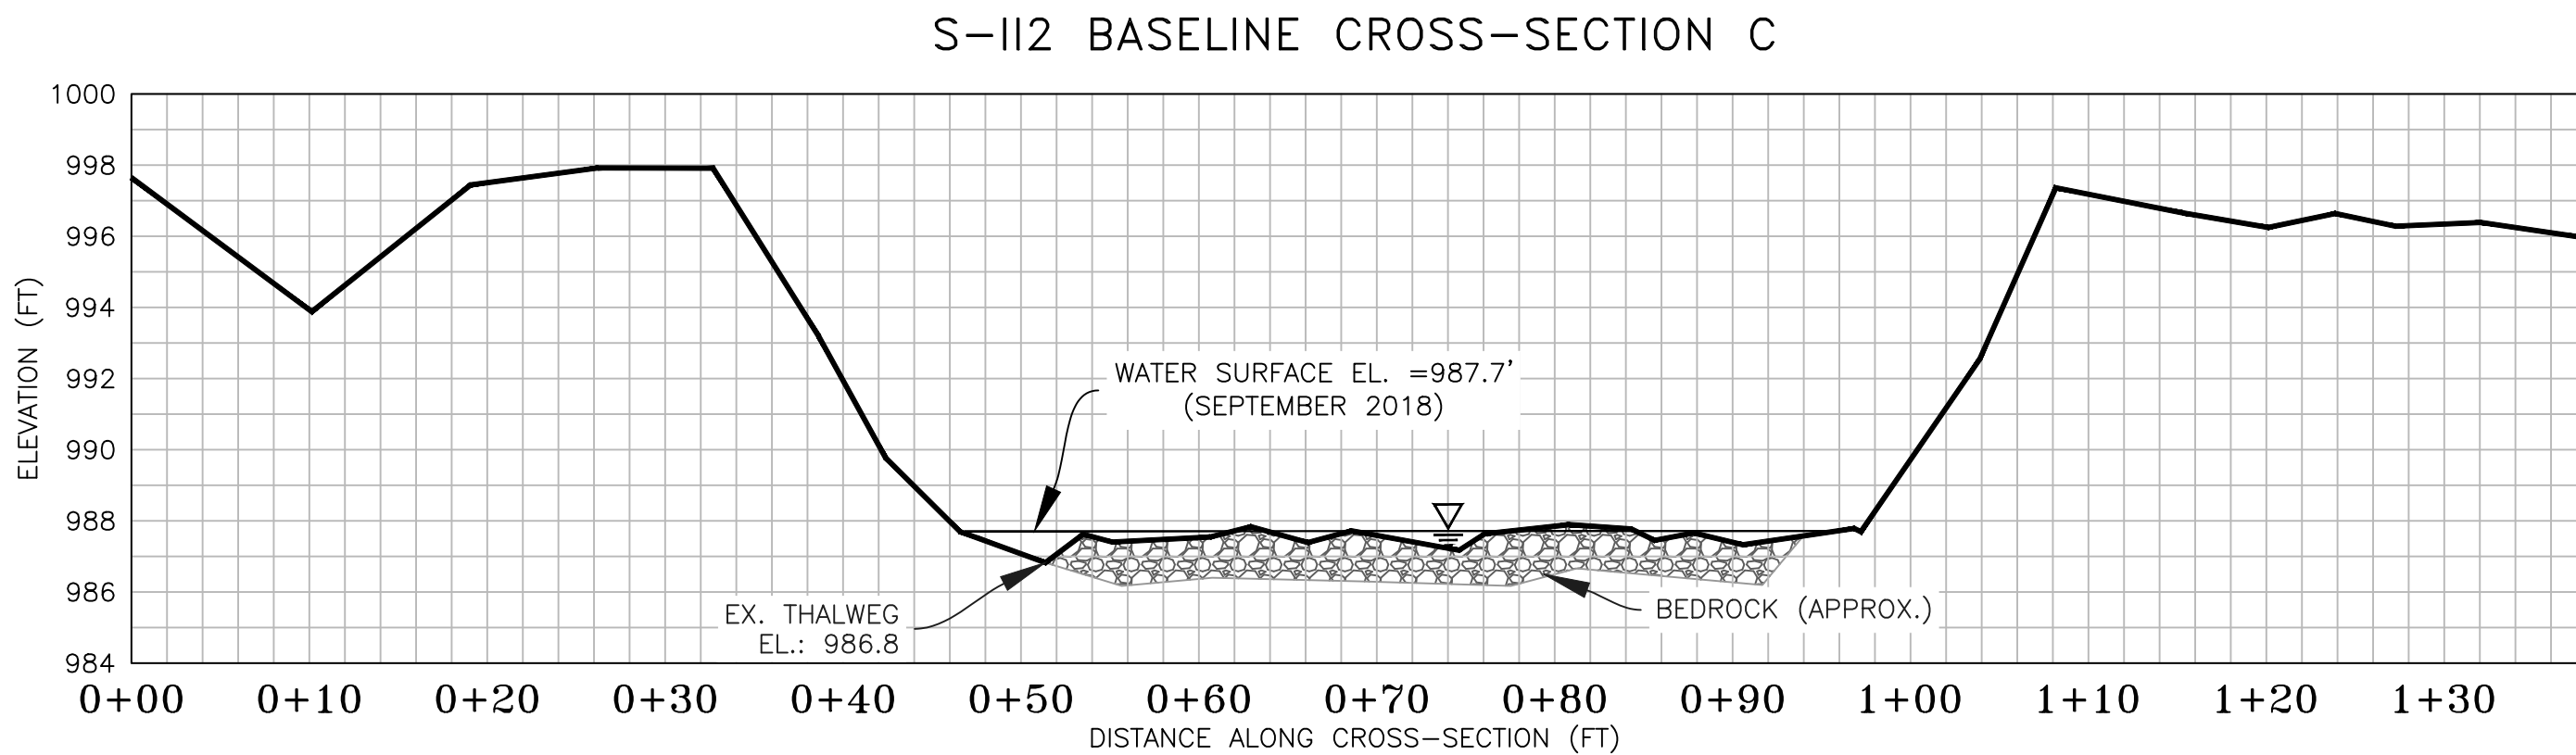
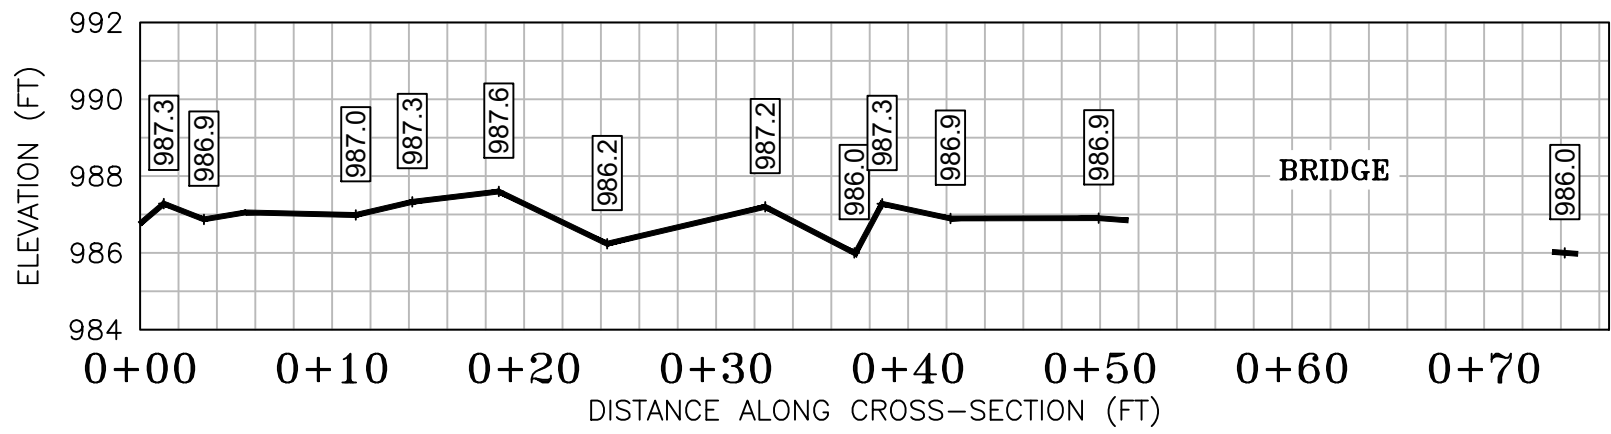
PROFILE  
SCALE: H: 1"=10'  
V: 1"=5'

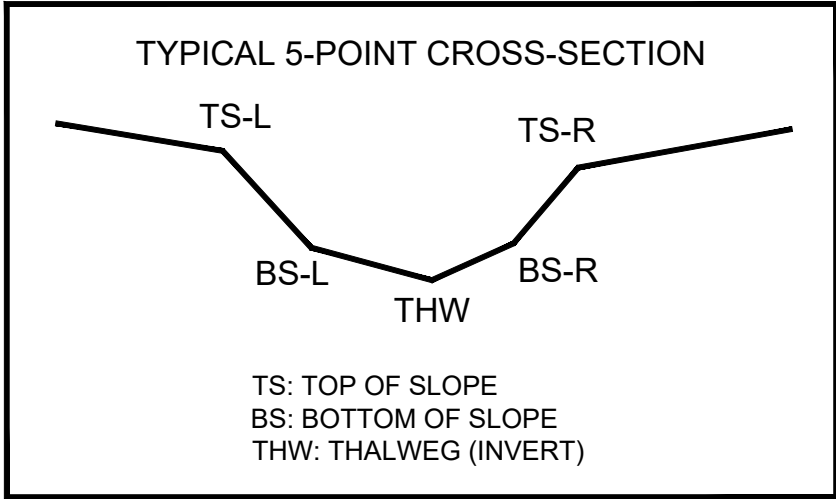
| CL STAKEOUT POINTS: S-II2 CROSS SECTION B (PIPE CL) | | | | |

| CL STAKEOUT POINTS: S-II2 CROSS SECTION B (PIPE CL) | | | | |
|---|---|---|---|---|
| PT. LOC. | PRE-CROSSING | | | POST-CROSSING |
| | NORTHING | EASTING | ELEV | VERT. DIFF. |
| TS-L | 13454365.85 | 1958808.36 | 996.68 | --- |
| BS-L | 13454361.42 | 1958817.70 | 987.99 | --- |
| THW | 13454344.50 | 1958835.39 | 986.69 | --- |
| BS-R | 13454330.45 | 1958856.37 | 987.66 | --- |
| TS-R | 13454328.55 | 1958861.43 | 996.58 | --- |
