## Baseline Assessment – Stream Attributes

### Reach S-Q15 (Pipeline ROW) Ephemeral Spread I Pittsylvania County, Virginia

**Stream S-Q15 (Pipeline ROW) Pittsylvania County**

Profile and Cross-Sections Baseline Survey

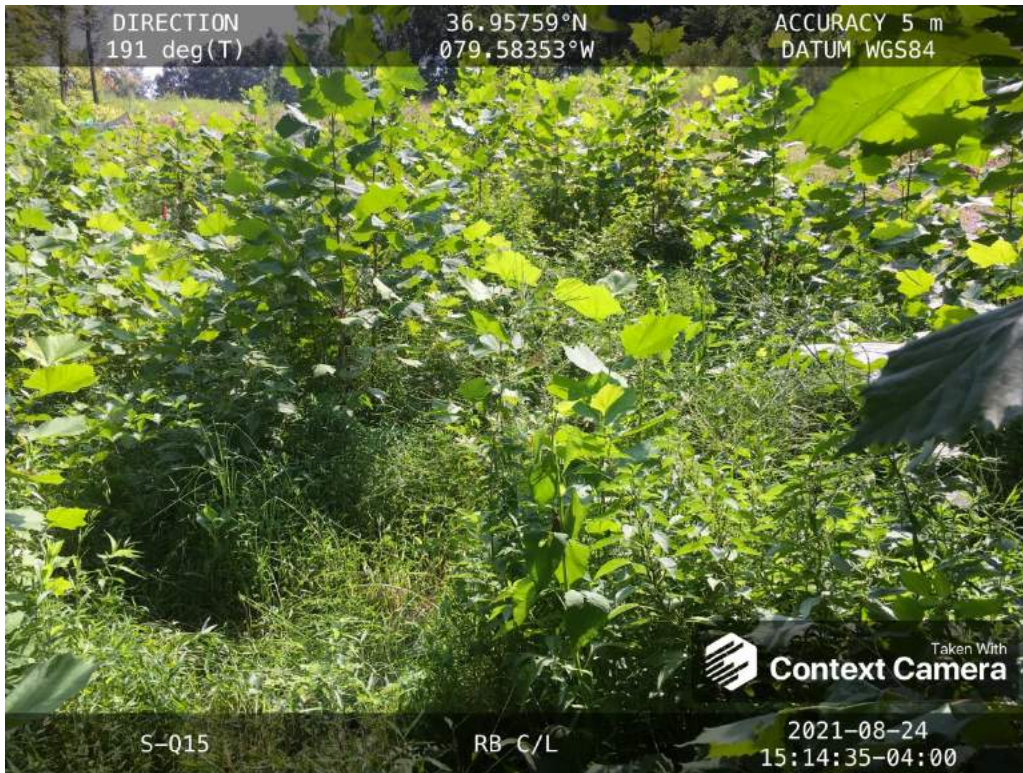
Photo Type: RB CL

Location, Orientation, Photographer Initials: On right bank at pipe centerline looking SW at left streambank, CB

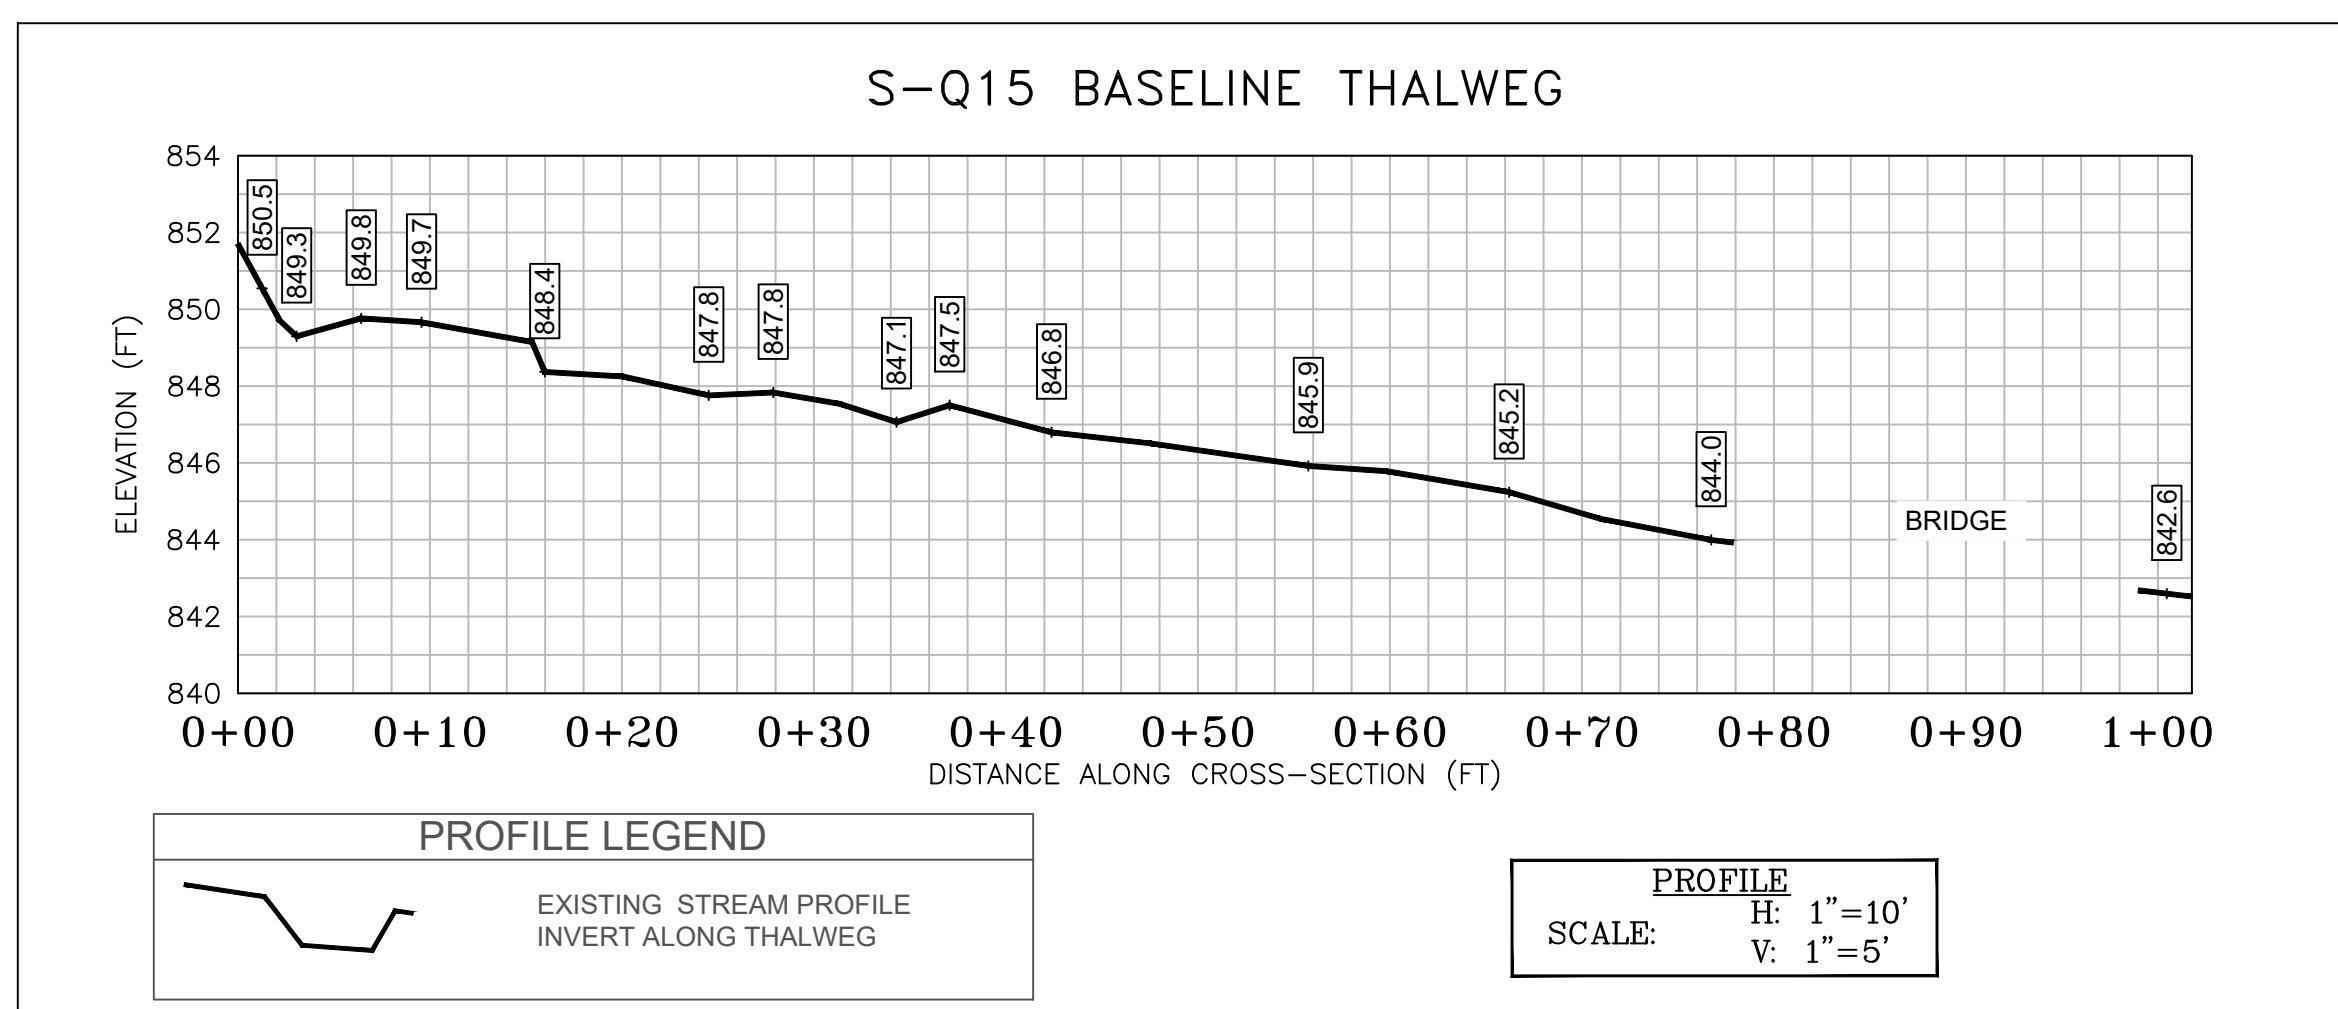
- This map has been oriented to NAD 1983 UTM ZONE 17N, and vertically to The North American Vertical Datum of 1988 (NAVD 88), using real time DGPS. Field locations were completed on January 11, 2019.
- Monumentation, including traverse stations and fly points, shown on this drawing should be used to orient any future boundary, topographic, or location survey.
- Easement lines shown on plan view were provided by Mountain Valley Pipeline (MVP).
- WSSI Contour Interval = 2.0'. Interpolated from cross-section and thalweg points without additional breakline shots.
- All section views shown left to right facing downstream.
- Cross section B shot at location of pipe centerline (based on field stakes).

CL STAKEOUT POINTS: S-Q15 CROSS SECTION B (PIPE CL)					
PT. LOC.	PRE-CROSSING			POST-CROSSING	
	NORTHING	EASTING	ELEV	VERT. DIFF.	HORZ. DIFF.
TS-L	13422212.67	2054157.08	847.22	----	----
BS-L	13422221.58	2054156.91	846.07	----	----
THW	13422223.26	2054156.73	845.77	----	----
BS-R	13422225.47	2054156.61	845.86	----	----
TS-R	13422229.69	2054156.38	846.11	----	----
